TECHNICAL MEMORANDUM

City of Brampton

Denison Avenue Extension Safety Review

Safety Review

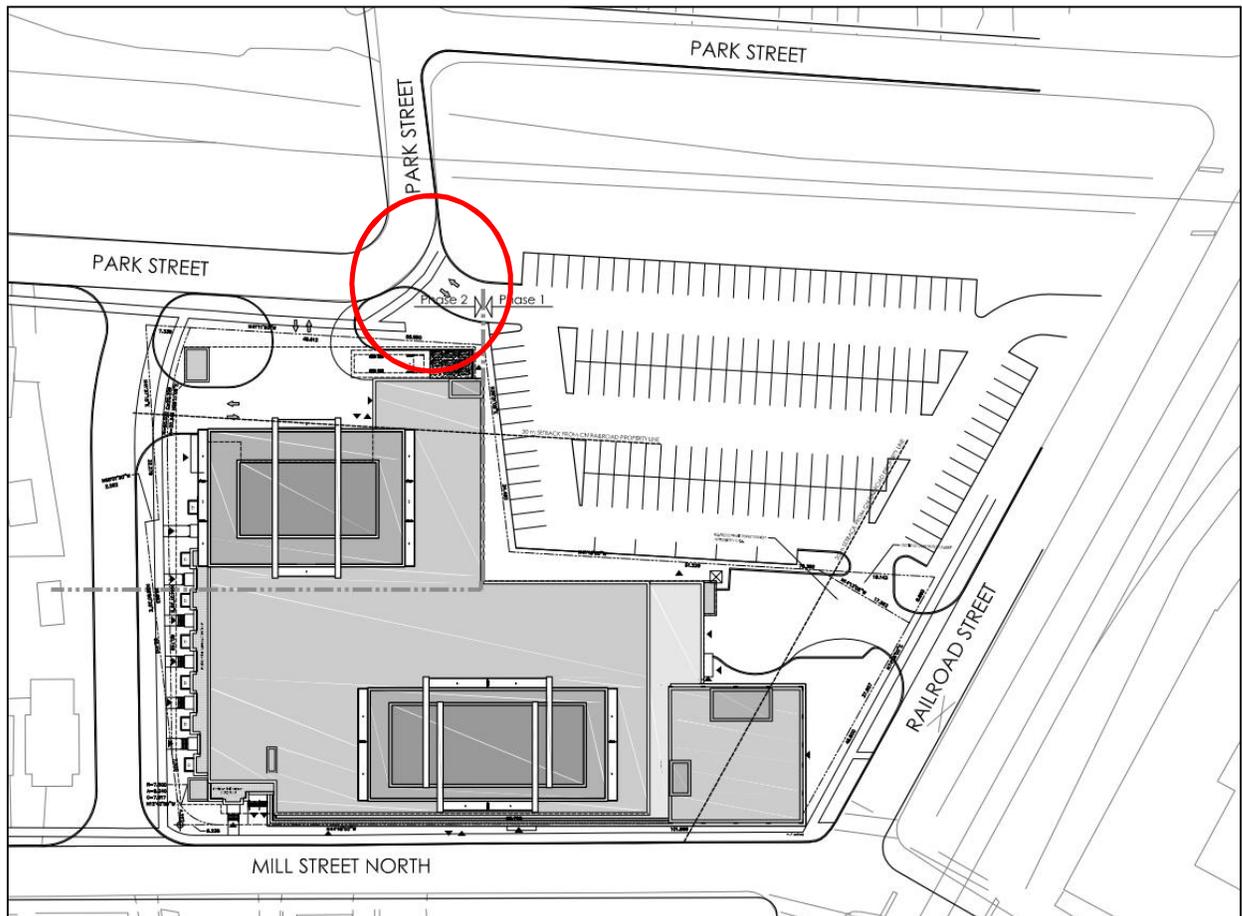
Figure 2-2
Site plan for 45 Railroad Street Development (areas of safety concern circled)

Areas of safety concern are highlighted in **Figure 2-2**. Placement of an access to the GO parking lot within the horizontal curve is considered problematic. According to the Transportation Association of Canada's (TAC) *Geometric Design Guide for Canadian Roads – Section 8.4.1*, 'accesses on horizontal curves are undesirable and should be avoided whenever possible'. The TAC Guide recommends that accesses be placed at least 150 metres from the end of a horizontal curve. Moreover, accesses on horizontal curve will have issues with decreased visibility, increased conflict potential for vehicles crossing the major roadway and pavement widening requirements through the horizontal curve. These safety concerns are somewhat mitigated given that the access is on the outside of the horizontal curve, offering adequate sightlines along both Park Street to the south and Denison Avenue to the west, along with the relatively low volume of traffic on these two roadways. Discussion on the proximity of the Metrolinx access on Park Street to the OBRY grade crossing is discussed in **Section 2.5**.

- The following was noted in the review of the Denison Avenue railway crossing:
 - The proposed access (owned by Metrolinx) noted in the 45 Railroad Street Site Plan (Figure 2-2) will fall within 30 metres of the railway crossing, as such it does not conform to the minimum requirements of the *Grade Crossing Standards*;

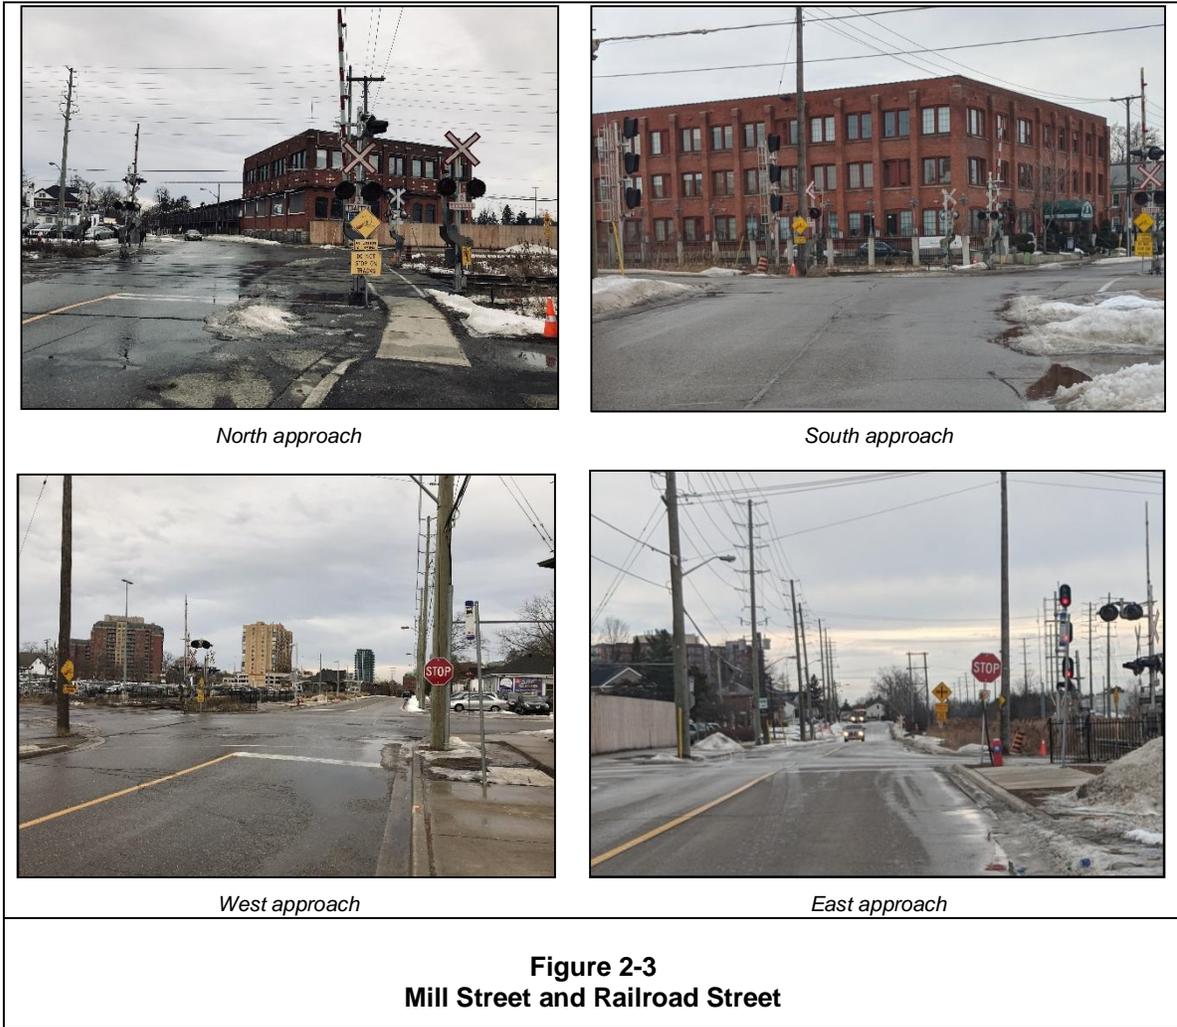
Mill Street at Railroad Street is a unique four-legged intersection, with stop control on Railroad Street. Views of the intersection are shown in **Figure 2-3**. Directly to the north is a set of double train tracks, operated by GO Transit and CN. Visibility on the northbound and eastbound approaches is limited due to the building on the southwest corner of the intersection. Drivers were observed creeping up past the stop bar to gain adequate visibility of northbound/southbound traffic. A review of the collision history suggests that the sightlines may be contributing to a pattern of angle collisions/turning movement collisions at the intersection. Six collisions were noted at this intersection, all were noted as 'angle' or 'turning movement'.

When a train arrives at the Brampton GO station, the train stops at the platform east of Mill Street. The gate at the crossing on Mill Street drops and remains down for approximately 2 minutes. This causes significant vehicle queues to form on all four approaches. The gates are raised for a short amount of time while passengers disembark, then are lowered when the train is ready to depart the station. At this point, commuters have walked to their vehicles and are attempting to leave the main lot via one of the three exits (one on Mill Street, the other two on Church Street, or from the two exits from the overflow parking lot on Railroad Street). Once the train has left, the gates are raised and traffic clears the area after a few minutes.

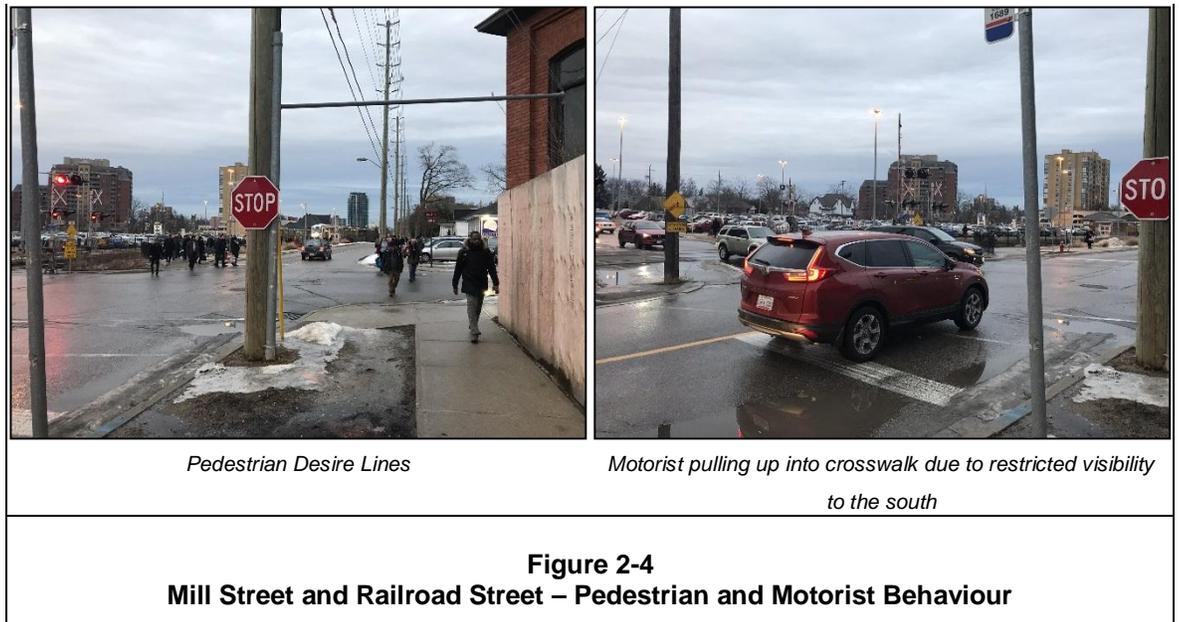
Traffic movements can be compounded by the significant number of pedestrians, either walking to the overflow lot, one of the two bus stops at Mill Street and Railroad Street, or walking along Mill Street and Railroad Street. The free flow operation on Mill Street makes eastbound and westbound movements at this intersection difficult during the period immediately following the train's departure. During the site visit, many pedestrians were noted as crossing the road in area where no crosswalks are provided, and drivers were

noted turning with obstructed views. Issues with pedestrian and motorist behaviour are shown in **Figure 2-4**.

- A sightline issue at the intersection of Mill Street and Railroad Street due to the geometry of the intersection and a structure on the southwest corner of the intersection. Traffic congestion was noted in conjunction with the afternoon arrival of the GO Train at various times. Field observations noted that motorists were required to creep up into the crosswalk on the west approach to observe northbound-southbound traffic flow. Pedestrians were noted walking diagonally across this intersection.

To address the visibility issue, the City of Brampton may wish to consider eliminating the pedestrian walkway and crosswalk on the west approach to the intersection in combination with shifting the stop bar closer to the intersection. This would provide motorists on the west approach with improved visibility of northbound and southbound traffic on Mill Street and simplify the driving task.

- To improve sightlines at the intersection of Railroad Street and Mill Street for eastbound motorists and address the issue with jaywalking it is recommended that the City consider:
 - Removing the pedestrian walkway on the west side of Railroad Street at the GO Train tracks, given its condition and AODA non-compliance;
 - Removing the crosswalk on the west approach; and,
 - Installing zebra crosswalks on the south and east approaches to the intersection.

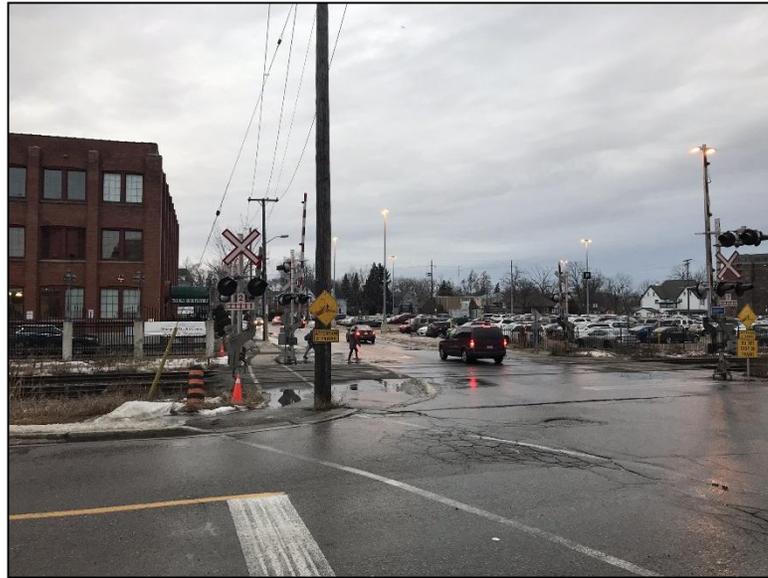
Figure 2-5
Pedestrian path across tracks on west side of Mill Street

It has been noted that the path on the west side of Mill Street across the tracks is substandard in width due to the placement of a utility pole and is not AODA compliant, as shown in **Figure 2-5**. To discourage pedestrians from jaywalking, directing them to cross at a location where motorists will expect them, it is recommended that zebra crosswalks be installed on the east and south approaches to the intersection.

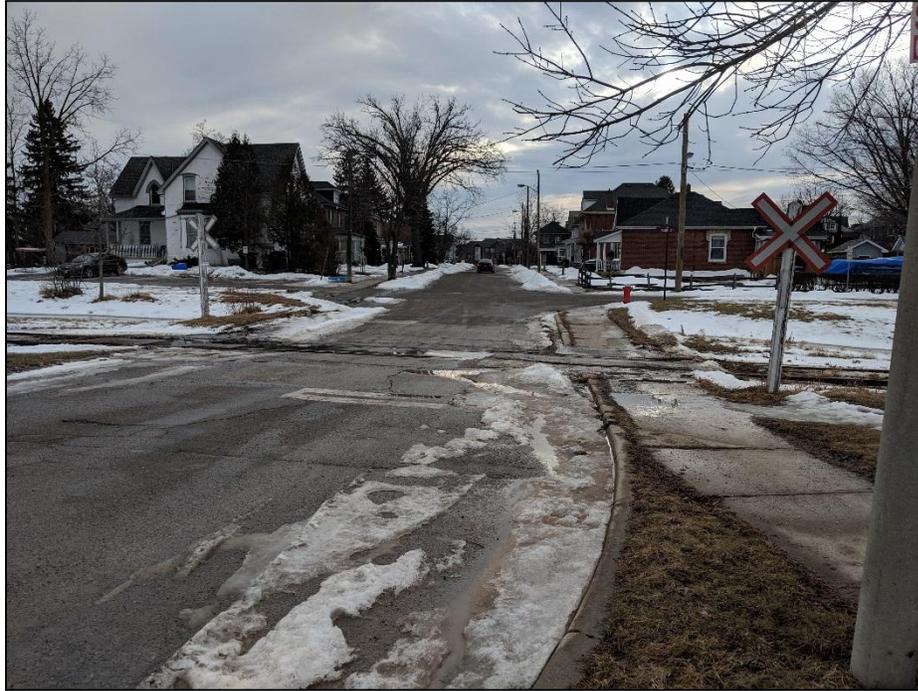
Figure 2-6
ORBY Grade Crossing (Park Street looking west)

According to *Section 6.1* of the Standards, the horizontal and vertical alignment of the road approach and the crossing surface must be smooth and continuous. The condition of the road directly surrounding the rail crossing are in poor condition and should be repaved.

The crossbucks on both approaches are in adequate condition, however the paint on the posts has deteriorated, reducing their reflectivity. Reflective strips are provided on the back of the signs.

Both the stop bars and painted X's are appropriately placed, and the paint is currently in suitable condition. However, the yellow centrelines were absent from this crossing location. Once construction at 45 Railroad

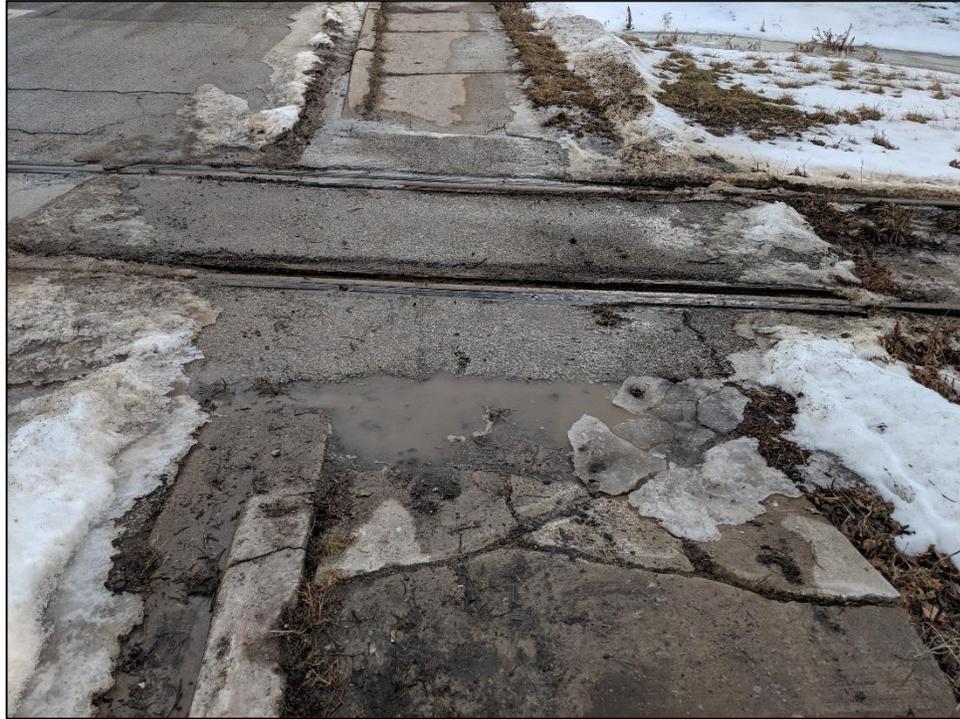
Figure 2-8
Current Condition of Sidewalk

As shown in **Figure 2-8**, the sidewalk approaching the rail crossing has an uneven surface due to broken slabs. The sidewalk should also be repaired along with the road at the crossing. The repaired sidewalk should have a grade that is in conformance with the Grade Crossing Standards (not exceeding 2 percent). If the sidewalk is intended to be accessible, the grade should not exceed 1 percent.

- The sidewalk on the north side of Park Street at the railway tracks is uneven due to broken slabs;
 - The existing pavement structure was in poor condition;

The sidewalk should also be repaired along with the road at the crossing. The repaired sidewalk should have a grade that is in conformance with the Grade Crossing Standards (not exceeding 2 percent). If the sidewalk is intended to be accessible, the grade should not exceed 1 percent.
