**William Parkway Improvements
Municipal Class EA**

**Torbram Road Over Mimico Creek
Culvert Structural Assessment Report**

**Submitted to:
City of Brampton, Ontario**

August 2024

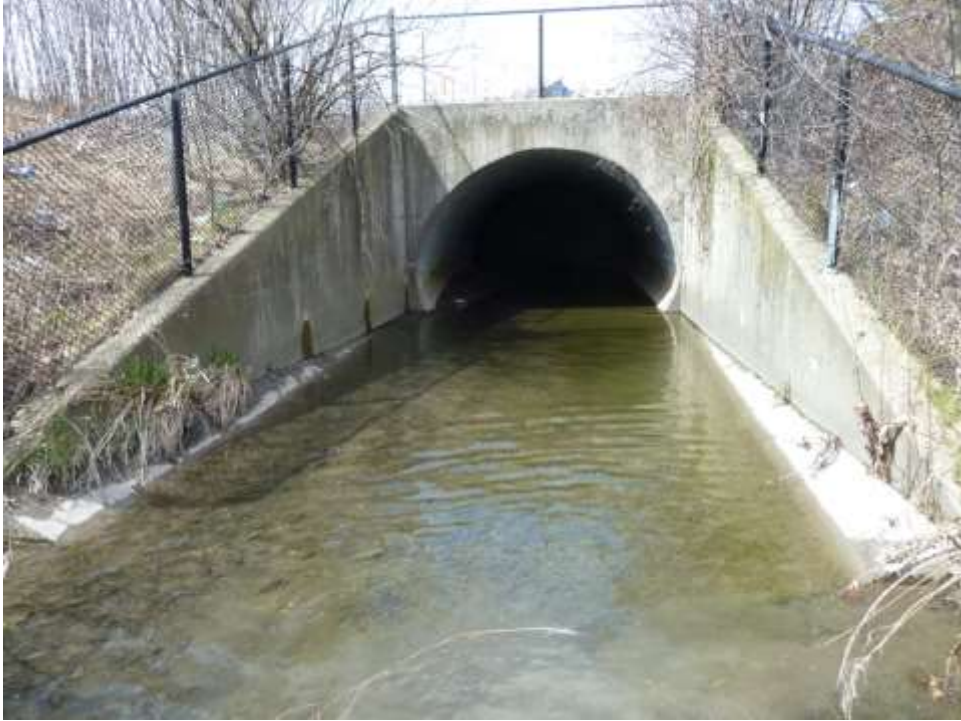
PHOTOGRAPH 1 OUTLET END WALLS

The end wall of culvert was found to be in excellent to good condition. Inlet end wall of the culvert shows the sign of medium deterioration.

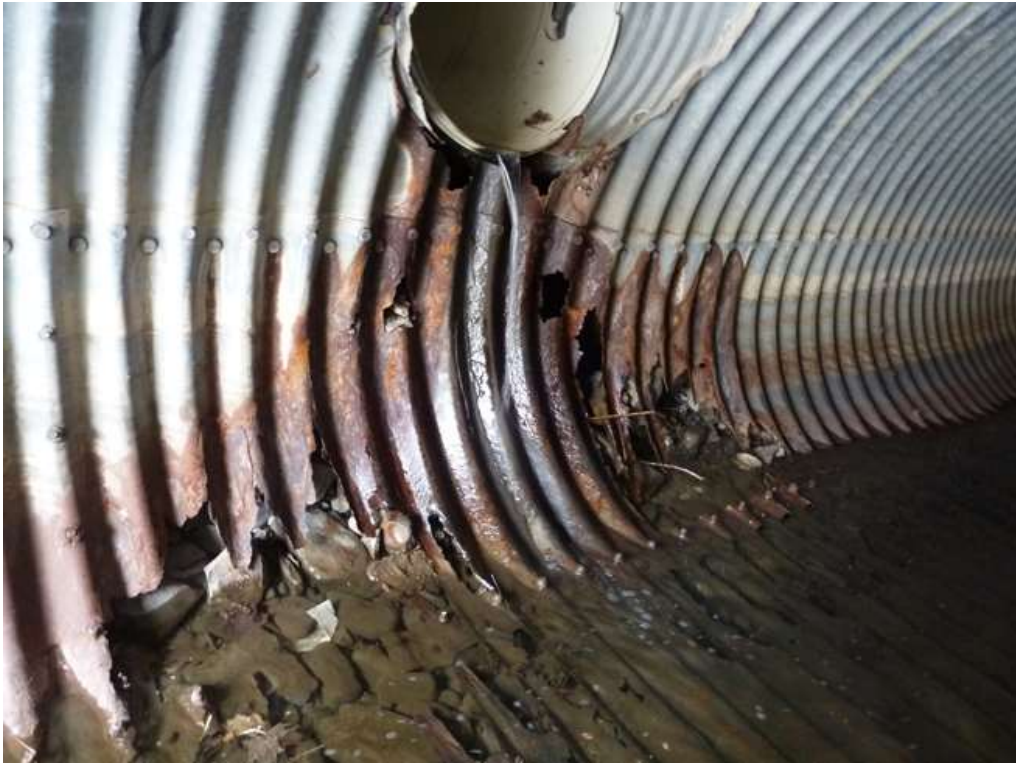
The CSP barrel of culvert was found to be in poor condition. The barrel deteriorated progressively as a result of corrosion. Most of the joints and bolts are in poor condition. The bottom side shows medium corrosion and sever to very sever isolated areas.

The culvert was visually inspected in April 2020. As per visual inspection, it is concluded that the culvert CSP barrel shows the sign of severe deterioration caused by corrosion and cannot be readily rehabilitated without excavation of the roadway or reduction to the hydraulic capacity. It is also noted that the culvert has surpassed approximately 40 years of the service life which is typical for these types of structures. Accordingly, rehabilitation or strengthening of the culvert is

PHOTOGRAPH 7 CULVERT BARREL - DETERIORATED

The visual inspection of the Torbram Road Over Mimico Creek Culvert indicates that the existing corrugated steel pipe culvert is in poor condition. Therefore, the full replacement of the culvert with the end walls, barrier and railing system is warranted.

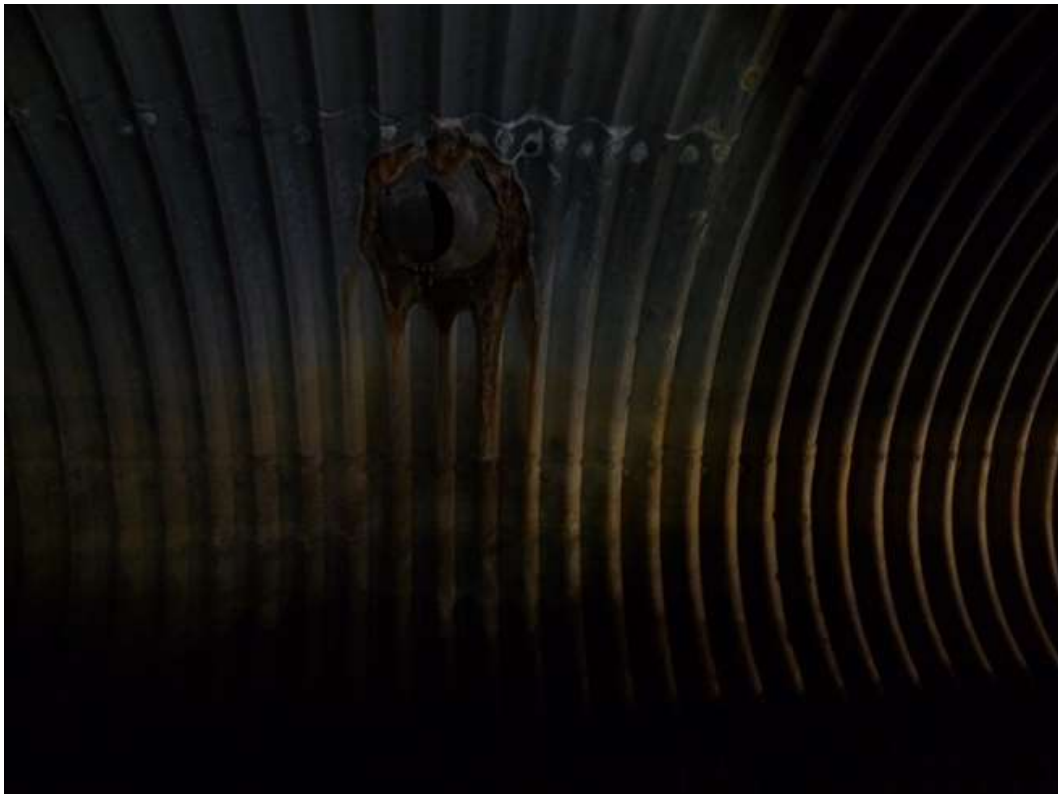
PHOTOGRAPH 8 CULVERT BARREL - RUSTED

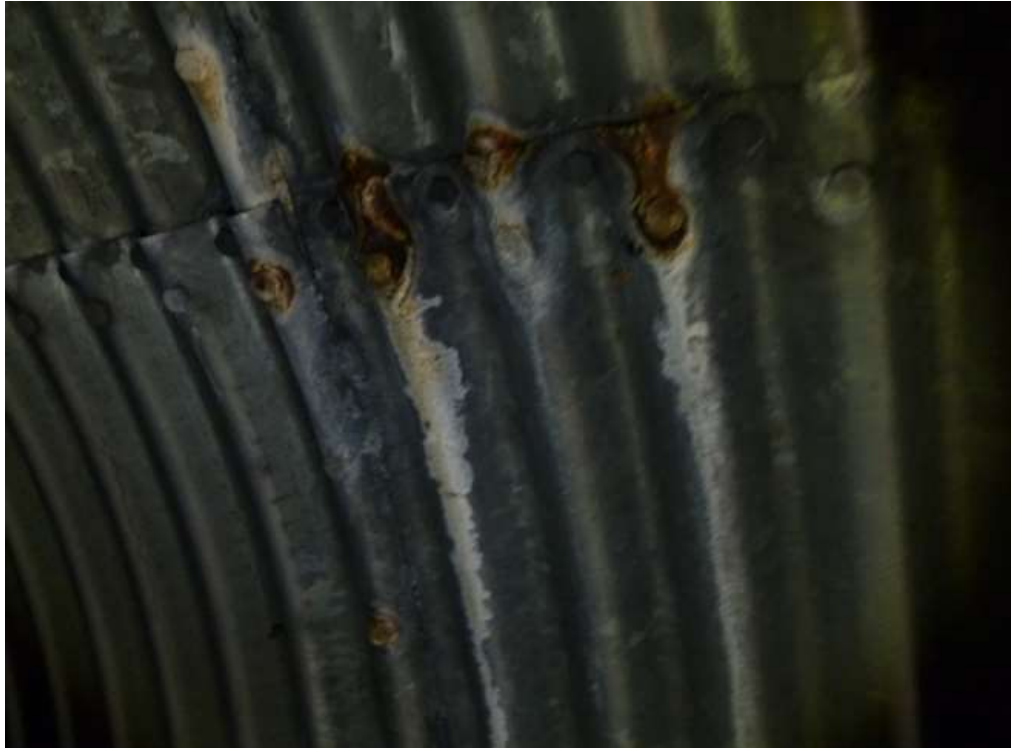
PHOTOGRAPH 9 CULVERT BARREL - RUSTED JOINTS

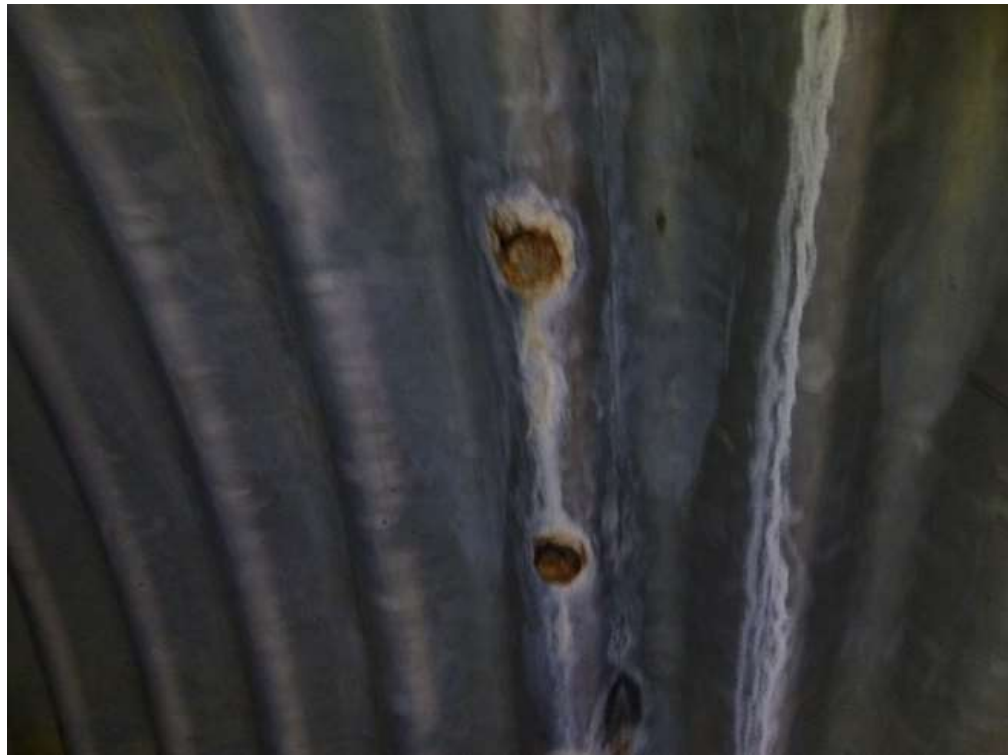
PHOTOGRAPH 10 RUSTED BOLTS
