**Improvements to Williams  
Parkway from Dixie Rd. to  
Torbram Rd.**

**Brampton, Ontario**

**Fluvial Geomorphological and  
Meander Belt Width Assessment**

**March 20, 2023**

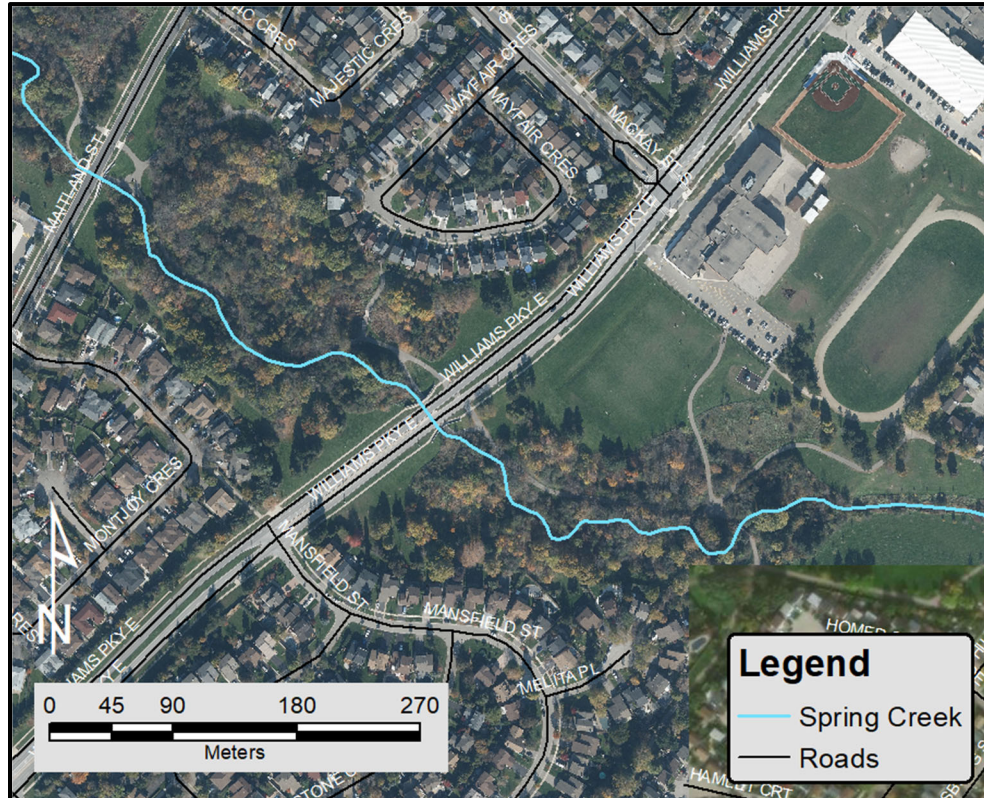
Figure 2: Aerial View of Spring Creek at Williams Pkwy

The Study Reach for this section of Spring Creek is from Maitland St. down to halfway between Williams Pkwy and Hilldale Crescent where the channel changes from gabion (failed) and concrete. Although the concrete is also failed it had much different characteristics than the upstream section of Spring Creek and was therefore not included in the study. Spring Creek flows from north to south through Williams Pkwy. The existing conditions of the channel are heavily influenced by its urban setting. It is immediately clear the channel regularly sees flashy rapid urban runoff from storm events. The floodplain shows signs of regular flooding with debris and loose vegetation caught in the underbrush of trees and shrubs.

The channel had a significant realignment during the 1970s when the surrounding subdivision was created. This realignment included the placement of gabion baskets as the channel lining as well as concrete through the Williams Pkwy bridge. Since that time the gabion baskets have all but completely disintegrated leaving only small portions of basket and copious amounts of rip rap in the channel. Upstream of Williams Pkwy the original width of the gabion lined channel was approximately 3 m, while the existing channel has widened to approximately 4 m. The bankfull width of the channel downstream of Williams Pkwy ranges from approximately 4 m through the narrower riffles to as large as 7 m in some pools. The downstream reach has more space between the channel and the trail system to allow for lateral migration. On the upstream side of the road the channel comes into contact with this asphalt trail system in a few locations. This points to lateral migration of the channel although the failure of the gabion plays into this. Erosion is common throughout the entire Study Reach of the creek, with the outside bends of pools being heavily eroded but erosion is also occurring on both sides of most riffles.

The riparian zone is typically densely vegetated which provides upwards of 80% shading of the channel. The roots of trees and shrubs that line the creek are exposed where both old and young roots are visible. The substrate majority of the substrate found within the channel is sourced from the failed gabion baskets. These dominate the riffles and are also found in pools although often silted over. Silt is found throughout the watercourse, likely sourced from the underlying tills which were exposed in some locations. Deposits of gravels were also found within some riffles and deposition zones however it is most likely these are sourced from channel modification works as well.

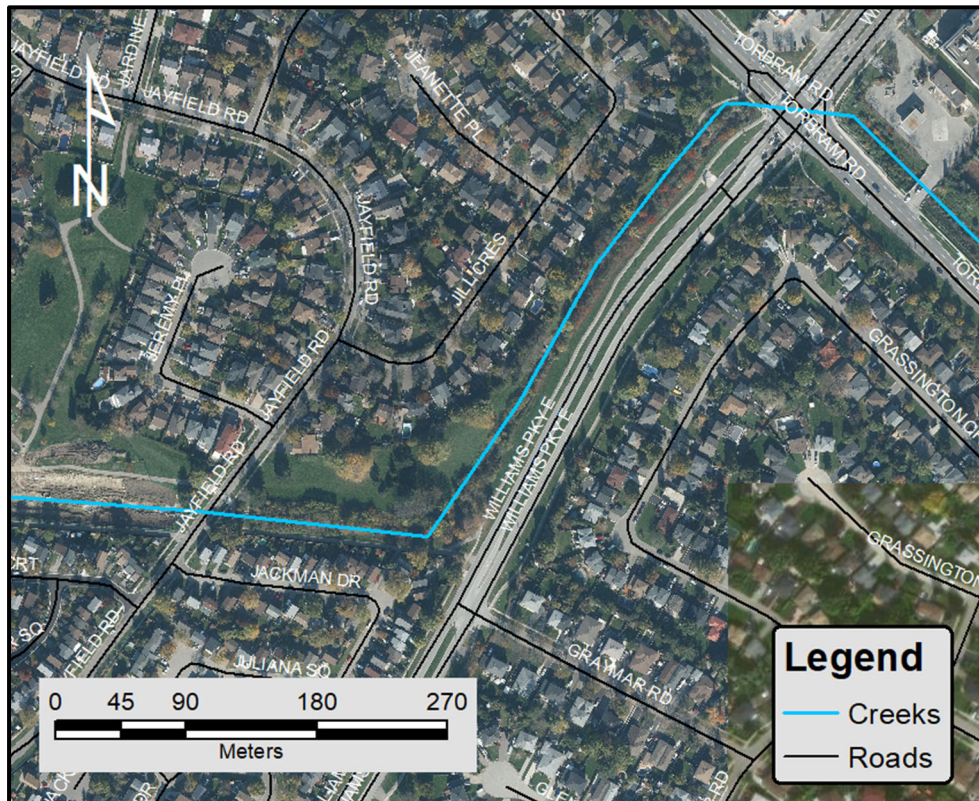
Figure 3: Aerial View of Mimico Creek at Williams Pkwy

The Study Area for the East Branch of Mimico Creek extends from Jayfield Rd. to Torbram Rd., which is 500 m in length. The existing channel is a concrete lined channel that was constructed in the 1970s. Over time this straightened concrete channel has degraded and at this point has essentially failed. The concrete channel has been scoured along both sides and large pools have formed there. In 2021 the TRCA initiated a stream restoration project on the section from Professor's Lake up to Williams Parkway to restore the channel to a more stable and natural condition. However, a short 200 m section up to Torbram Rd. has been left out of the stream restoration construction, and it is also in very poor structural condition.

As noted, the channel is a failed concrete lined channel that is eroding the banks adjacent to it. Very little can be gleaned from the channel geomorphic characteristics due to the interference of the concrete providing no opportunity for the creek to establish any equilibrium. The riparian along this 200 m reach is narrow and includes trees and shrubs with some grasses. Canopy coverage is roughly 75% and the riparian has localized gaps along it. The banks have young and old roots that have been exposed by the bank erosion. The substrate found along the channel where the banks have been exposed by erosion includes silt, sand, and gravel which are likely native. Additional materials were also present in the eroded areas which included blocks of shale and concrete which are likely not normally native to this section of the channel and could have been imported when the concrete channel was constructed.

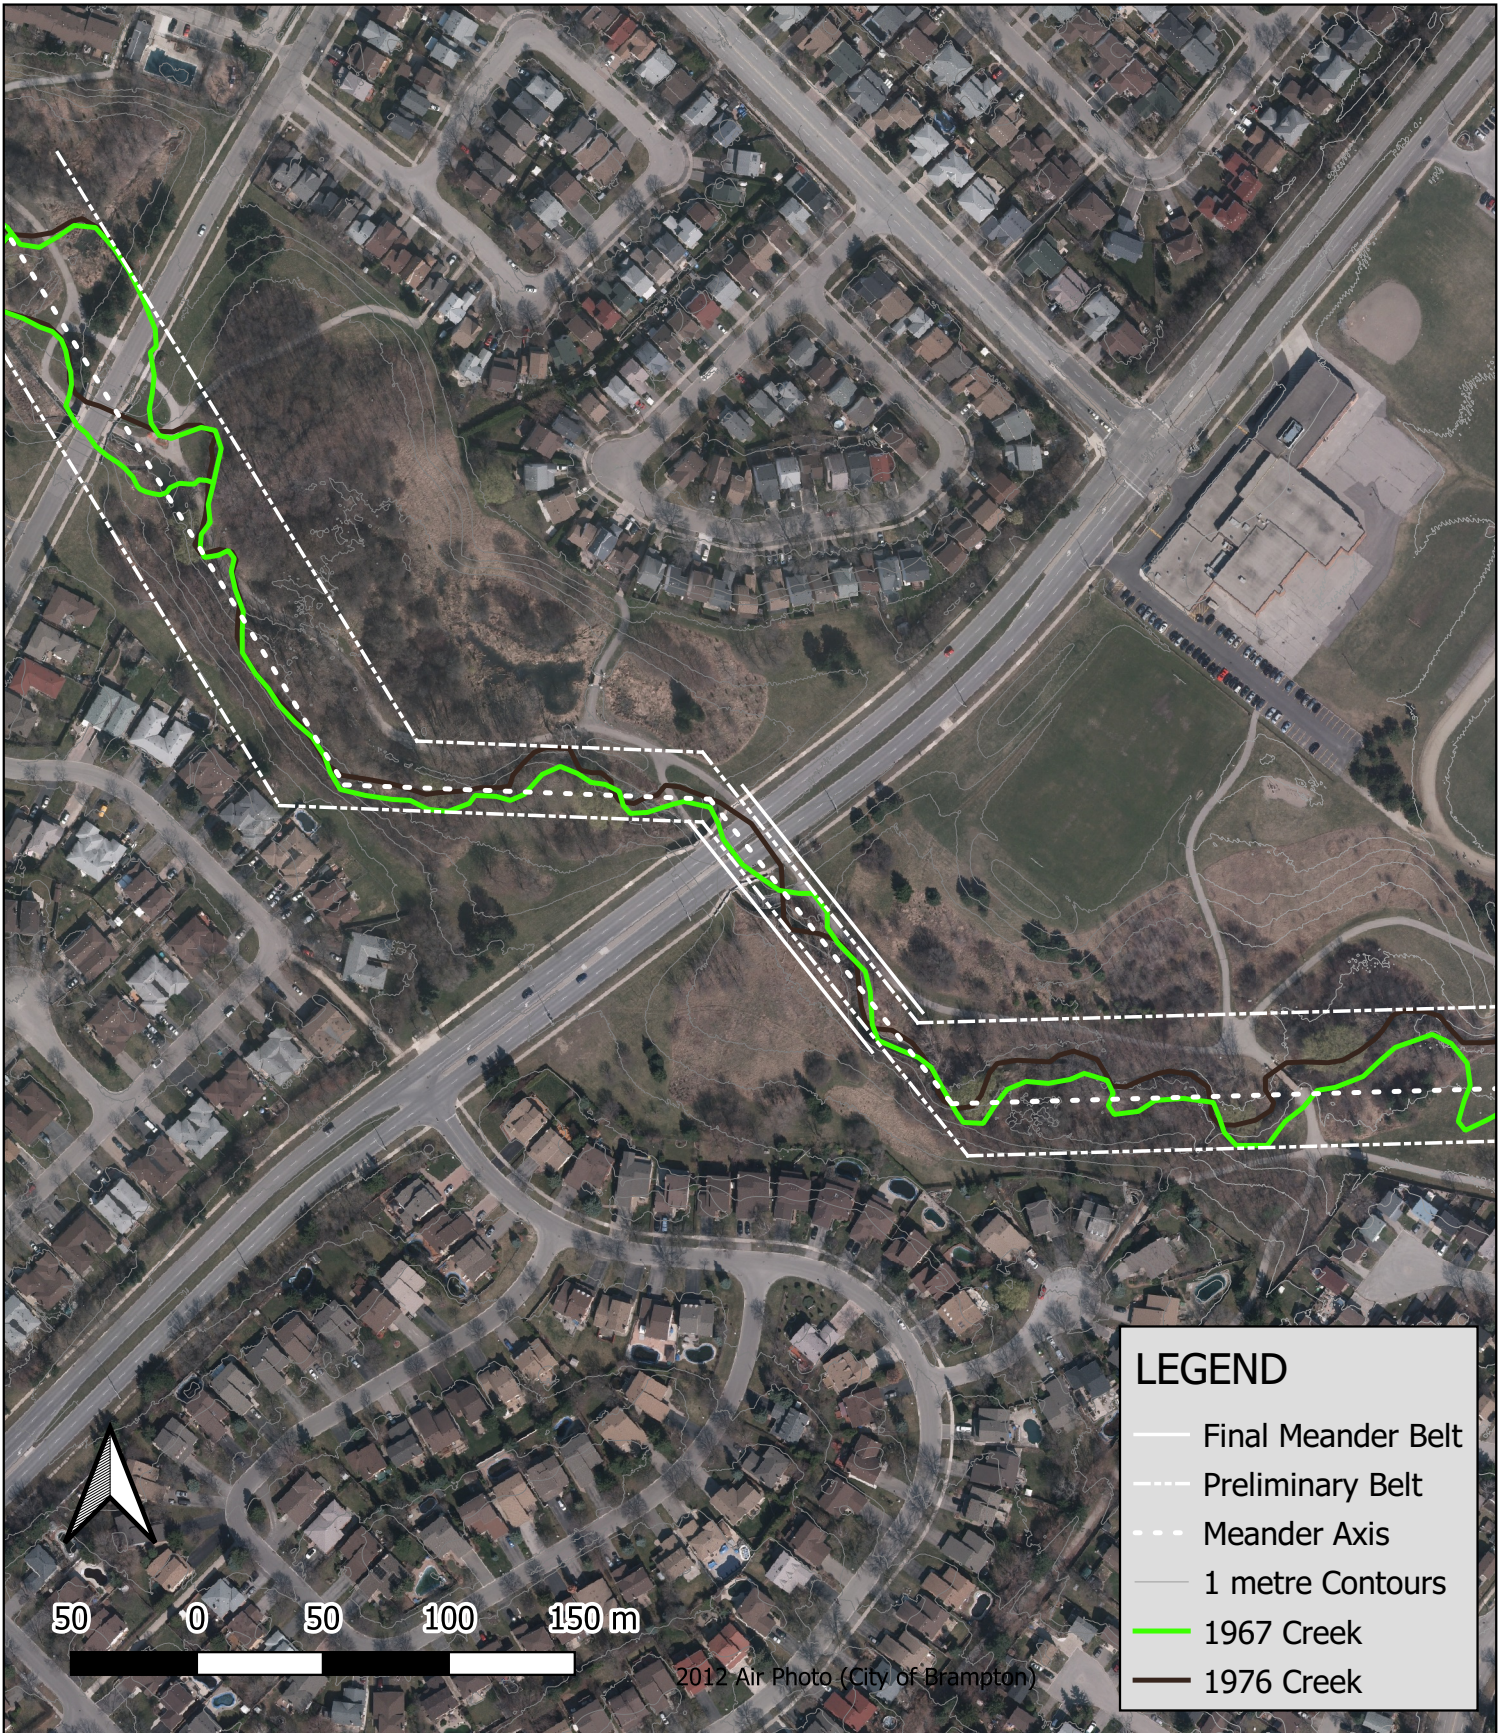
| | Williams Parkway Environmental Assessment<br>City of Brampton | | Date:<br>Dec. 2, 2022 | Map 1 |

Firstly, the meander axis needs to be identified for the channel. The meander axis is the general valley direction or trend of a stream's planform (**Map 1**). Next, all procedures, including Procedure 2, require that the confinement of the channel be determined. The OMNR guideline considers unconfined channels to be in areas of 'relatively flat to gently rolling plains and not confined by valley walls.' Confinement can be difficult to determine for some creeks, but in general the main concern is whether the channel is definitively bound to its valley corridor or if it contacts large valley walls. A valley may be described as having slopes of 3 metres or greater as well. Reviewing the contours and through site observations the site was assessed to be unconfined. The contours of the area show that there are shallow slopes of approximately 3-4 m in some areas, however the majority of the slopes are very shallow. Steeper areas along the corridor have likely been graded for the development in the area. **Map 1** shows the contours through the study area.

Once the channel has had the meander axis delineated, parallel lines are drawn on either side of the meander axis at the outermost edge of the historical meanders. These parallel lines follow the meander axis' and are described as the preliminary belt width. The measured width of the preliminary belt width is 17.3 m at the Williams Pkwy crossing. **Map 1** shows this preliminary belt width as well as the belt widths of one or two meander axis upstream and downstream of the crossing. Once the belt width is set typically both the bankfull width and the 100-year erosion rate are then applied to the channel for the final erosion hazard offset, however due to the quality of the 1967 and 1976 air photos calculating erosion rates was not possible.

In place of the 100-year erosion rate a factor of safety will be used as the buffer along the meander belt. Typically, the final meander belt would consist of the belt width plus the erosion rate and a 5% factor of safety for belt widths less than 50 m. In this case the factor of safety of 20% will be used which is typically reserved for belt widths greater than 50 m. With this the final belt width will consist of the preliminary belt width, the bankfull width of the channel, and the 20% safety factor. This results in a 25.5 m final belt width. This can be applied to existing channel on which it would be centred.

With this in mind, the proposed crossing size is based on the recommendation that the size of the crossing should accommodate the meander belt width of the creek. Therefore, the crossing would span 25.5 m which would allow a rehabilitated channel to meander through the crossing while accommodating any potential future migration. This crossing would also have footings rather than a smaller box structure and therefore would accommodate another of the TRCA's guidelines.

- Spring Creek was assessed to have a 25.5 m belt width at the Williams Pkwy crossing,
- Crossing structure span for Spring Creek at Williams Pkwy should be based on the final meander belt width of 25.5 m, and

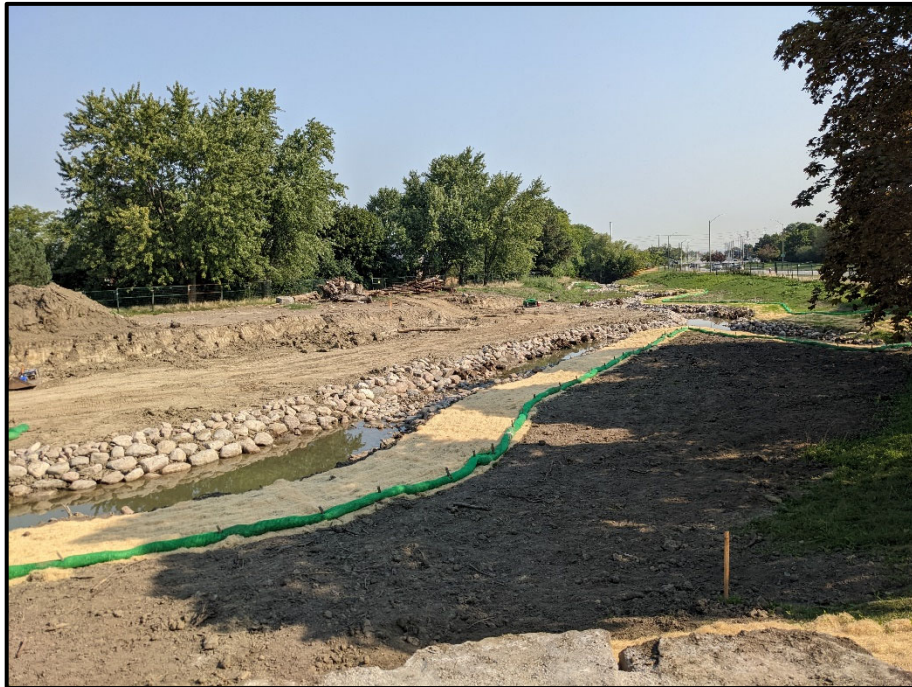
**PHOTOGRAPH NO.: 1**

FROM: Jayfield Park Restoration Project, north of Williams Pkwy.

LOOKING: Downstream towards the end of the restoration and start of concrete channel.

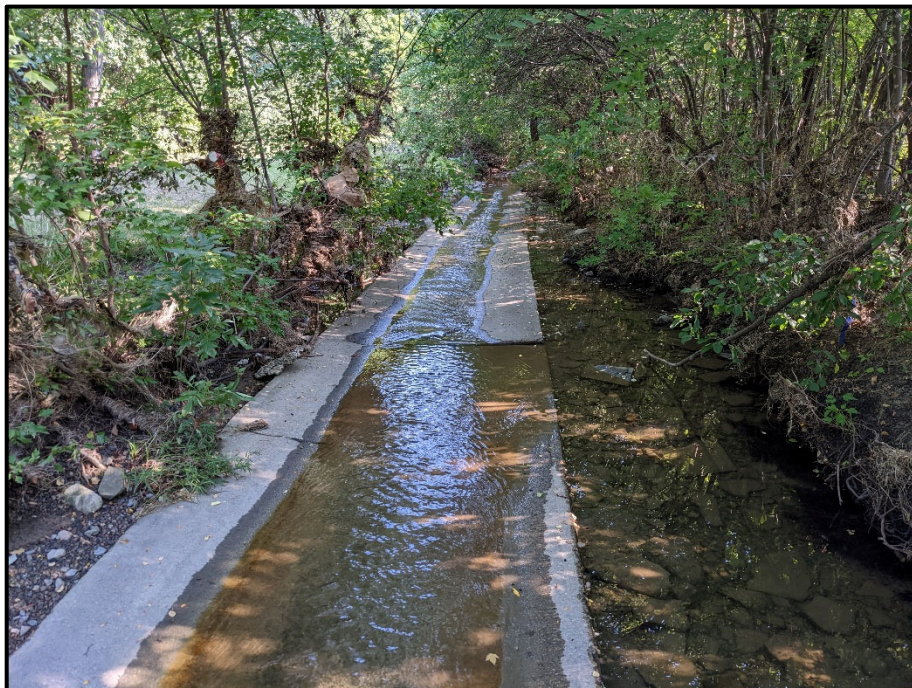
**PHOTOGRAPH NO.:2**

FROM: Centre of channel at upstream end of concrete channel section.

LOOKING: Downstream along channel. Heavily eroded banks.

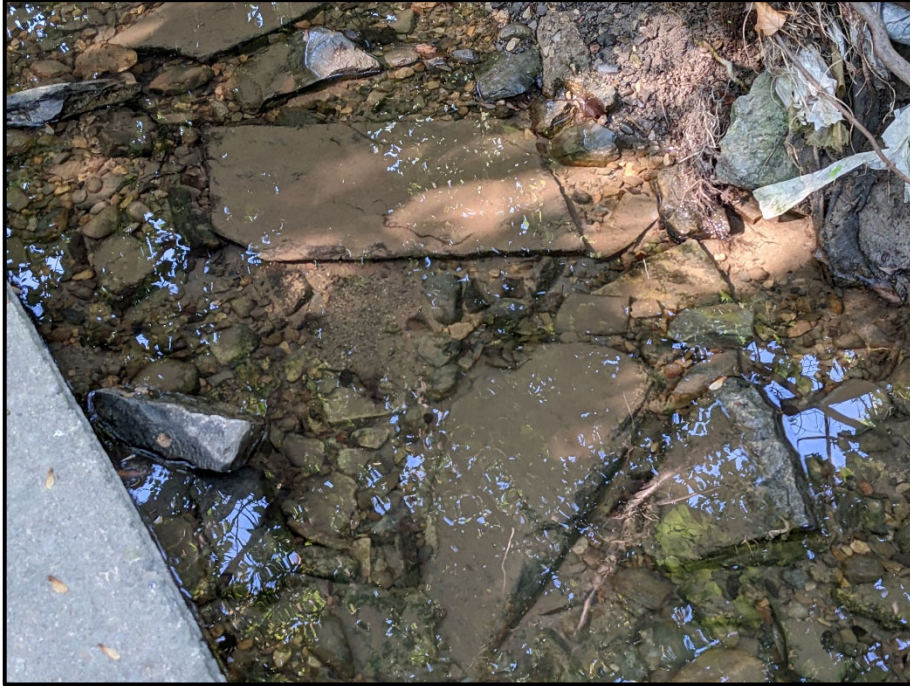
**PHOTOGRAPH NO.: 3**

FROM: Centre of channel near start of concrete channel section.

LOOKING: At substrate found along eroded banks. Gravels, silts, and limestone blocks.

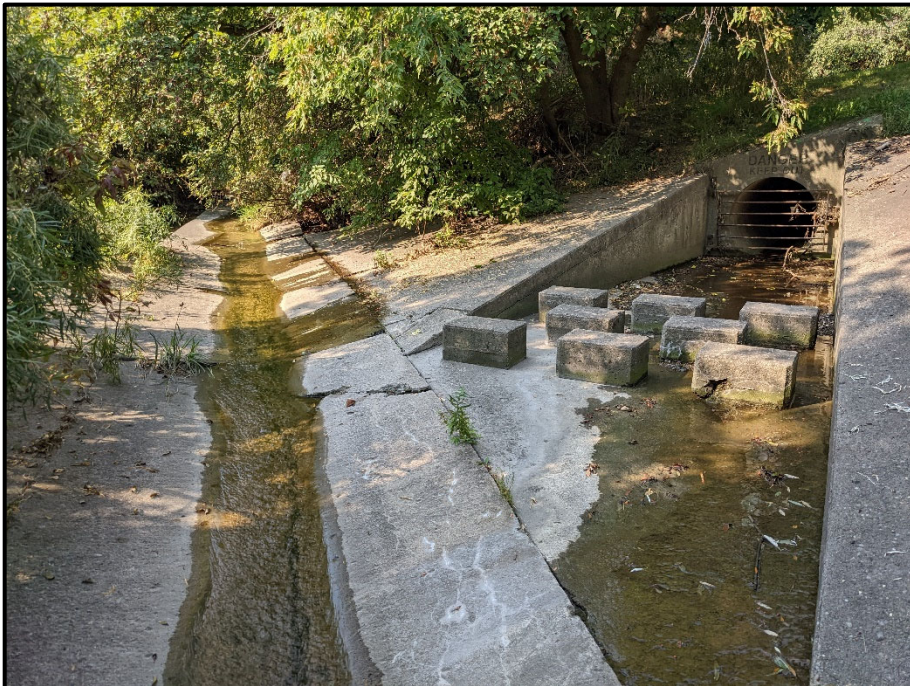
**PHOTOGRAPH NO.: 4**

FROM: Centre of channel near middle to end of concrete section.

LOOKING: Upstream at storm water outfall.

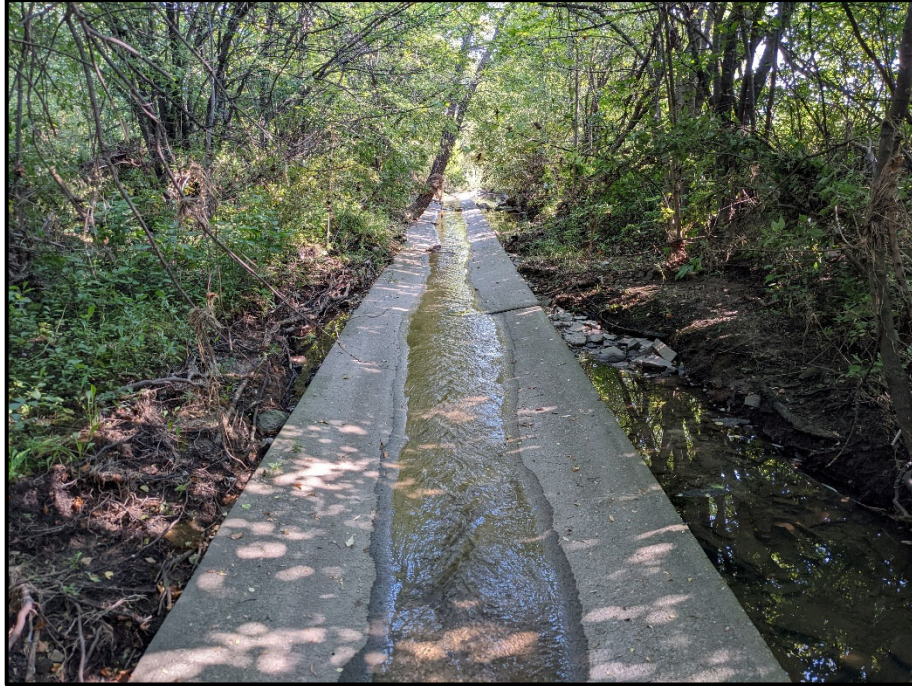
**PHOTOGRAPH NO.: 5**

FROM: Centre of channel near middle of concrete channel section.

LOOKING: Downstream along typical channel conditions, thick riparian with brush.

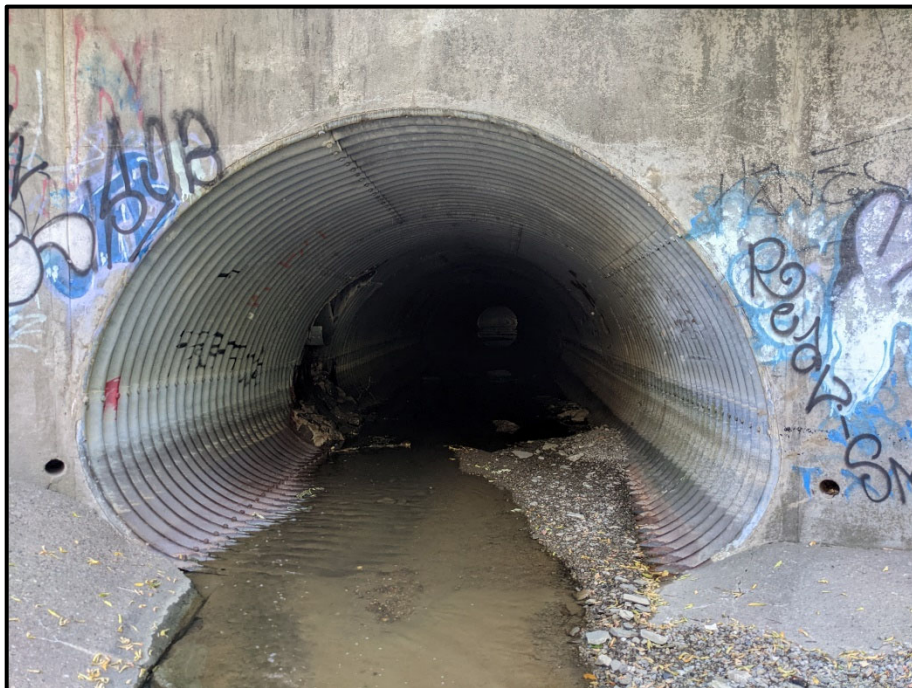
**PHOTOGRAPH NO.: 6**

FROM: Centre of channel, upstream of culvert.

LOOKING: Downstream into culvert.

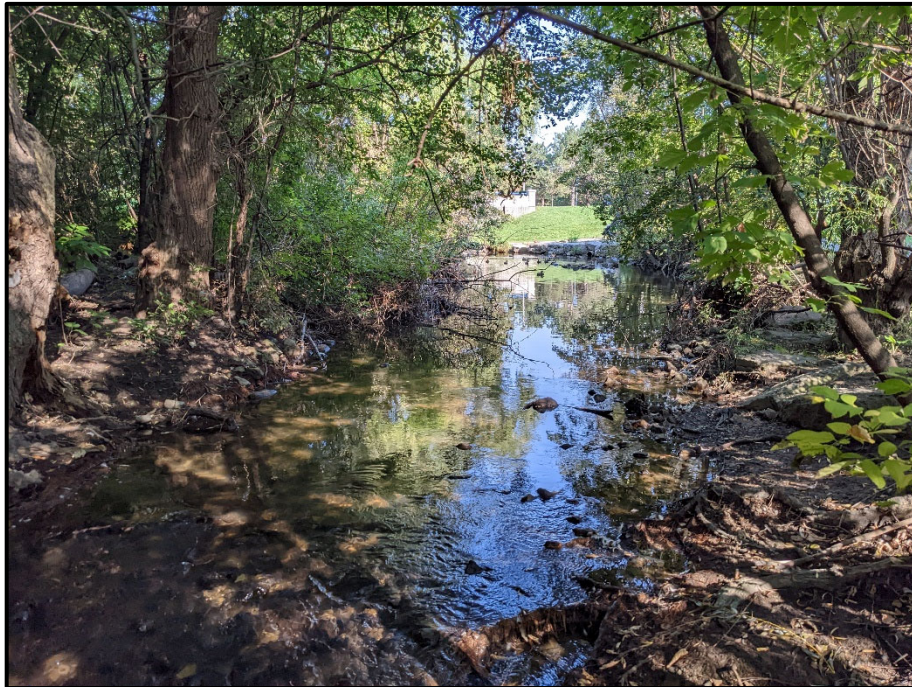
**PHOTOGRAPH NO.: 7**

FROM: Upstream end of study reach near Maitland St.  
LOOKING: Upstream towards road.

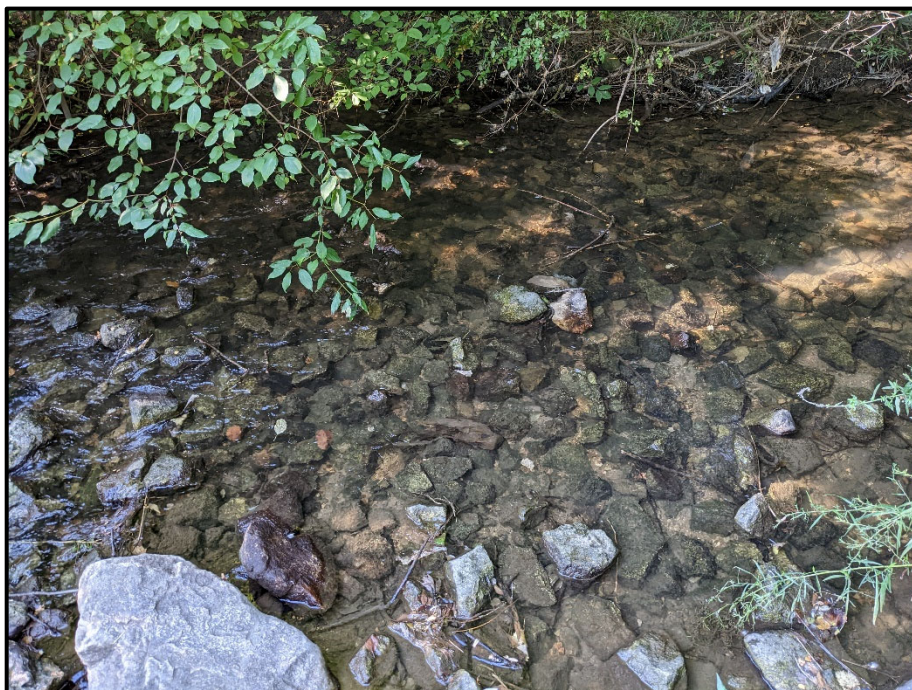
**PHOTOGRAPH NO.: 8**

FROM: Upstream end of study reach near Maitland St.  
LOOKING: Looking at typical substrate which is rip rap sourced from failed gabions.

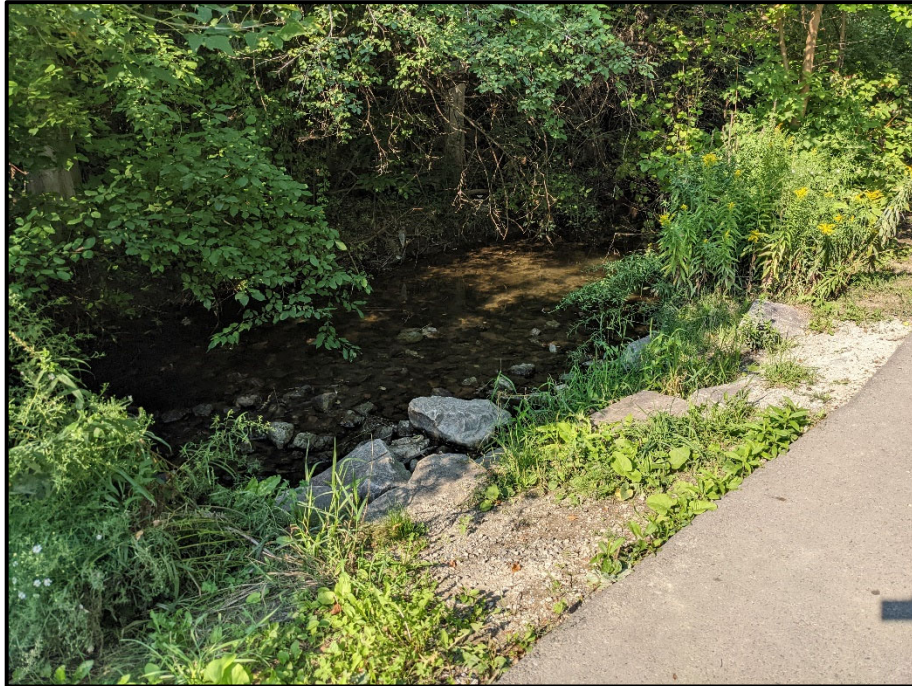
**PHOTOGRAPH NO.: 9**

FROM: Trail along creek, near upper middle of study reach.

LOOKING: At channel bank which had recently been repaired for encroaching on trail.

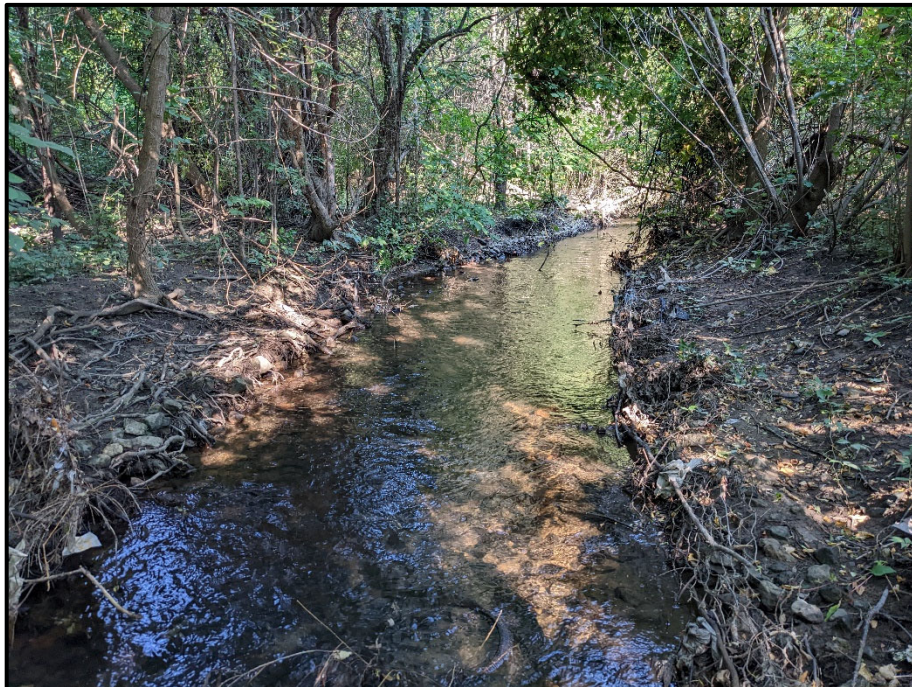
**PHOTOGRAPH NO.: 10**

FROM: Centre of channel at middle of upper reach in study area.

LOOKING: Upstream at typical channel conditions, thick riparian, eroding banks.

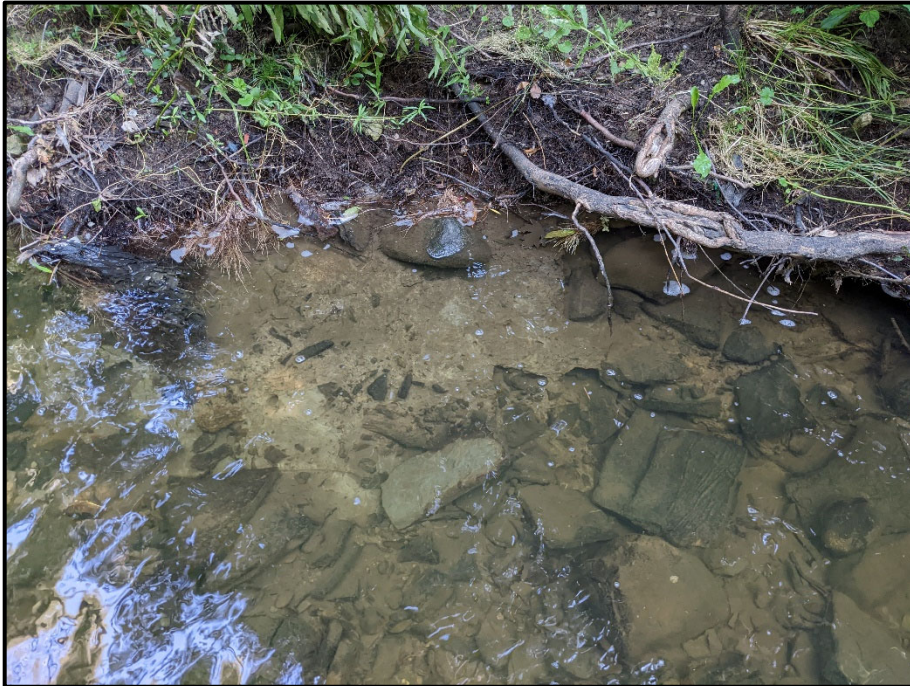
**PHOTOGRAPH NO.: 10**

FROM: Centre of channel in mid to lower section of upper study area reach.

LOOKING: At channel substrate which includes exposed till, gabion stone, and gravels.

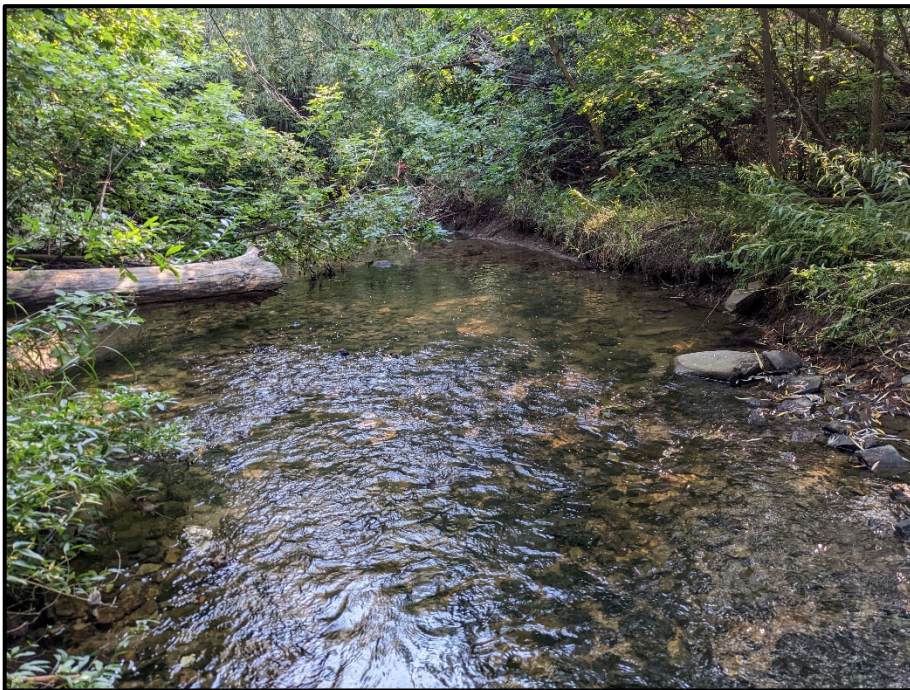
**PHOTOGRAPH NO.: 10**

FROM: Centre of channel, near lower section of upper study area reach.

LOOKING: Upstream at typical channel conditions.

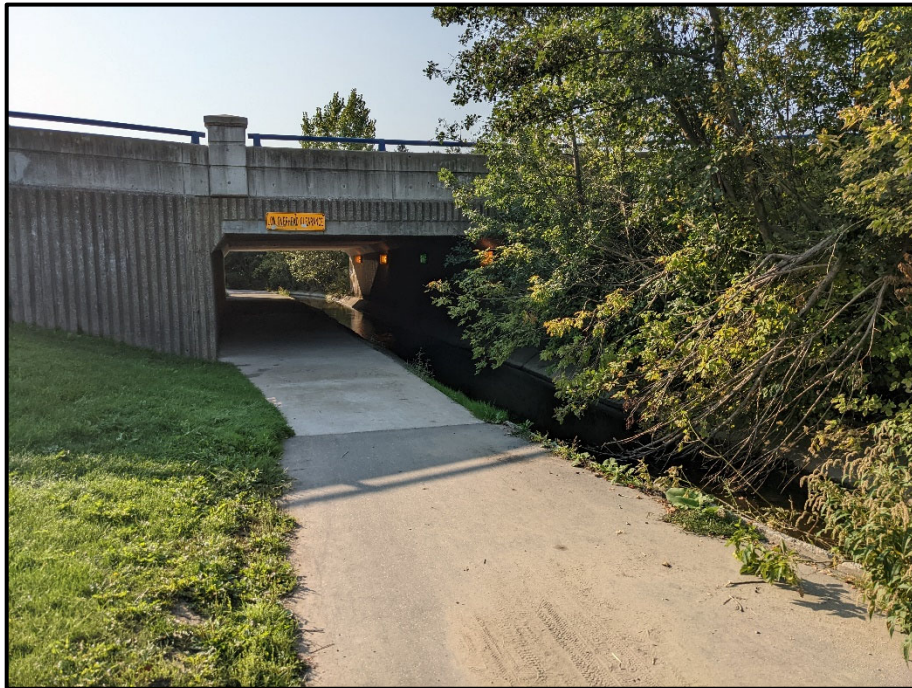
**PHOTOGRAPH NO.: 10**

FROM: Left bank of creek immediately downstream of Williams Pkwy crossing.  
LOOKING: Upstream at the existing crossing with small concrete channel and trail.

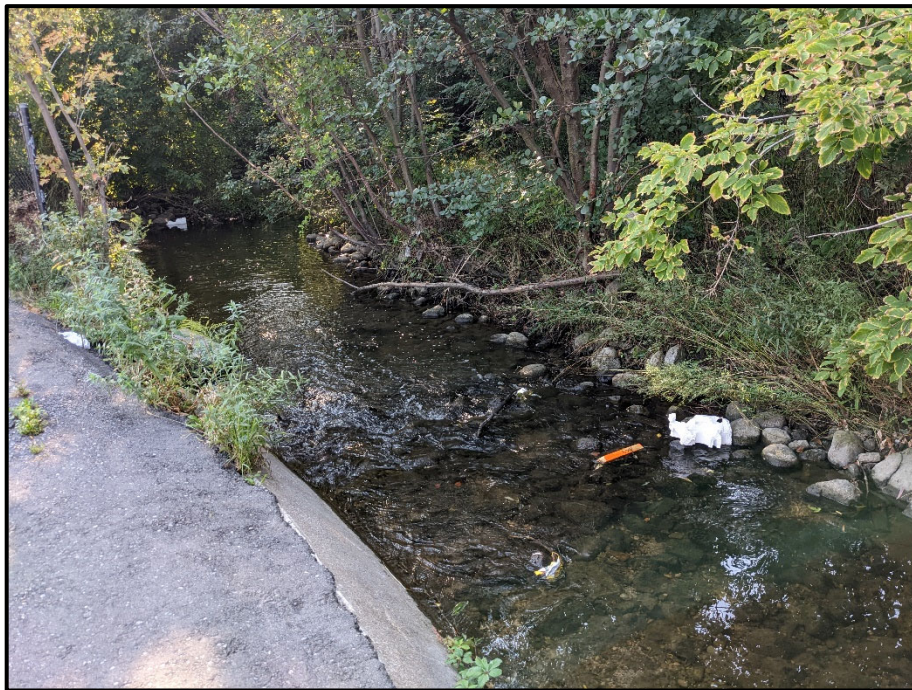
**PHOTOGRAPH NO.: 10**

FROM: Right bank of creek on asphalt trail downstream of Williams Pkwy.  
LOOKING: Creek has likely migrated into existing concrete trail.

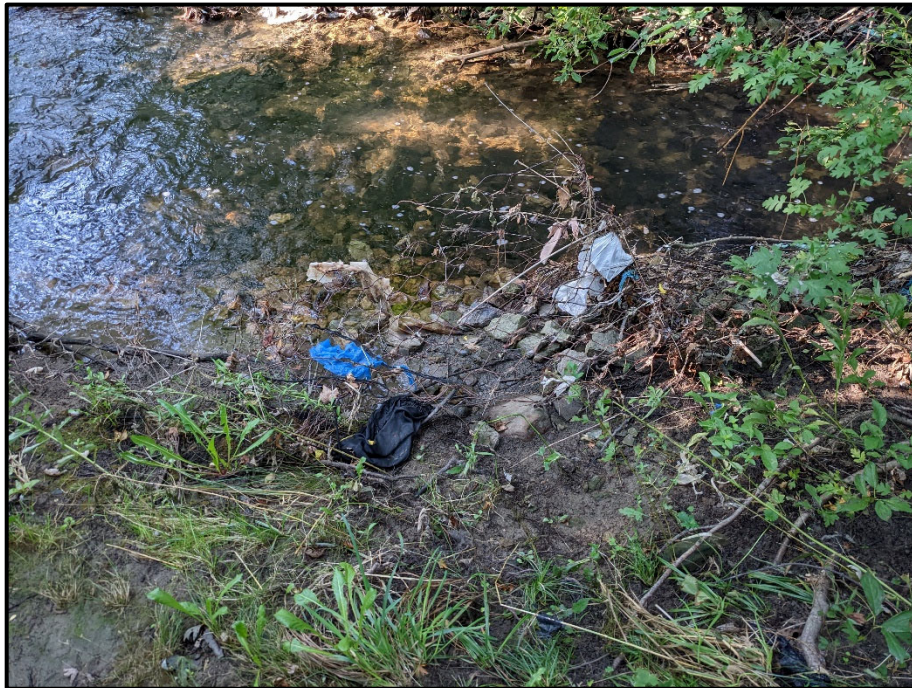
**PHOTOGRAPH NO.: 10**

FROM: Right bank of creek near middle of lower study reach area.  
LOOKING: At channel with failed gabion baskets on left bank.

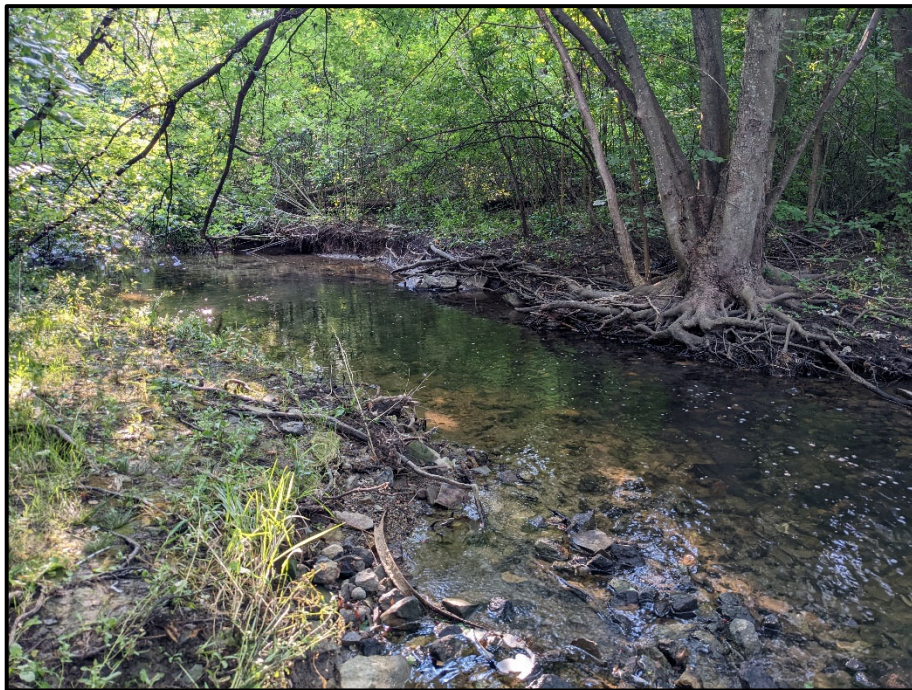
**PHOTOGRAPH NO.: 10**

FROM: Right bank of creek near middle of lower study reach area.  
LOOKING: Across channel at typical channel conditions, eroding banks and exposed roots.

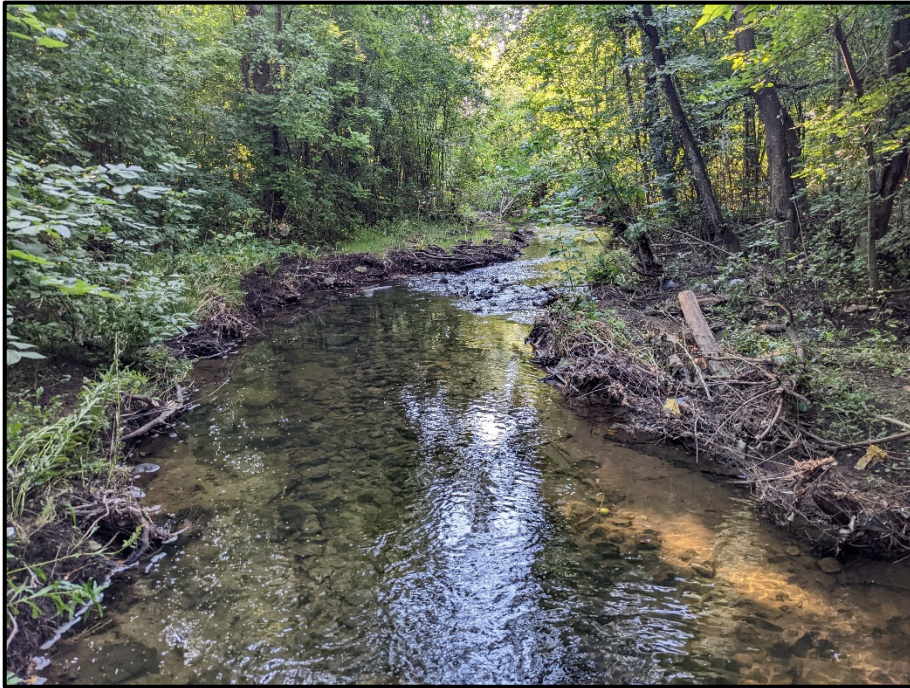
**PHOTOGRAPH NO.: 10**

FROM: Centre of creek near lower middle of lower study reach area.

LOOKING: Downstream at typical channel conditions.

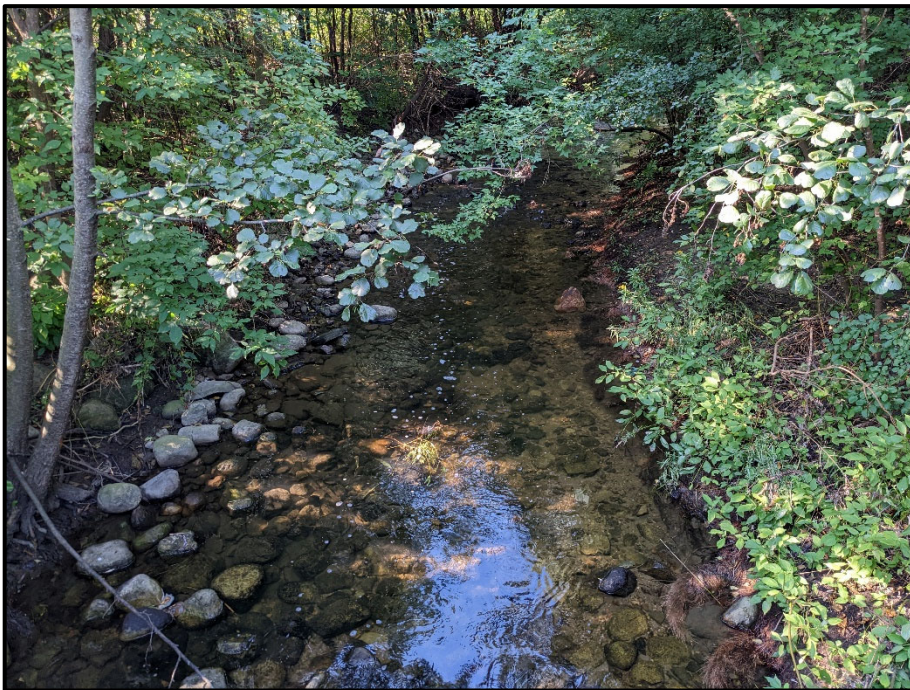
**PHOTOGRAPH NO.: 10**

FROM: Centre of creek at lower section of lower study reach area.

LOOKING: Upstream towards end of gabion lined section of Spring Creek, start of concrete.
