# Heart Lake Road Ecology Monitoring Project

## 2025 Report

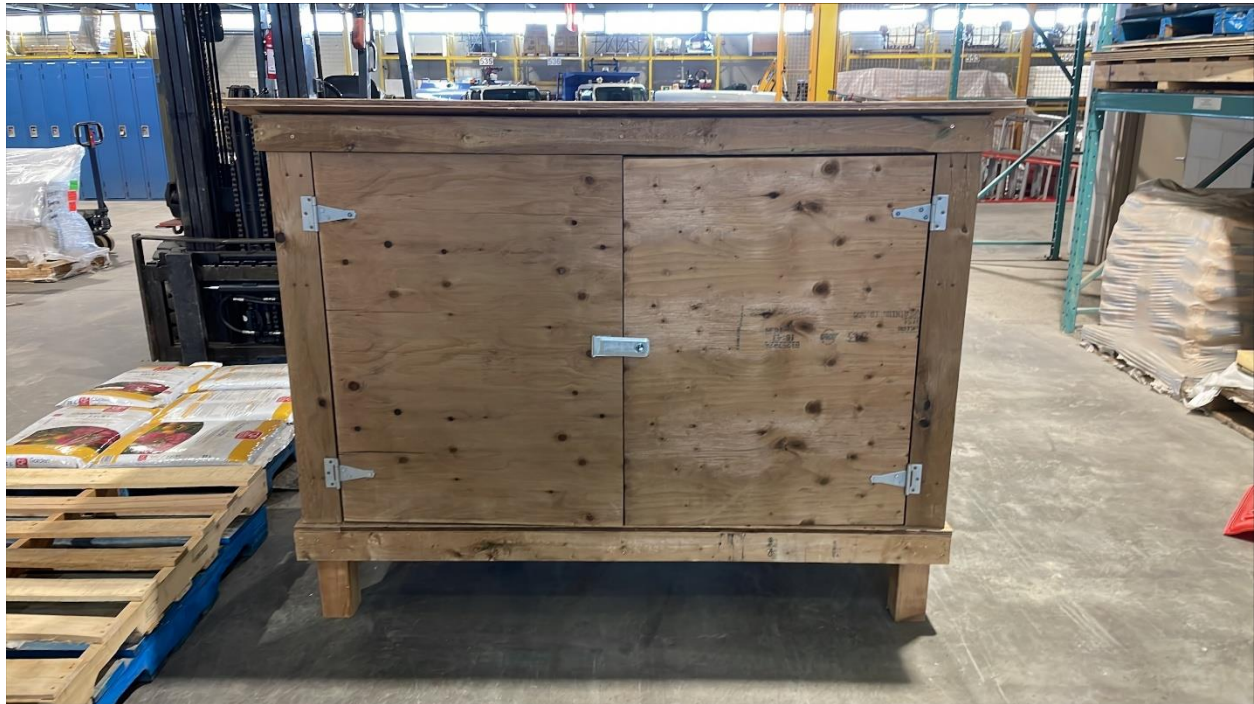
In April 2025, a storage box was constructed and delivered by the City of Brampton to Heart Lake Conservation Park to house materials for the HLREMP (figure 1). The storage box was reinforced by TRCA staff with sealant, application of a natural rodent deterrent, and steel wool to prevent further rodent activity or entry. In preparation for the project and monitoring season, the storage box was equipped with high-visibility safety vests, reptile and amphibian identification guides, a collapsible trolley, dust pans and paint scrapers to remove road mortalities, a shovel, garbage pickers, garbage bags, hand sanitizer,

*Figure 1 Storage box constructed by the City of Brampton for storage of HLREMP materials.*

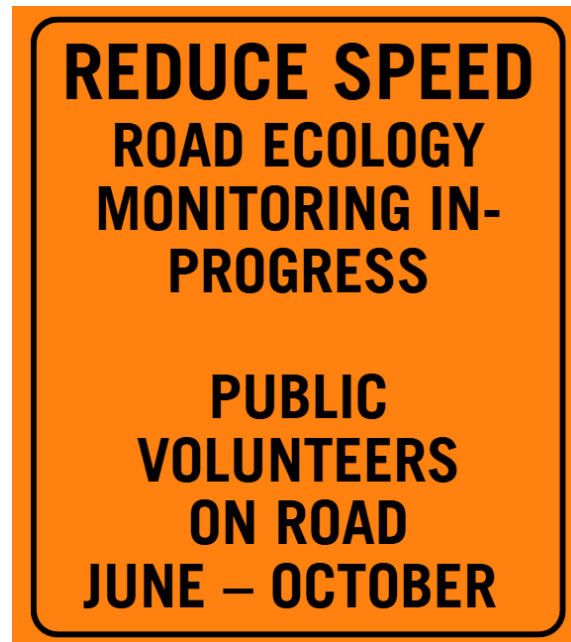
In early June, two signs were installed on Heart Lake Road at Countryside Dr and Sandalwood Pkwy E providing notice to drivers of monitoring activity on the roads (figure 2).

*Figure 2 The design for the speed reduction signs installed along Heart Lake Road for the monitoring season.*

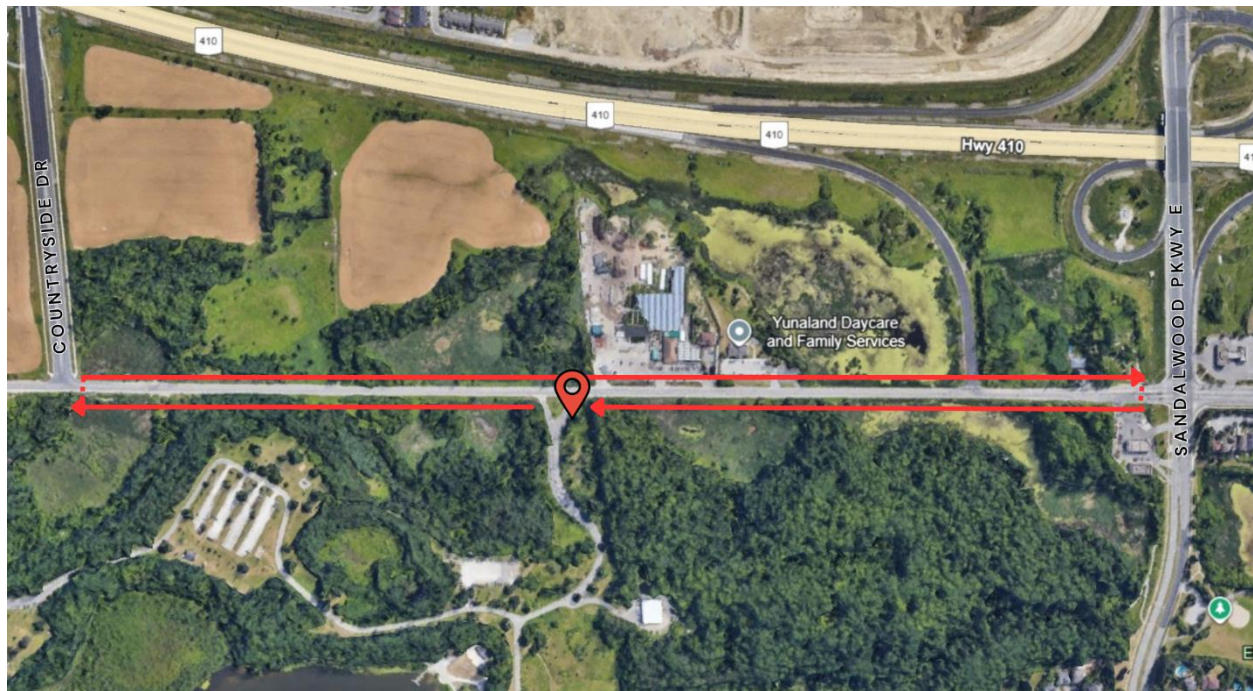
*Figure 3 The HLREMP volunteer monitoring route, where the pin at the starting point is the Heart Lake Conservation Park entrance at Heart Lake Road.*

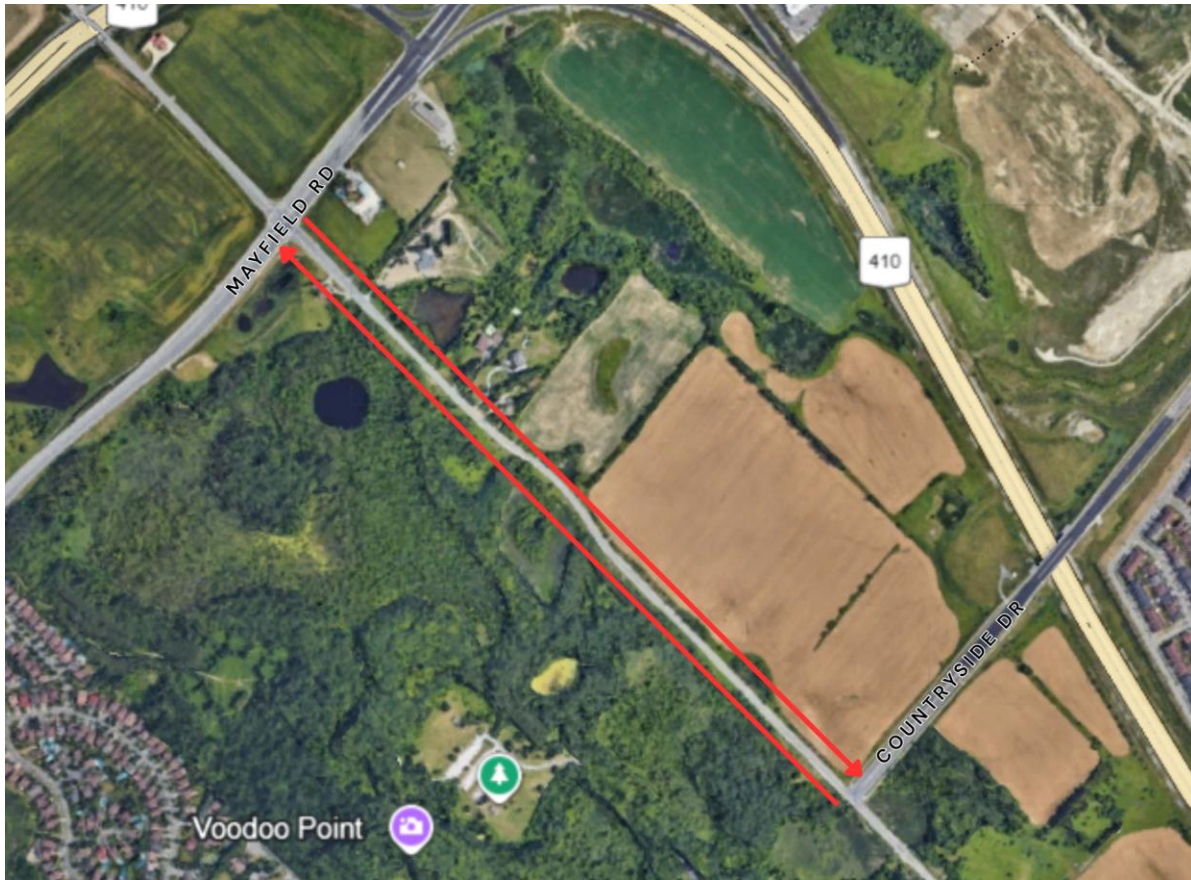
*Figure 4 The HLREMP monitoring route for the northern segment of Heart Lake Road, from Countryside Dr to Mayfield Rd.*

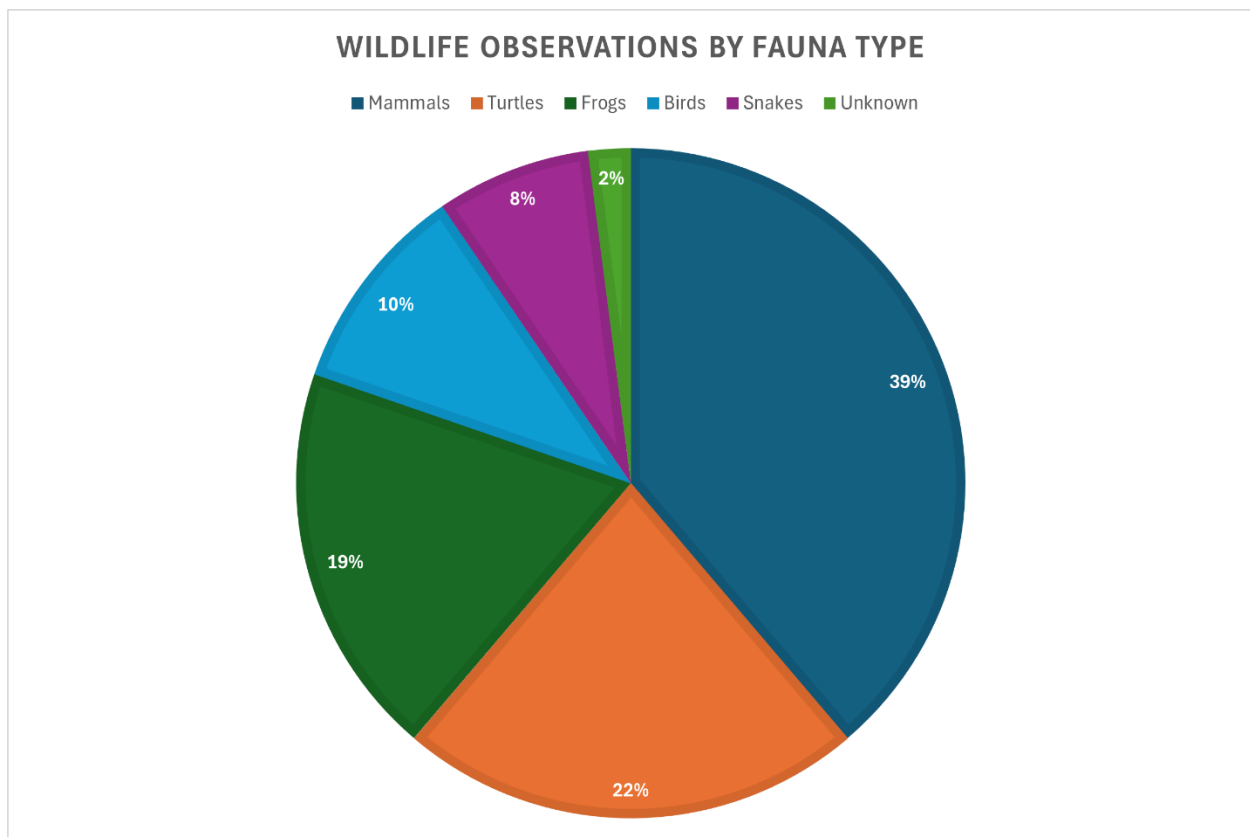
Figure 5 All wildlife observations by fauna type, as observed by monitoring volunteers and TRCA staff.

The wildlife observations by fauna type are summarized in figure 5. Mammals were amongst the most reported fauna type along both monitoring segments of Heart Lake Road. The most recorded mammal species, both alive and dead, was the Gray Squirrel (*Sciurus carolinensis*).

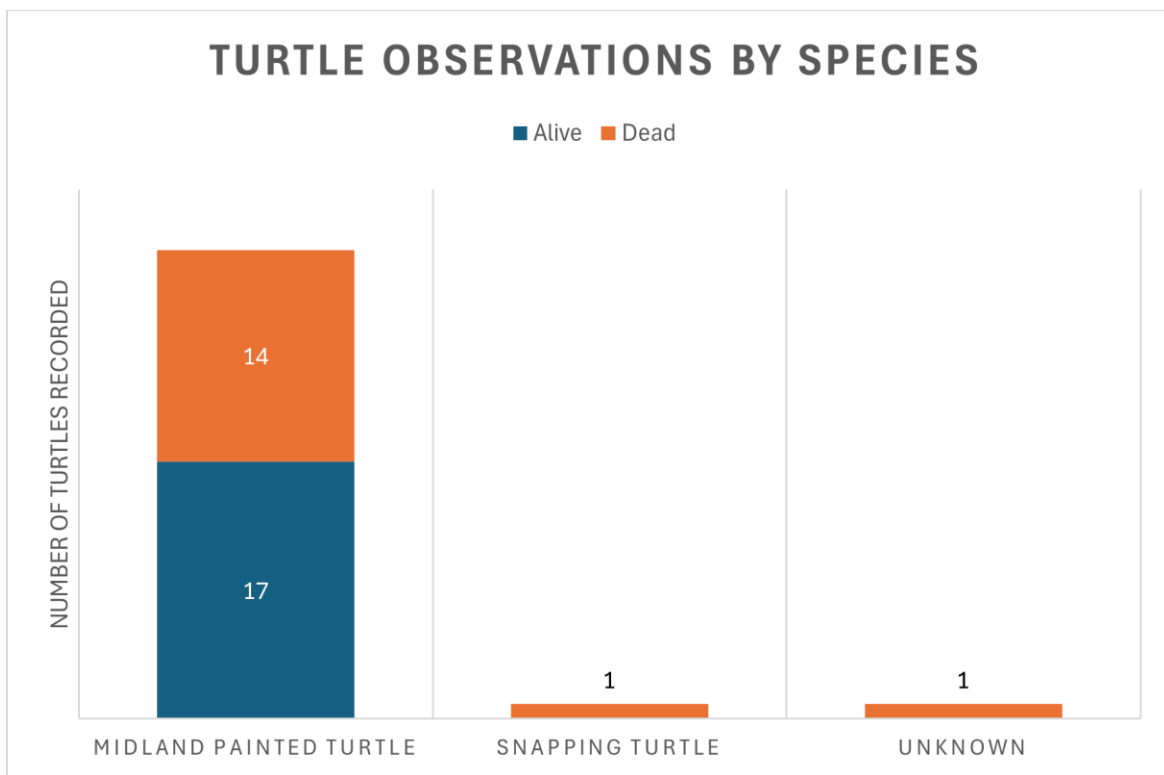
(*Chrysemys picta*) recorded as alive were observed off-road, beyond the exclusion fencing and in the surrounding wetlands. Figure 6 summarizes all recorded turtle observations by species. Of the recorded observations, 6% were hatchlings, 18% were juveniles, 54% were adults, and 21% were unknown.

Figure 6 The number of recorded turtle observations by species.

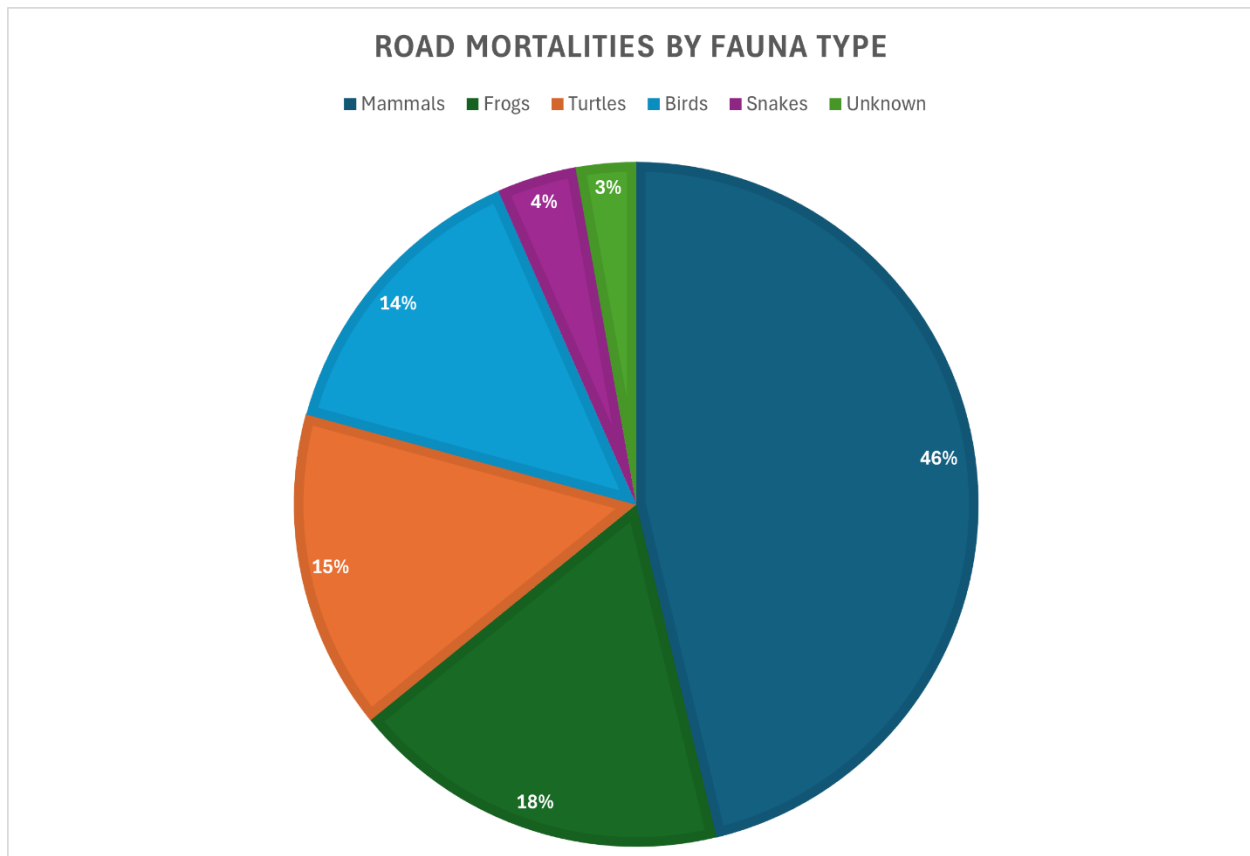
Mortalities caused by Wildlife Vehicle Collisions (WVCs) dominated the observations collected by both volunteers and TRCA staff. A total of 106 mortalities were reported, with mammals being the most impacted by WVCs (figure 7). Species identification of WVCs was less certain or reliable, depending on the severity of the collision or the duration of time between collision and observation. Of the mammal mortalities, 21% were labelled as unknown, due to the severity of the collisions, predation or time elapsed since the collision occurred. Despite this, mammal mortalities proved to be the easiest to identify, as they remained intact for longer than their herpetofauna or ornitofauna counterparts. Gray Squirrels (*Sciurus carolinensis*) were amongst the highest reported mortalities (24.5%).

*Figure 7 Percentage of Wildlife Vehicle Collision mortalities by fauna type, as observed by monitoring volunteers and TRCA staff.*

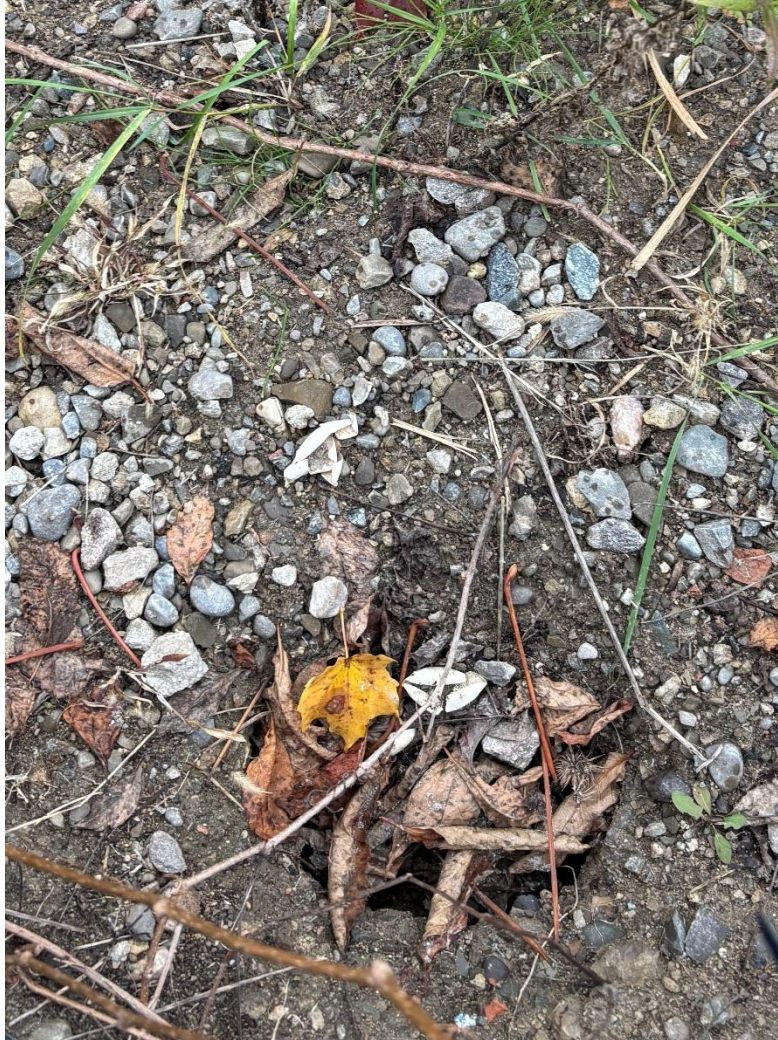
While volunteers and TRCA staff monitored Heart Lake Road for turtle nests, none were recorded up until November 7<sup>th</sup>. During the second last monitoring shift, two predated turtle nests were found on the eastern side of Heart Lake Road, less than 30 meters north of Highway 410. TRCA staff and a volunteer observed a hole dug at each nest and fragments of eggs scattered (figure 8).

*Figure 8 Predated turtle nest observed on South Heart Lake Road monitoring route.*

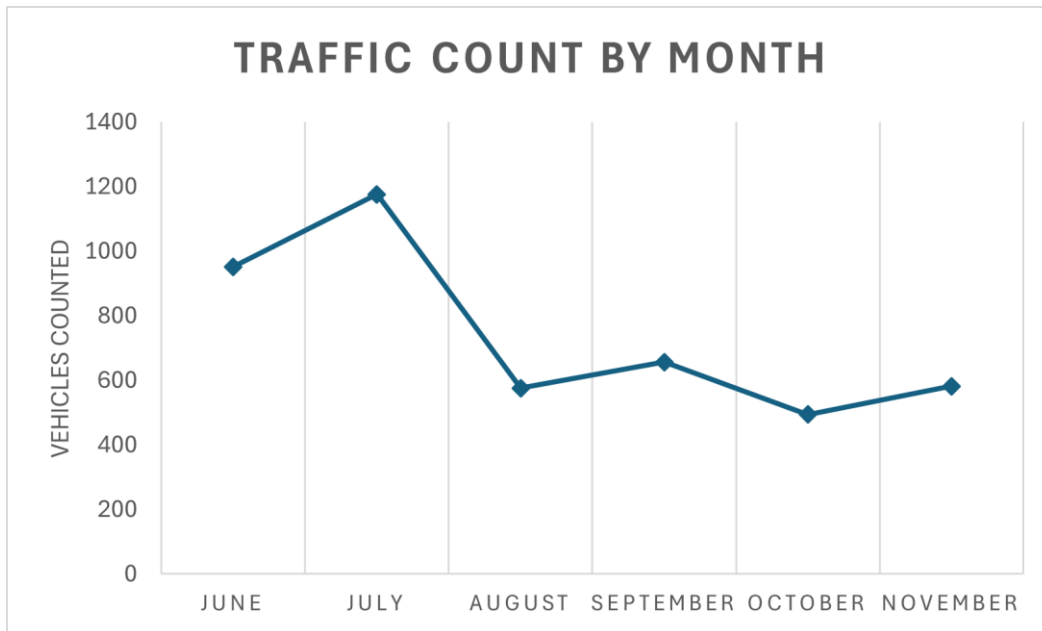
The results from traffic counts completed during this project are summarized in figure 9. The highest number of vehicles was observed in the month of July, with a total of 1,176 recorded. Total traffic counts plateaued between the months of August and November, with the limitations imposed by the construction along Heart Lake Road. Traffic counts remained a component of the monitoring shift, however fewer shifts were delivered at this time, and traffic was bottlenecked with the reduction of the road to one lane for both directions of traffic. Despite construction complications, an average of 143 vehicles per 15-minute count was observed. Further monitoring would be required to provide greater insight into the use of Heart Lake Road.

Figure 9 Vehicles counted within a 15-minute time period throughout the monitoring season.

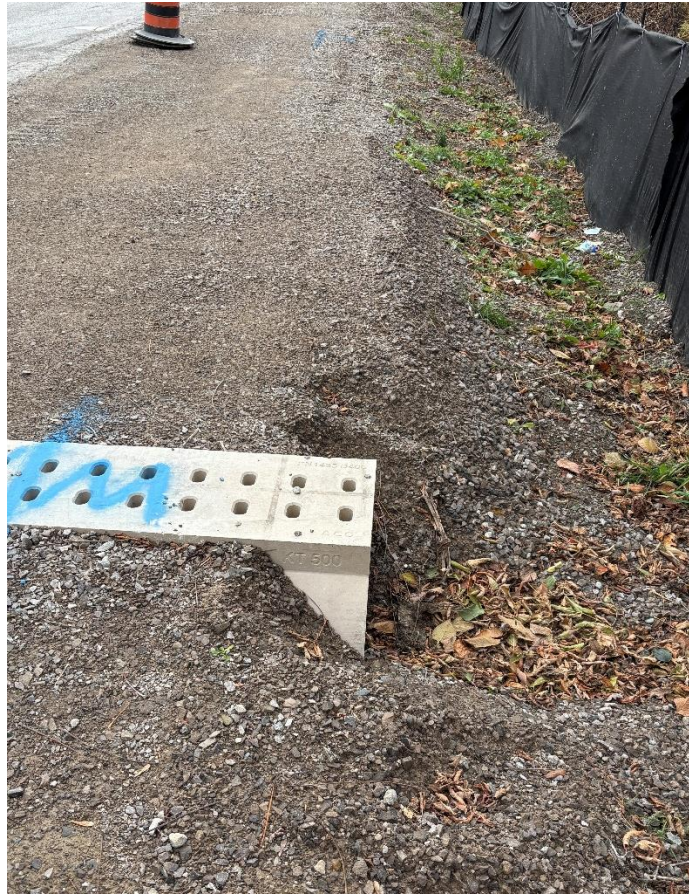
While it was fortunate that the option to pivot was available, the construction complicated the monitoring protocol and quality of data being captured. The exclusion fencing between tags S00651-S00661 (appendix A, Map C) was removed during construction and had not been replaced by the end of the monitoring season. Of particular concern is the section of removed fencing surrounding the northern wildlife passage (figure 11).

*Figure 11 Wildlife culvert passage exposed, allowing wildlife to bypass and cross the road.*

The fencing intended to direct wildlife into the concrete passage has not been replaced, making this tool ineffective and posing threats to the safety of wildlife using the road. The sediment fencing installed in place of the wildlife fencing had been punctured in several places, creating gaps for wildlife to pass through and cross Heart Lake Road.

To encourage continued use of the two wildlife passages, additional maintenance and monitoring is recommended. While monitoring of the passages were outside the scope of the project this year, there may be benefit in re-installing a trail camera or similar image collection device to understand the fauna using the passages and how it may be enhanced. We recommend regular maintenance to ensure that the passage is kept clean and safe for wildlife. With the development and road construction taking place, additional efforts may be required to prevent buildup of materials in these passages. This includes clearing debris from inside the passages and seasonal flushing.

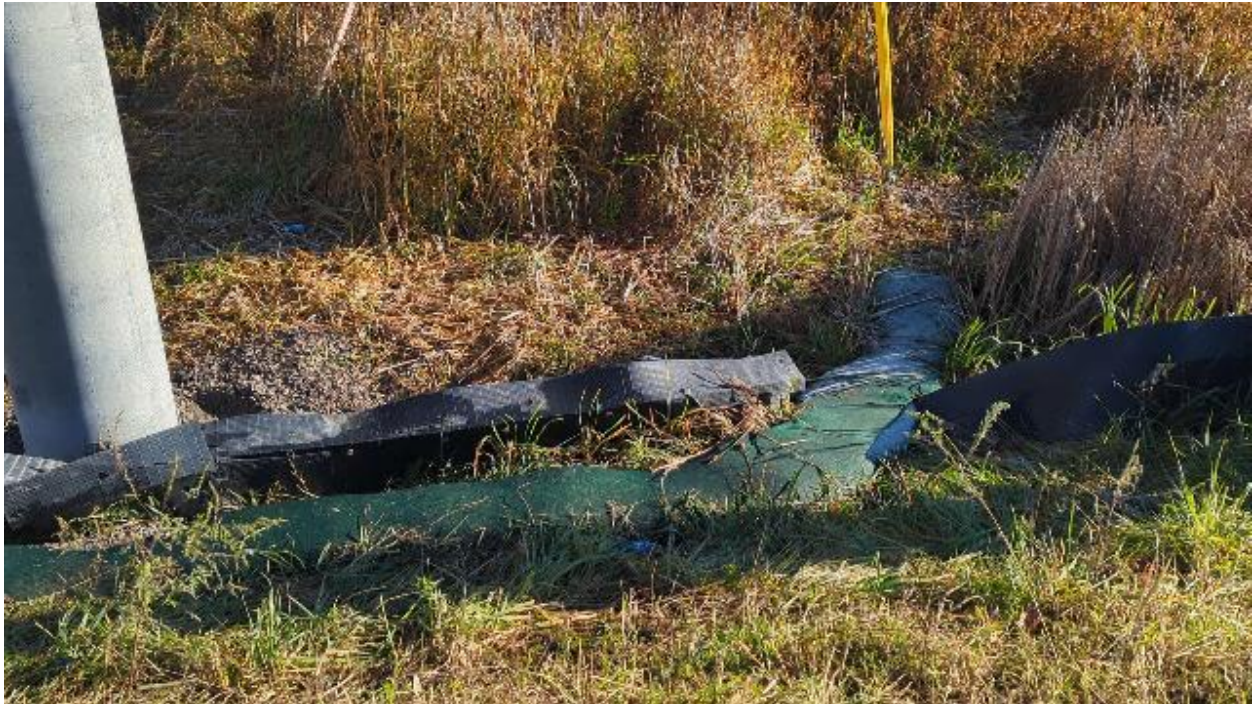
Furthermore, the construction caused undue damage to some of the existing wildlife fencing, with several panels damaged due to improperly discarded silt socks (figure 12).

*Figure 12 Improperly discarded silk sock causing damage to the exclusion fencing.*

While fence repairs were implemented twice during the monitoring season, the age and integrity of the existing exclusion fence is a concern for the wildlife using Heart Lake Road. Nearly 10 years after installation, the fence is deteriorating at numerous points throughout the extent. To better protect wildlife and encourage the use of the wildlife passages, new exclusion fencing is strongly recommended. In its current state, there are innumerable holes to be patched, wash outs in the gravel at the base of the fence, overhangs that are missing and require replacement, and entire segments of missing fence. Regular maintenance is also required along the areas adjacent to the fencing. Vegetation is growing over much of the fence, creating a bridge for wildlife to bypass the fence and cross the road.

With the complications caused by construction, there was significant delays in completing the second round of repairs due to the inability of staff to access the exclusion fence. Timely repairs are essential in maintaining an effective barrier for wildlife and mitigating WVCs, particularly during key migratory periods where fauna are more active and vulnerable.

Regular maintenance and permanent, more structurally sound solutions are recommended to effectively protect wildlife and keep them off the road.

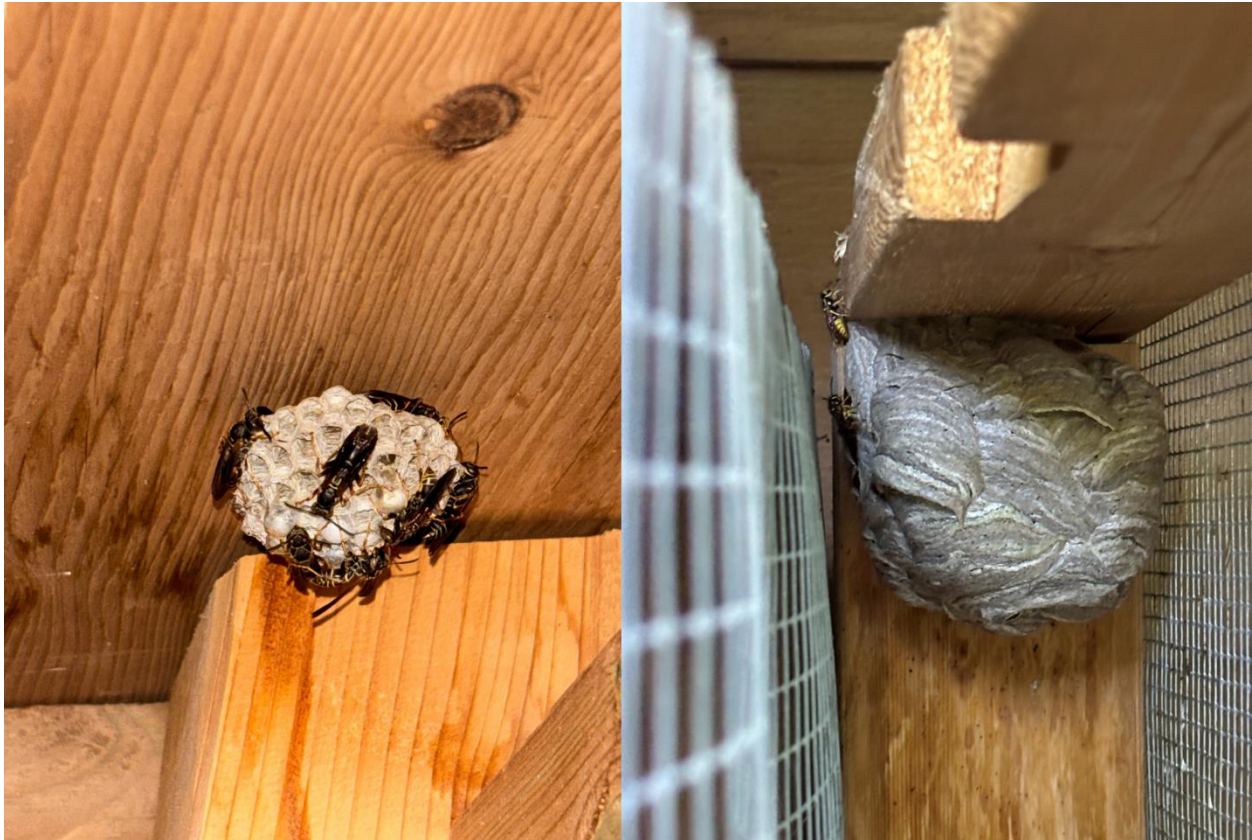
In late July, two Paper Wasp (*Polistes spp.*) nests were found in the storage box by TRCA staff. The first, more mature, nest had been built on a turtle nest protector. The second nest, caught in the beginning stages of construction, was found hanging from the top of the storage box. The wasps were active and present in both nests (figure 13).

*Figure 13 Paper Wasp nests in the HLREMP storage box. The more mature nest is pictured on the right, and the newer nest is on the left.*

The nests were promptly dealt with by TRCA staff. The more mature nest was relocated by transporting the attached turtle protector into a safe location within the neighbouring forest. The nest protector was retrieved in November, at the end of the monitoring season. The smaller nest was treated chemically and disposed of in the appropriate disposal site at Heart Lake Conservation Park. For the health and safety of the volunteers, two monitoring shifts were cancelled during the removal and treatment phase as a preventative measure.

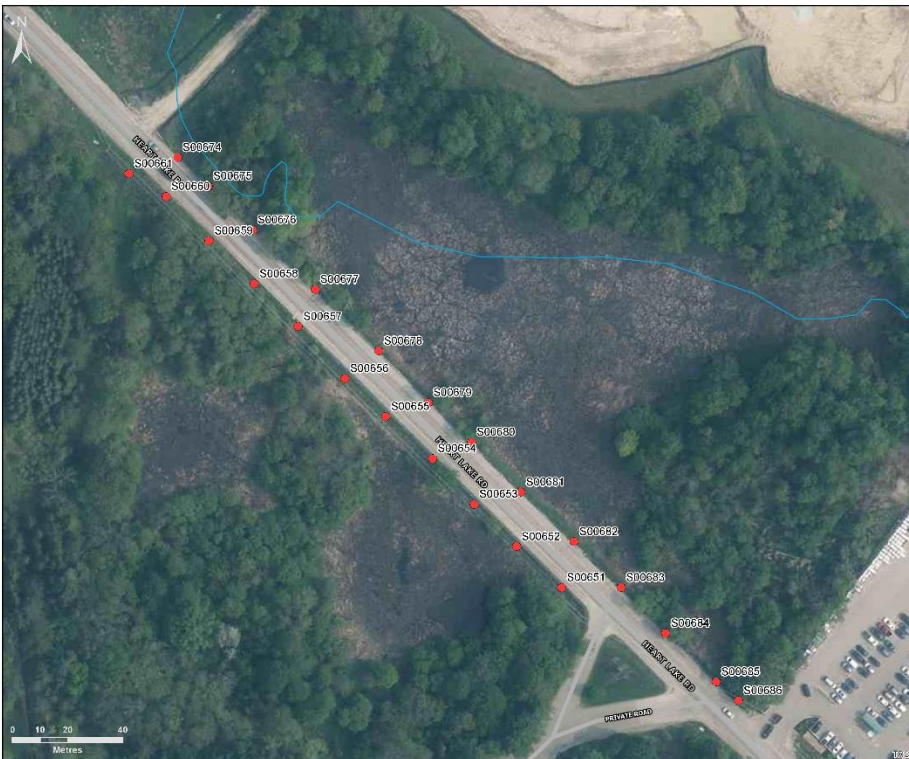
**Map C**

**Heart Lake Road Ecology Monitoring  
Exclusion Fencing Tags**

Prior to the start of the monitoring season in June, TRCA staff and HLTT executives walked the monitoring route between Countryside Dr and Sandalwood Pkwy E, adding numbered tags to the exclusion fence at an interval of 10 panels. These tags were recorded using a handheld GPS unit and mapped for future reference and training purposes (appendix A). Project volunteers were trained to record the tag numbers to provide a spatial reference for exclusion fencing damage, and subsequently to provide City of Brampton staff with precise panels requiring repair.

Volunteers also monitored and reported damage to the exclusion fencing on the Survey123 platform. In reference to the fence tags (appendix A), volunteers would record the nearest tag number, the number of panels damaged, and a description of the damage. TRCA staff would summarize these results and communicate them to City of Brampton staff for repair.

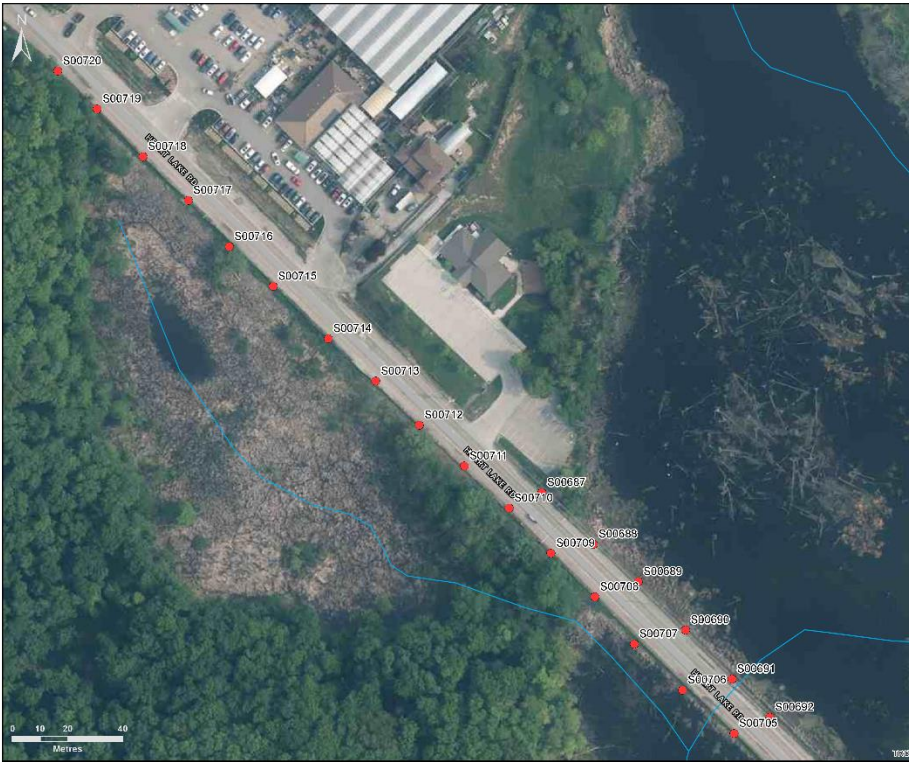
**Map D**

**Heart Lake Road Ecology Monitoring Exclusion Fencing Tags**

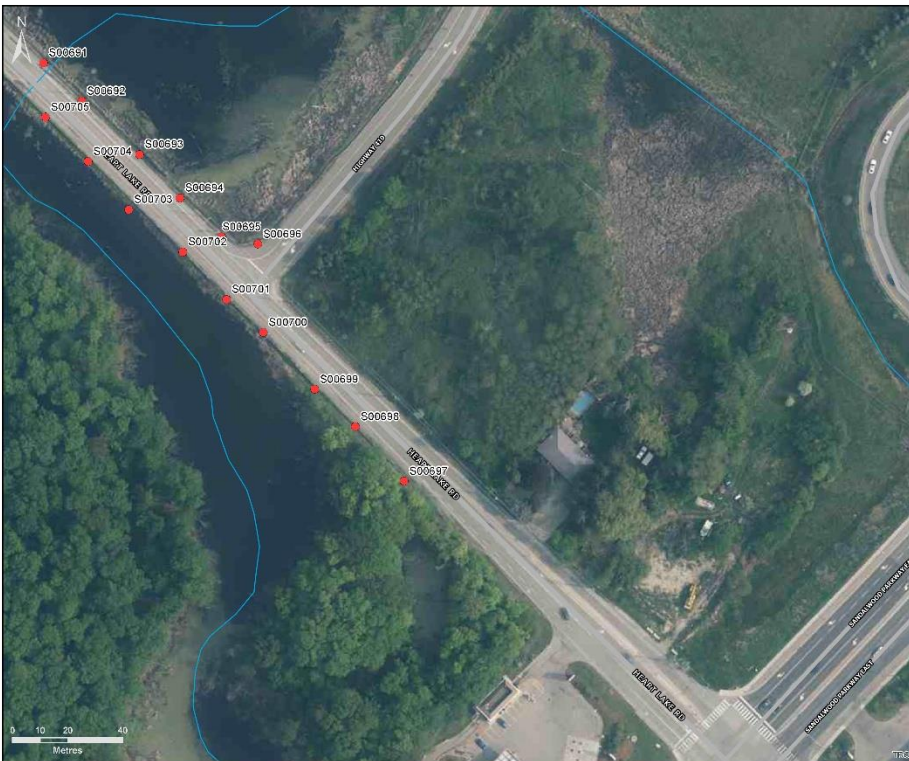
**Map E**

**Heart Lake Road Ecology Monitoring Exclusion Fencing Tags**

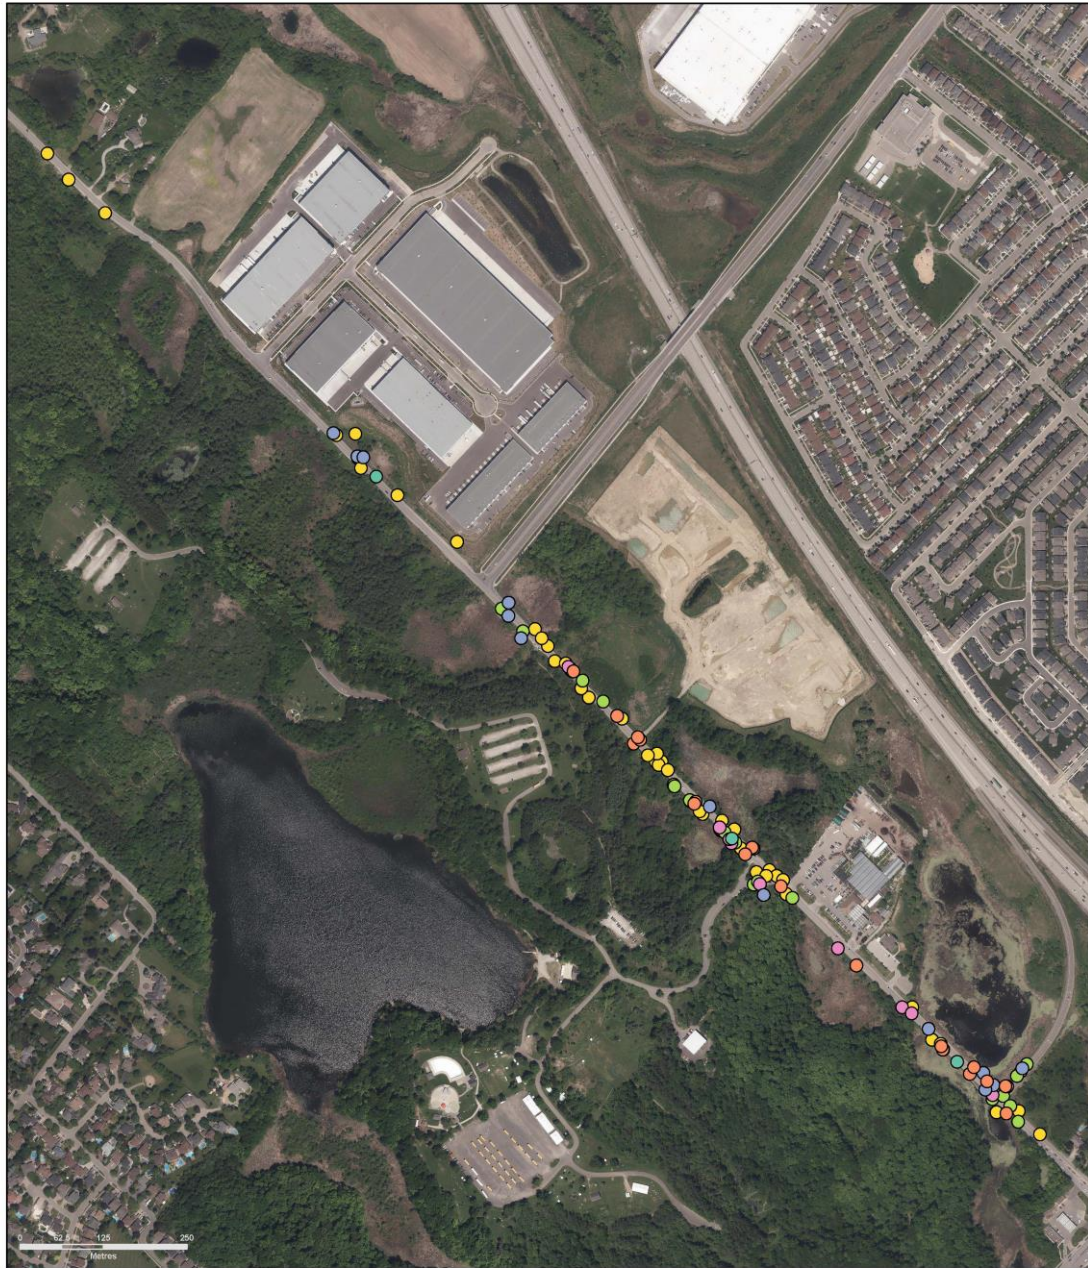
<p>Date: 2025-12-04 Created by: Restoration and Infrastructure Ordningshot: First Base Solutions, City of Toronto, Peel Region, York Region, Durham Region, 2024</p>	  <h3>Heart Lake Road Ecology Monitoring</h3> <p>All Observations</p>	<p><b>Legend</b></p> <ul style="list-style-type: none"> <li><span style="color: orange;">●</span> Turtles</li> <li><span style="color: green;">●</span> Frogs</li> <li><span style="color: purple;">●</span> Snakes</li> <li><span style="color: blue;">●</span> Birds</li> <li><span style="color: yellow;">●</span> Mammals</li> <li><span style="color: teal;">●</span> Unknown</li> </ul>
<p><small>Disclaimer: The data used to create this map was compiled from a variety of sources &amp; dates. The TRCA takes no responsibility for errors or omissions in the data and retains the right to make changes &amp; corrections at anytime without notice. For further information about the data on this map, please contact the TRCA Restoration and Infrastructure Division. (416) 661-6600. May not be reproduced without permission. This is not a plan of survey. Produced by Toronto and Region Conservation Authority under licence with the Ministry of Natural Resources &amp; Forestry. © Queen's Printer for Ontario.</small></p>

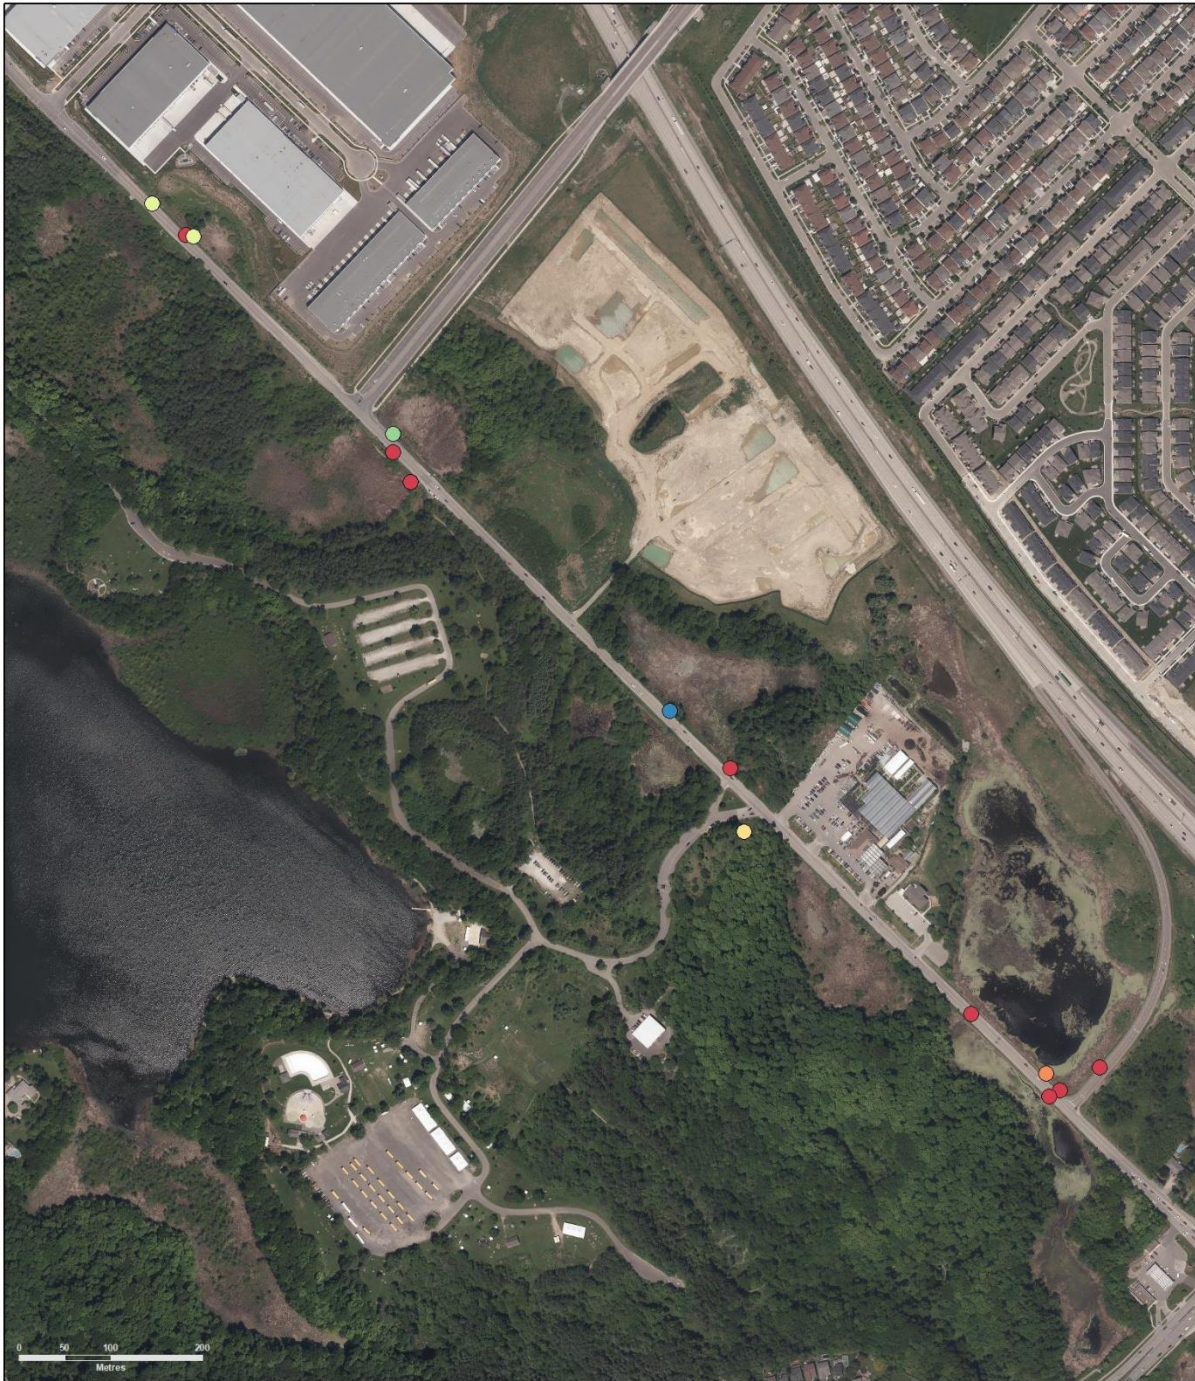
<p>             Date: 2025-12-04              Created by: Restoration and Infrastructure              Orthophoto: First Base Solutions, City of Toronto, Peel Region, York Region, Durham Region, 2024         </p>	<p> <b>Heart Lake Road Ecology Monitoring</b>              Bird Observations         </p>	<p><b>Species Recorded</b></p>

<table><tr> <td><span style="color: blue;">●</span> Northern Cardinal</td> <td><span style="color: yellow;">●</span> European Starling</td> </tr></table>

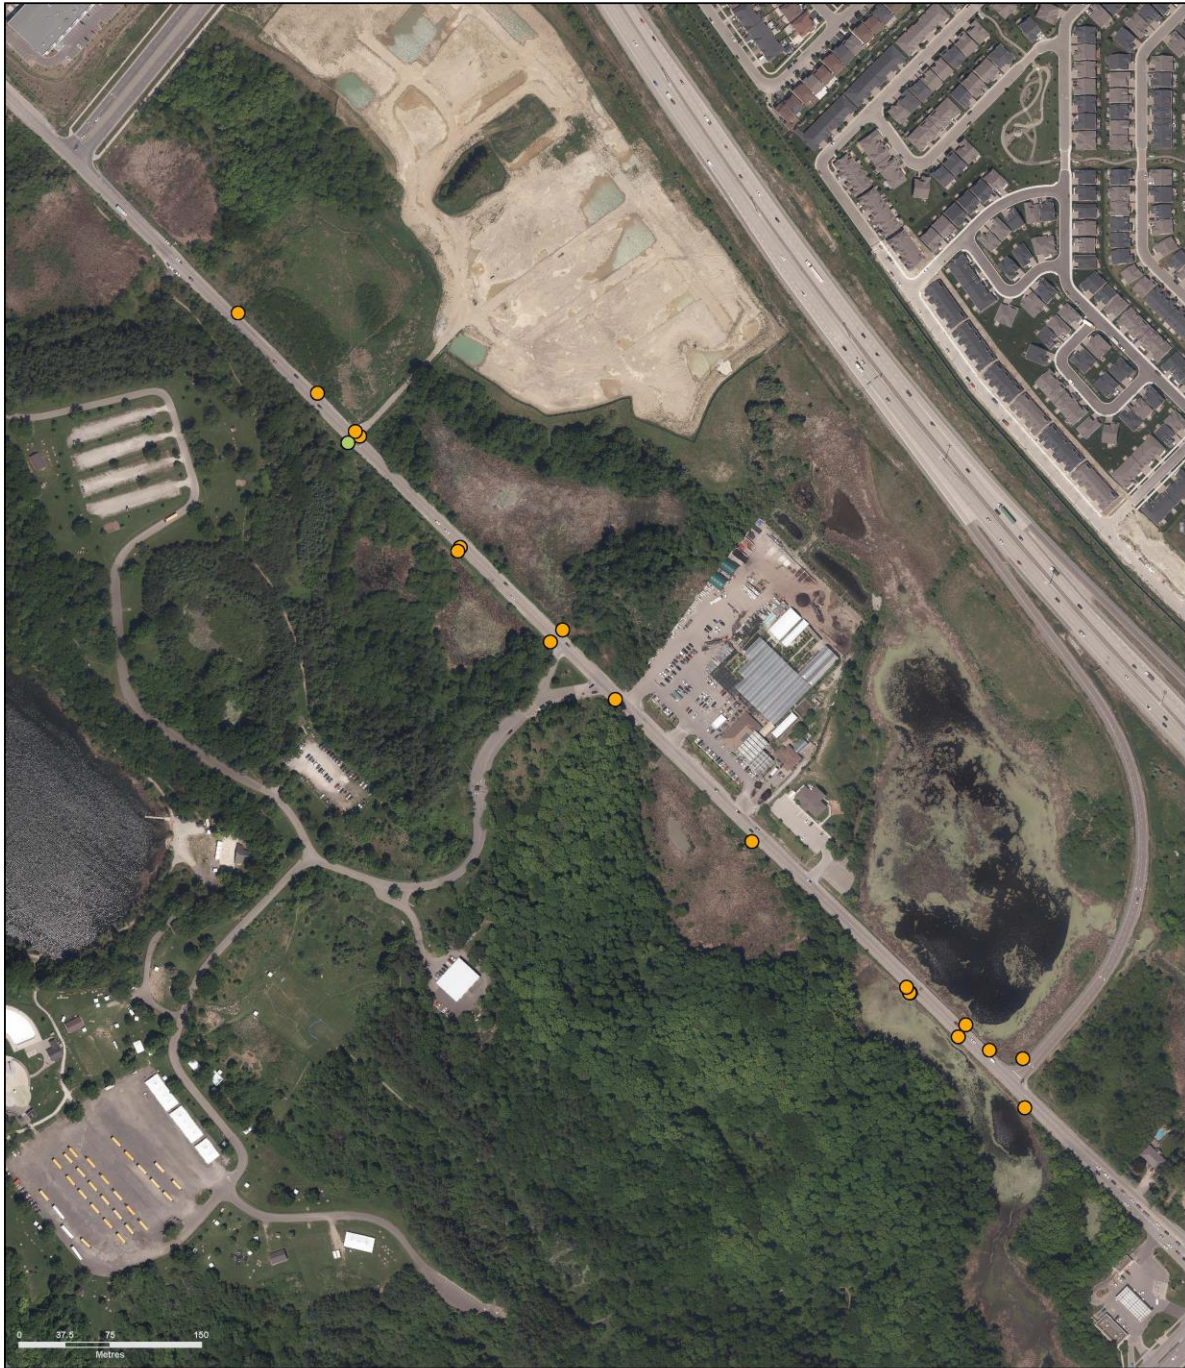
**Heart Lake Road  
 Ecology Monitoring**  
 Turtle Observations
