**BRAMALEA ROAD CORRIDOR IMPROVEMENTS, MUNICIPAL CLASS
ENVIRONMENTAL ASSESSMENT STUDY**

Geotechnical Investigation

Proposed Road Improvements

Bramalea Road from Queen Street to South City Limit

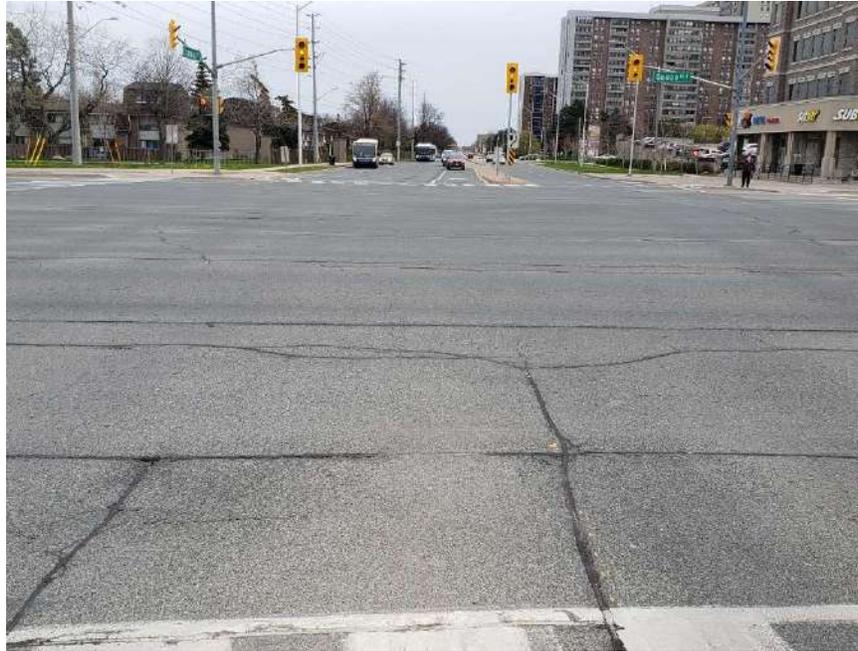
Photograph 1 – Bramalea Road, looking South, near the intersection of Queen Street East and Bramalea Road, showing moderate to severe longitudinal and transverse cracking associated with slight to moderate random cracking and slight pavement raveling.

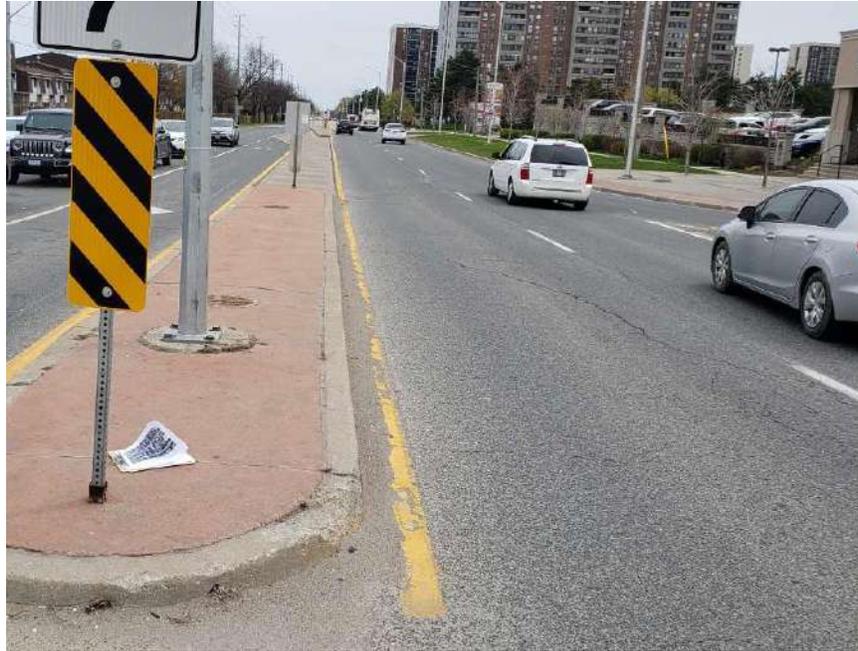
Photograph 3 – Bramalea Road, Southbound, looking South, near the intersection of Queen Street East and Bramalea Road, showing moderate longitudinal and transverse cracking associated with slight to moderate random cracking, slight alligator cracking and slight pavement raveling.

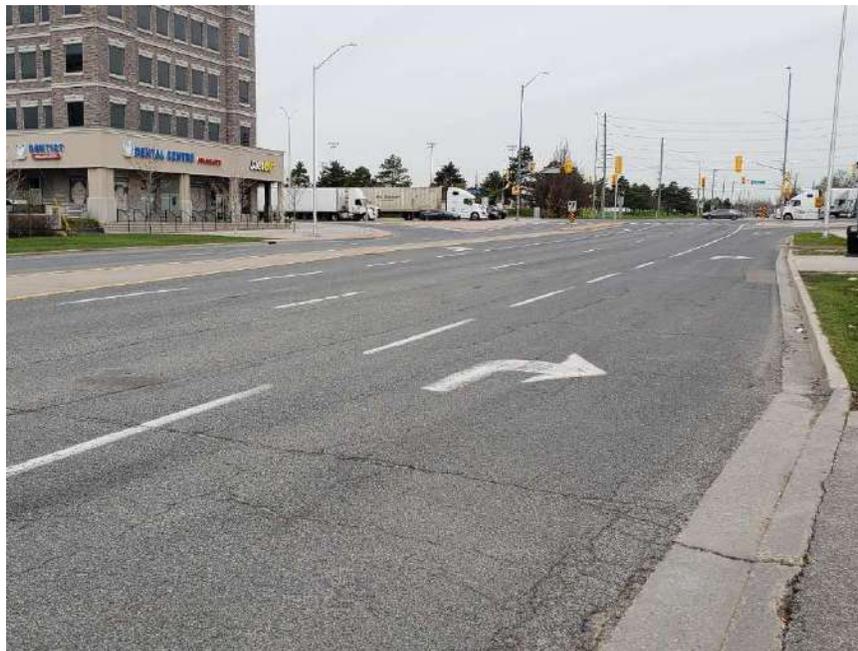
Photograph 4 – Bramalea Road, Northbound, looking North, approximately 105 m South of Queen Street East, showing moderate longitudinal and transverse cracking associated with slight to moderate random cracking, slight block cracking, slight to moderate alligator cracking, slight potholes, moderate to severe pavement edge cracking and slight pavement raveling. Noting sections of patching.

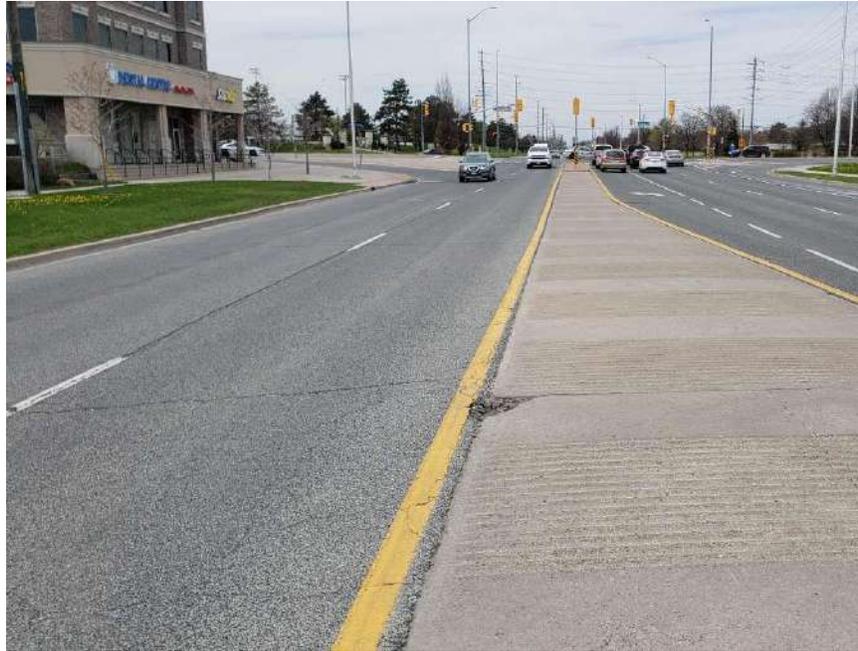
Photograph 5 – Bramalea Road, Southbound, looking North, approximately 110 m South of Queen Street East, showing moderate longitudinal and transverse cracking associated with slight to moderate random cracking, slight potholes, slight pavement edge cracking and slight pavement raveling.

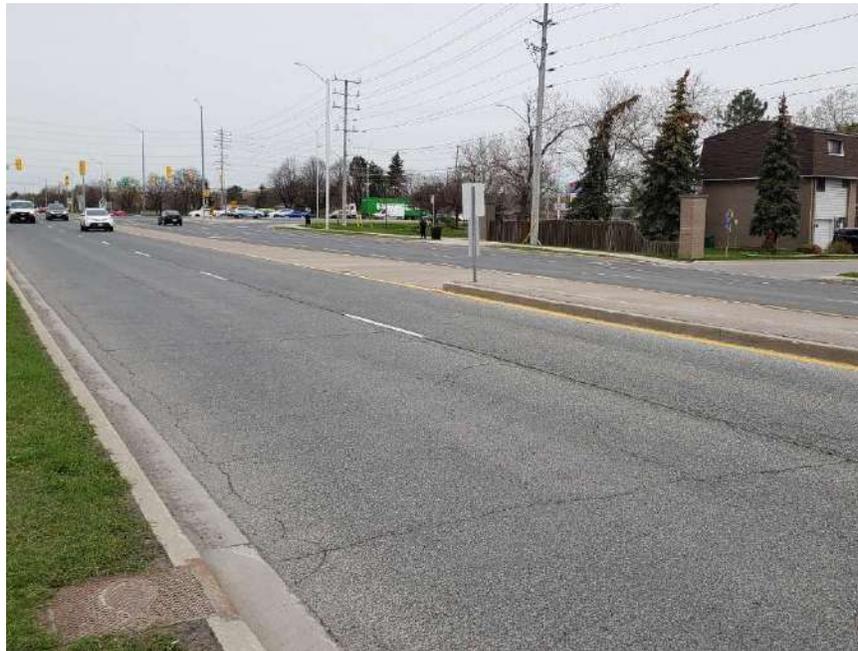
Photograph 6 – Bramalea Road, Southbound, looking North, approximately 135 m South of Queen Street East, showing moderate longitudinal and transverse cracking associated with moderate random cracking, slight to moderate pavement edge cracking and slight pavement raveling.

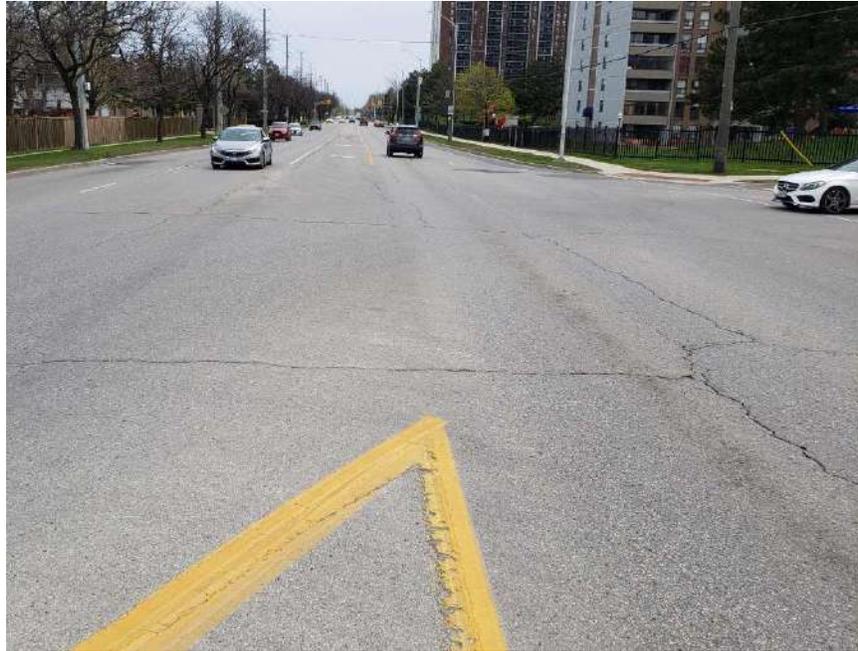
Photograph 7 – Bramalea Road, looking South, near the intersection of Kensington Road and Bramalea Road, showing moderate to severe longitudinal and transverse cracking associated with slight to moderate random cracking and slight pavement raveling. Noting sections of patching.

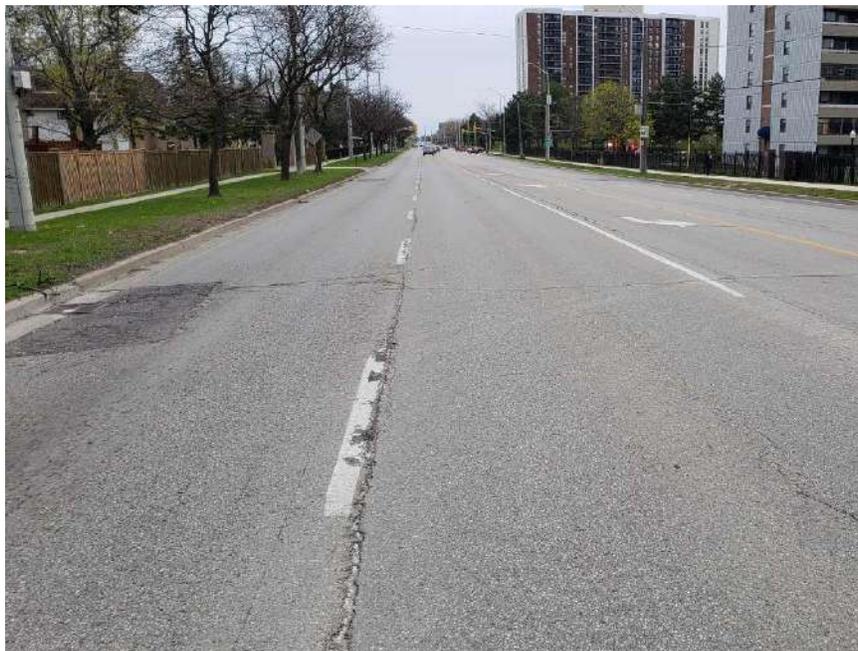
Photograph 8 – Bramalea Road, Northbound, looking South, at the intersection of Kensington Road and Bramalea Road, showing moderate longitudinal and transverse cracking associated with moderate random cracking, slight pavement edge cracking and slight pavement raveling. Noting sections of patching.

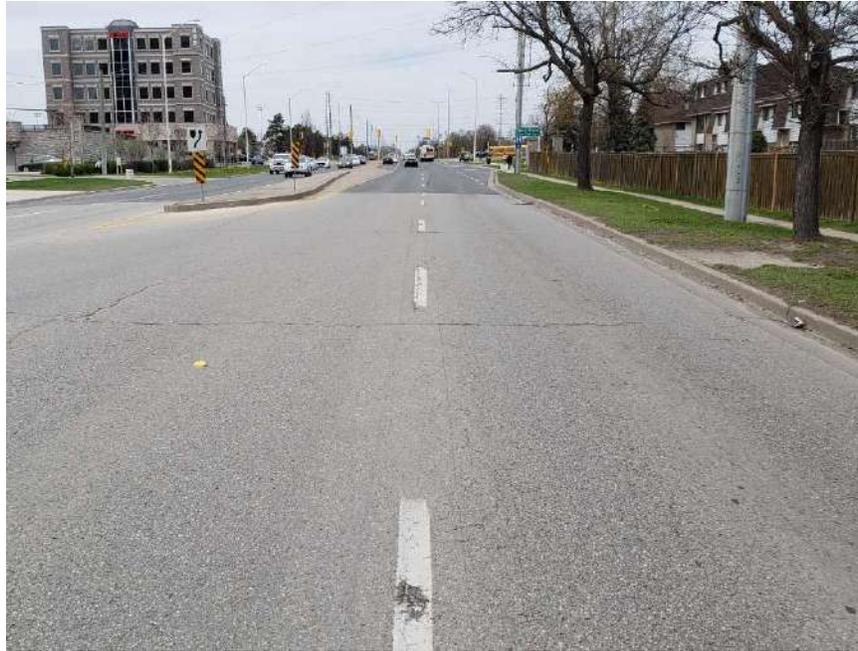
Photograph 9 – Bramalea Road, Northbound, looking North, near the intersection of Kensington Road and Bramalea Road, showing moderate longitudinal and transverse cracking associated with slight random cracking, slight pavement edge cracking and slight pavement raveling.

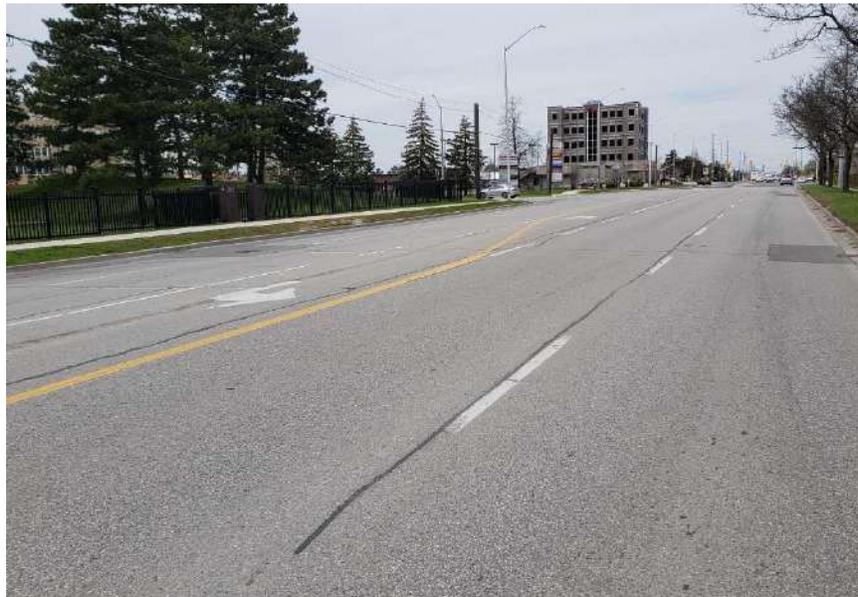
Photograph 10 – Bramalea Road, Northbound, looking North, near the South intersection of Gates of Bramalea and Bramalea Road, showing moderate longitudinal and transverse cracking associated with slight random cracking, slight pavement edge cracking and slight pavement raveling. Noting sections of patching.

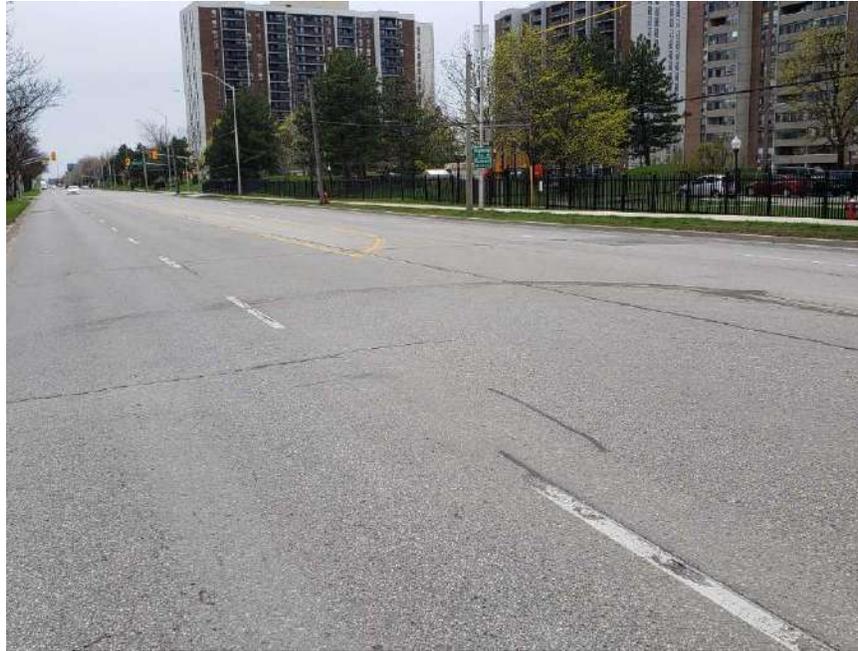
Photograph 11 – Bramalea Road, Northbound, looking South, near the South intersection of Gates of Bramalea and Bramalea Road, showing slight to moderate longitudinal and transverse cracking associated with slight random cracking, slight pavement edge cracking and slight pavement raveling. Noting sections of patching.

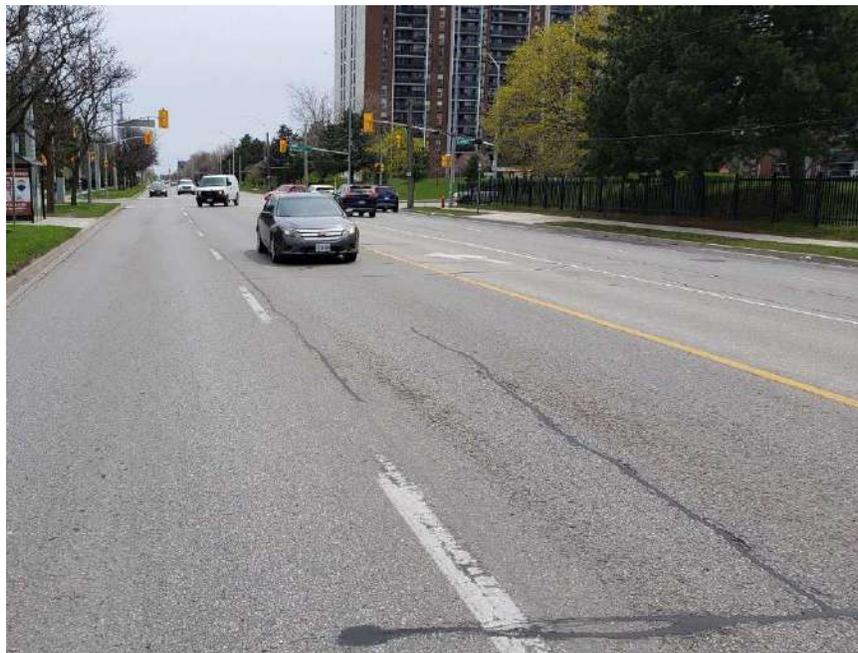
Photograph 12 – Bramalea Road, Northbound, looking South, approximately 70 m North of Fleetwood Crescent, showing slight to moderate longitudinal and transverse cracking associated with slight random cracking, slight pavement edge cracking and slight to moderate pavement raveling.

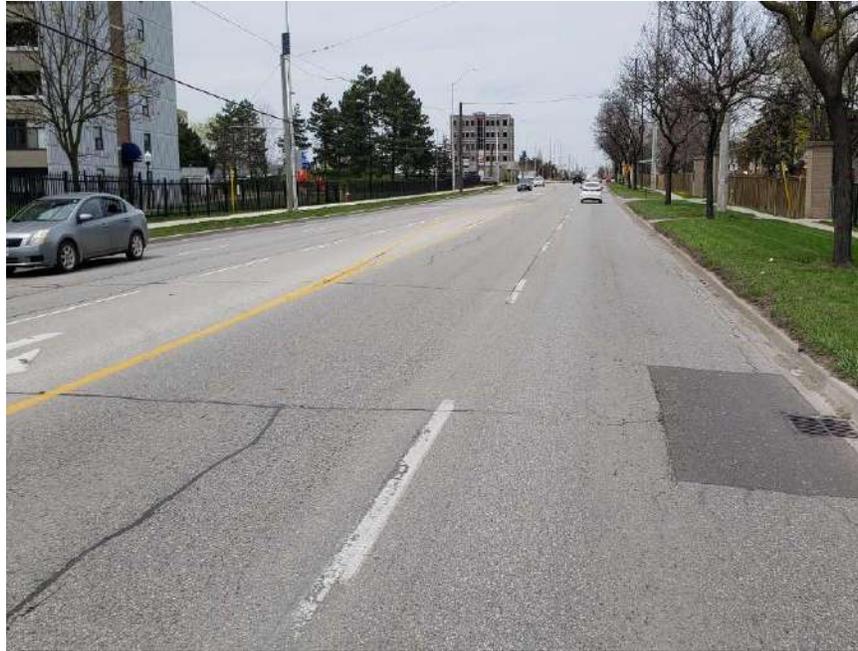
Photograph 13 – Bramalea Road, Northbound, looking North, approximately 85 m North of Fleetwood Crescent, showing moderate longitudinal and transverse cracking associated with slight random cracking, slight to moderate pavement edge cracking and slight to moderate pavement raveling. Noting patching around catch basin.

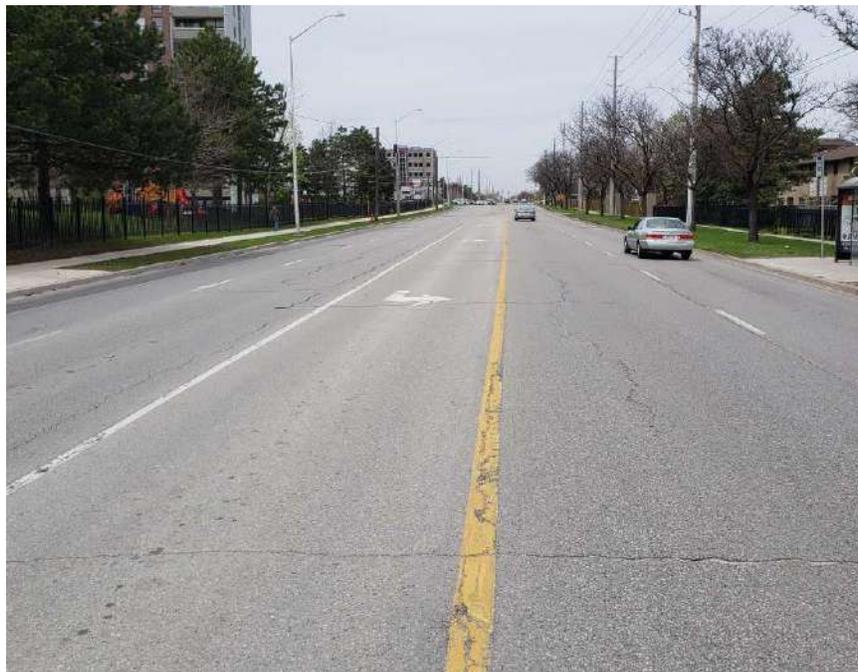
Photograph 14 – Bramalea Road, looking North, near the intersection of Fleetwood Crescent and Bramalea Road, showing moderate longitudinal and transverse cracking associated with slight random cracking, slight pavement edge cracking and slight pavement raveling. Noting utility patching.

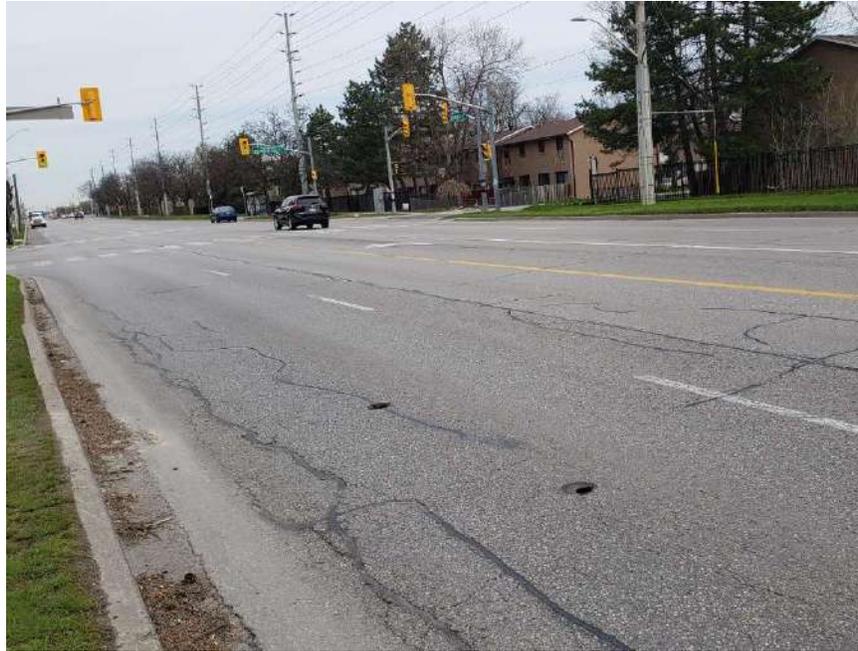
Photograph 15 – Bramalea Road, Southbound, looking North, in the vicinity of the intersection of Bramalea Road and Fleetwood Crescent, showing moderate to severe longitudinal and transverse cracking associated with moderate random cracking, slight potholes, slight to moderate pavement raveling and moderate pavement edge cracking.

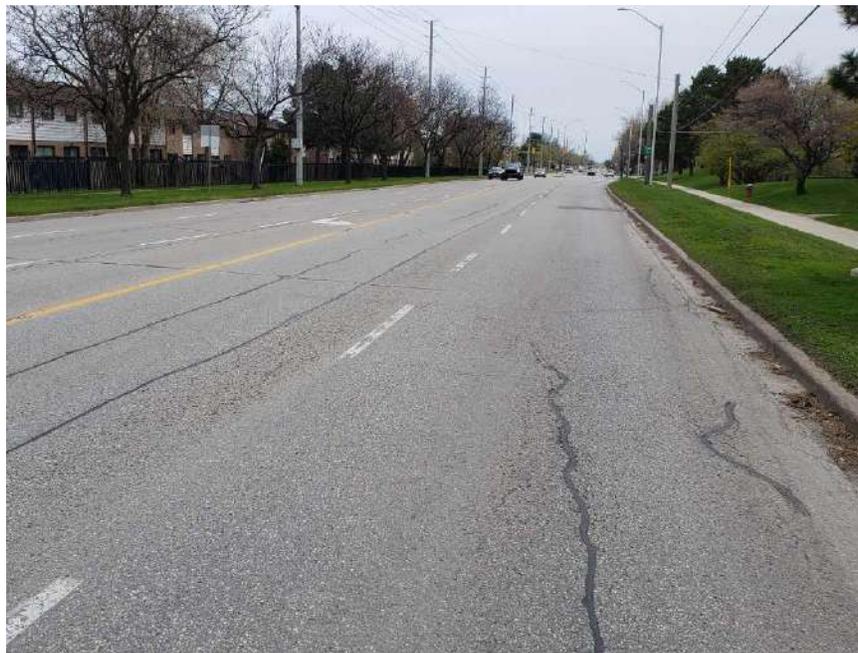
Photograph 16 – Bramalea Road, Southbound, looking South, approximately 70 m South of Fleetwood Crescent, showing moderate to severe longitudinal and transverse cracking associated with slight to moderate random cracking, slight pavement depressions, slight to moderate pavement raveling and slight to moderate pavement edge cracking.

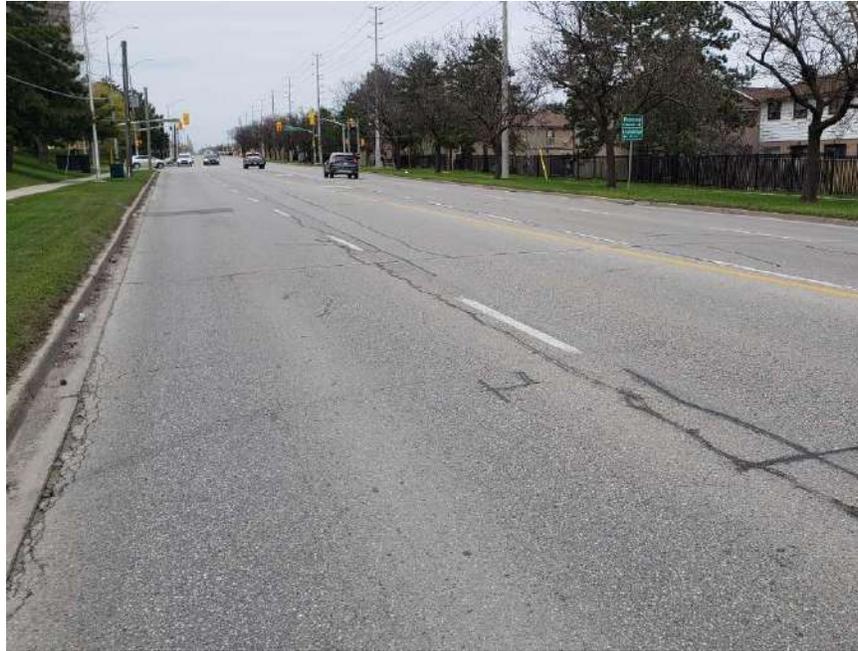
Photograph 17 – Bramalea Road, Southbound, looking North, approximately 105 m South of Fleetwood Crescent, showing moderate longitudinal and transverse cracking associated with slight to moderate random cracking, slight pavement raveling, slight alligator cracking and moderate pavement edge cracking.

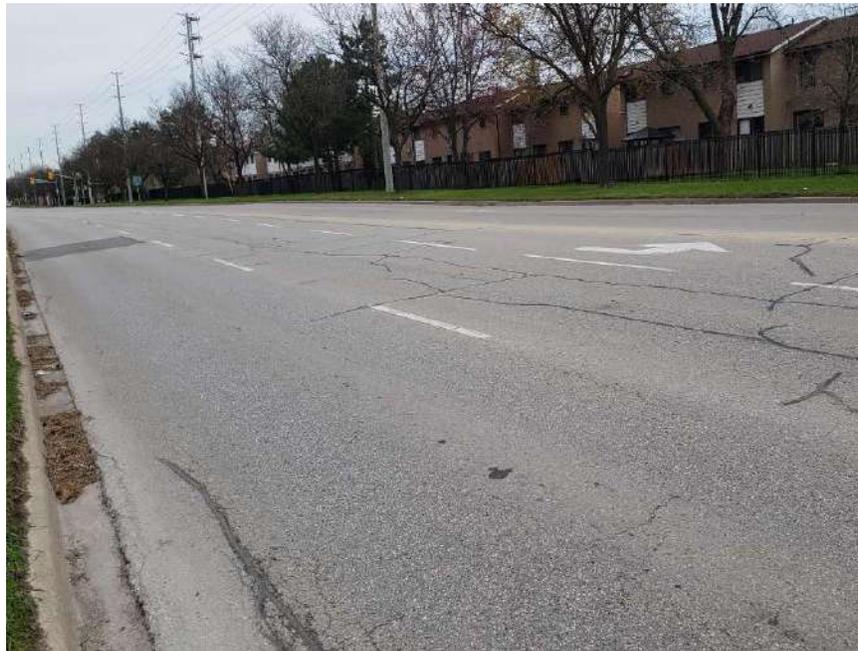
Photograph 18 – Bramalea Road, Southbound, looking North, approximately 125 m South of Fleetwood Crescent, showing moderate to severe longitudinal and transverse cracking associated with moderate random cracking, slight to moderate pavement raveling and slight to moderate pavement edge cracking.

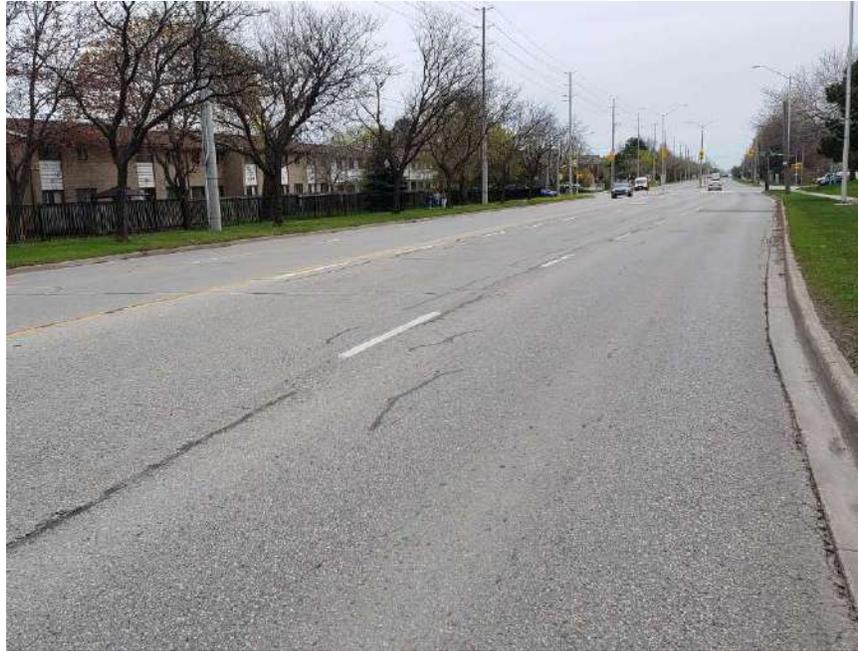
Photograph 19 – Bramalea Road, Southbound, looking South, approximately 150 m South of Fleetwood Crescent, showing moderate to severe longitudinal and transverse cracking associated with moderate random cracking, slight pavement depressions, slight to moderate pavement raveling and slight pavement edge cracking.

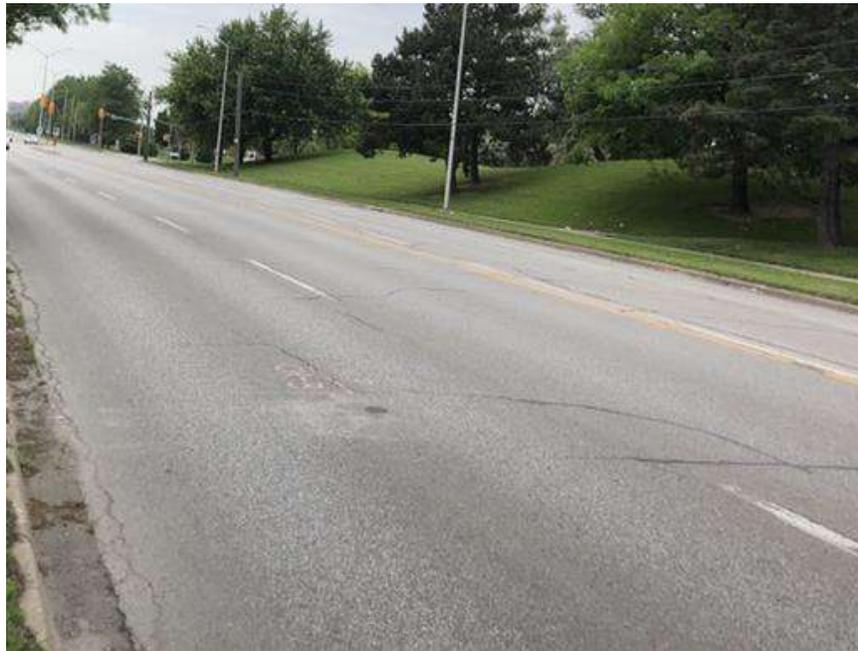
Photograph 20 – Bramalea Road, Northbound, looking South, approximately 150 m South of Fleetwood Crescent, showing moderate longitudinal and transverse cracking associated with moderate random cracking, slight pavement depressions, slight to moderate pavement raveling, slight potholes and moderate to severe pavement edge cracking.

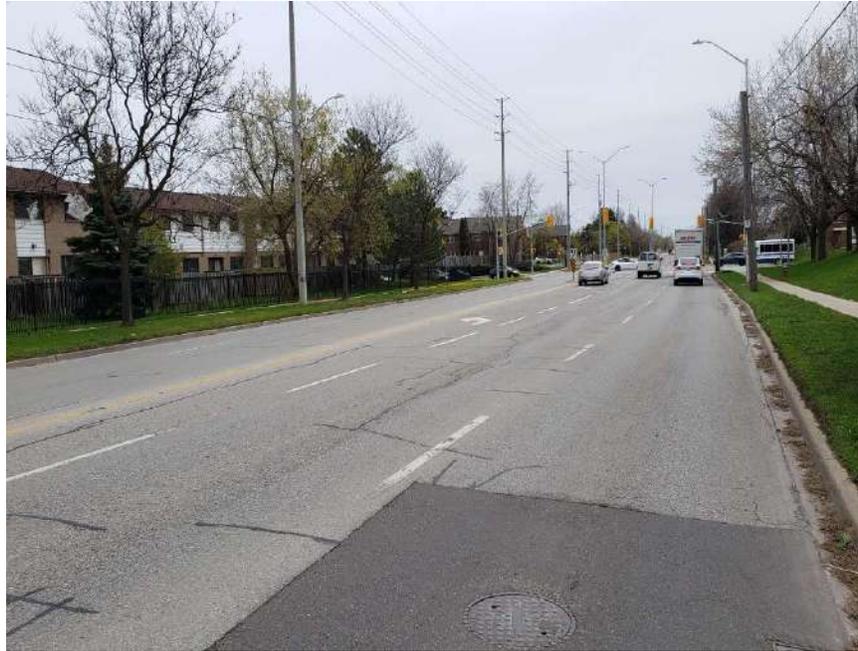
Photograph 21 – Bramalea Road, Southbound, looking South, approximately 100 m North of Clark Boulevard, showing moderate to severe longitudinal and transverse cracking associated with slight to moderate random cracking, slight to moderate pavement raveling and slight pavement edge cracking. Noting patching around catch basin and manhole.

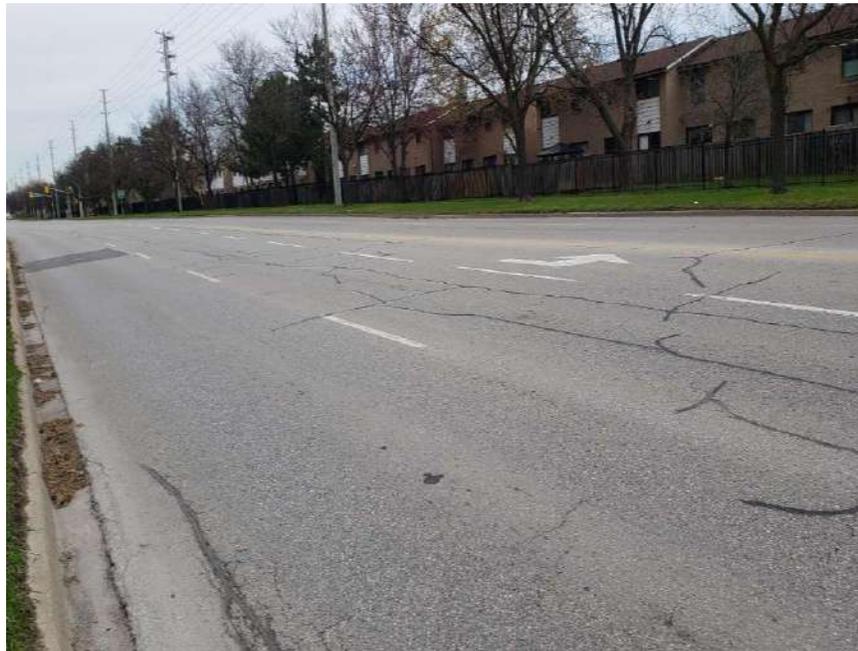
Photograph 22 – Bramalea Road, Southbound, looking North, approximately 75 m North of Clark Boulevard, showing moderate to severe longitudinal and transverse cracking associated with moderate random cracking, slight block cracking, slight to moderate pavement raveling, and slight to moderate pavement edge cracking. Noting patching around catch basin and manhole.

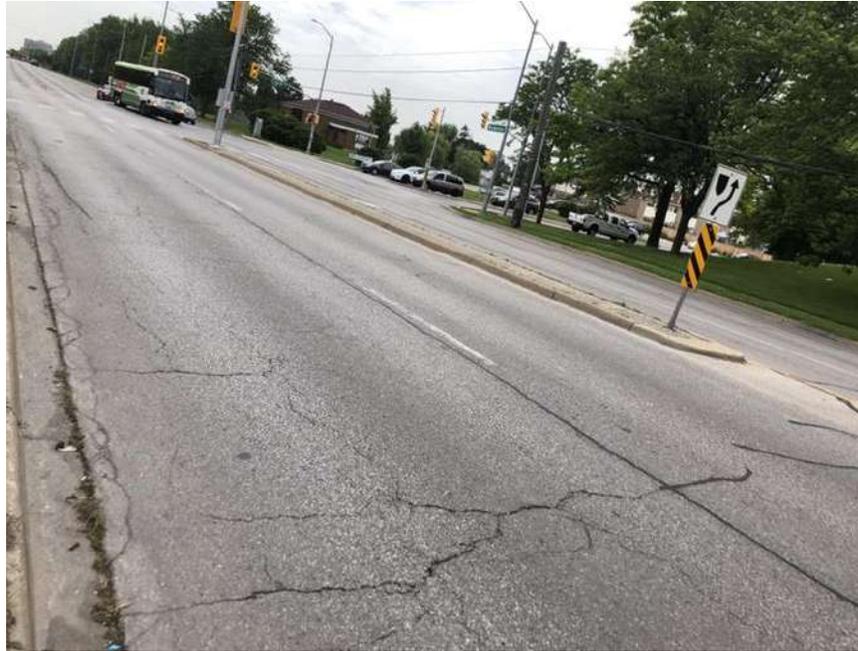
Photograph 23 – Bramalea Road, Northbound, looking South, approximately 50 m North of Clark Boulevard, showing moderate to severe longitudinal and transverse cracking associated with moderate to severe random cracking, slight alligator cracking, slight pavement raveling and moderate to severe pavement edge cracking.

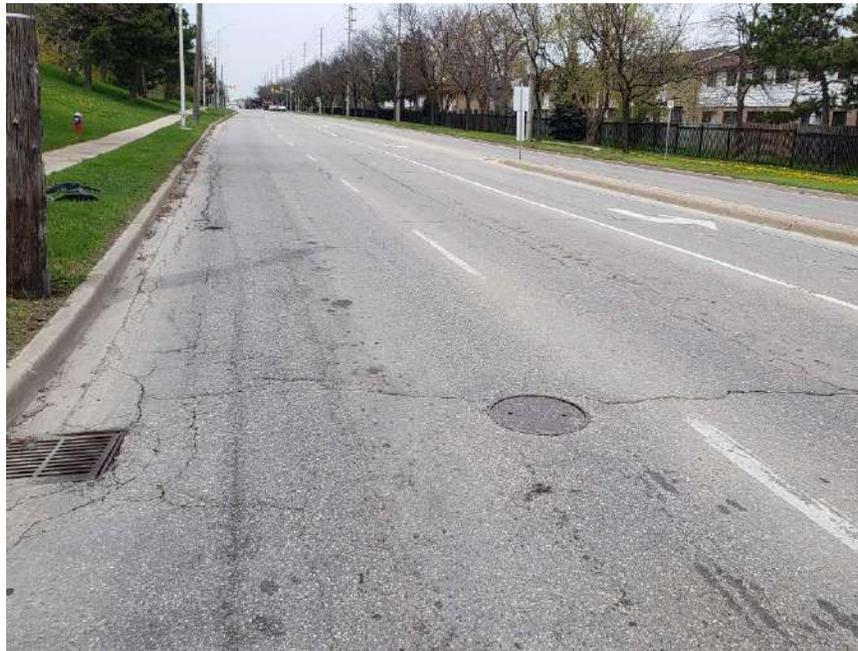
Photograph 24 – Bramalea Road, Southbound, looking North, near the intersection of Bramalea Road and Clark Boulevard, showing moderate longitudinal and transverse cracking associated with slight to moderate random cracking, slight to moderate alligator cracking, slight to moderate pavement raveling and moderate to severe pavement edge cracking. Noting moderate to severe alligator cracking around catch basin.

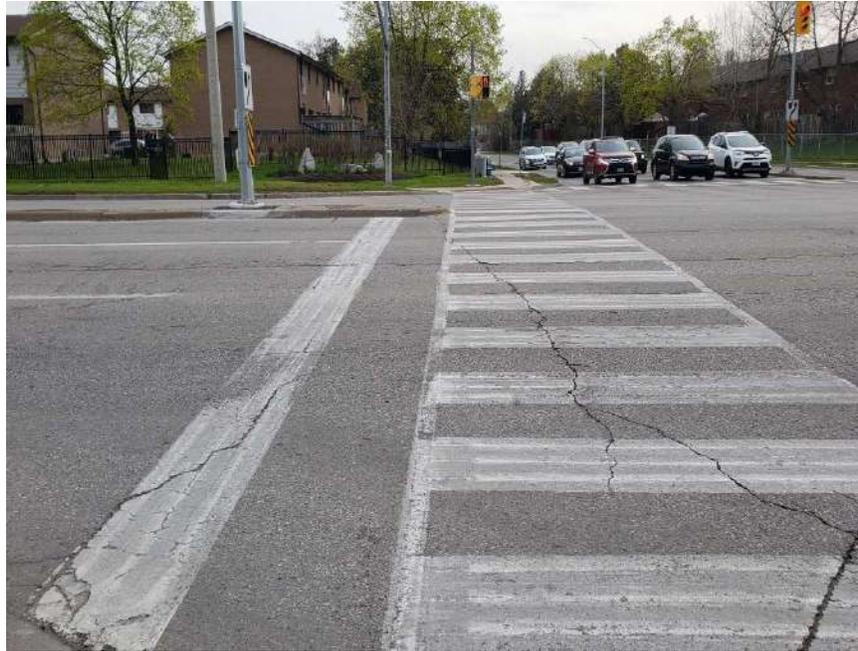
Photograph 25 – Bramalea Road, Southbound, looking East, near the intersection of Bramalea Road and Clark Boulevard, showing moderate to severe longitudinal and transverse cracking associated with moderate to severe random cracking, slight to moderate pavement raveling and slight to moderate pavement edge cracking.

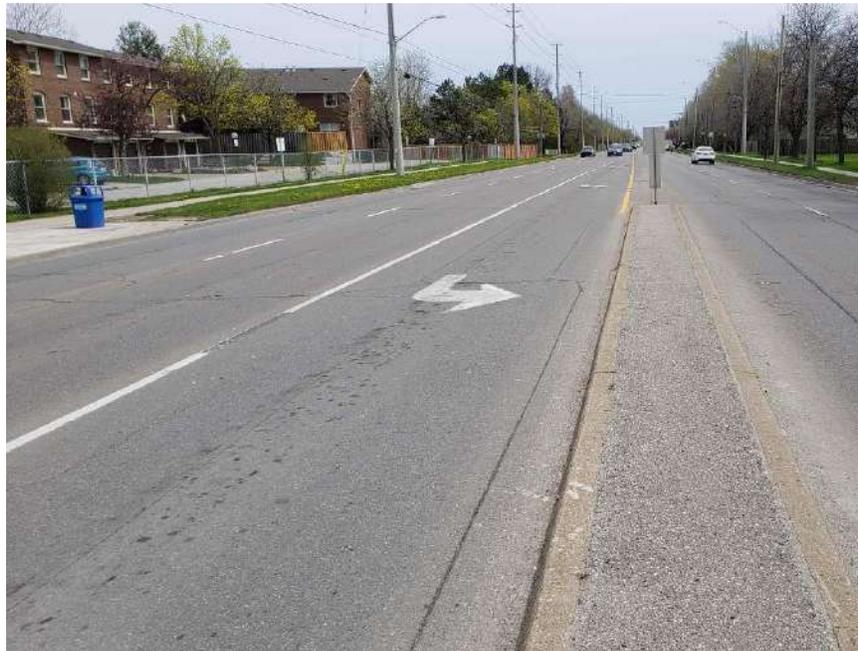
Photograph 26 – Bramalea Road, Northbound, looking South, near the intersection of Bramalea Road and Clark Boulevard, showing moderate longitudinal and transverse cracking associated with slight to moderate random cracking, slight pavement raveling and slight pavement edge cracking.

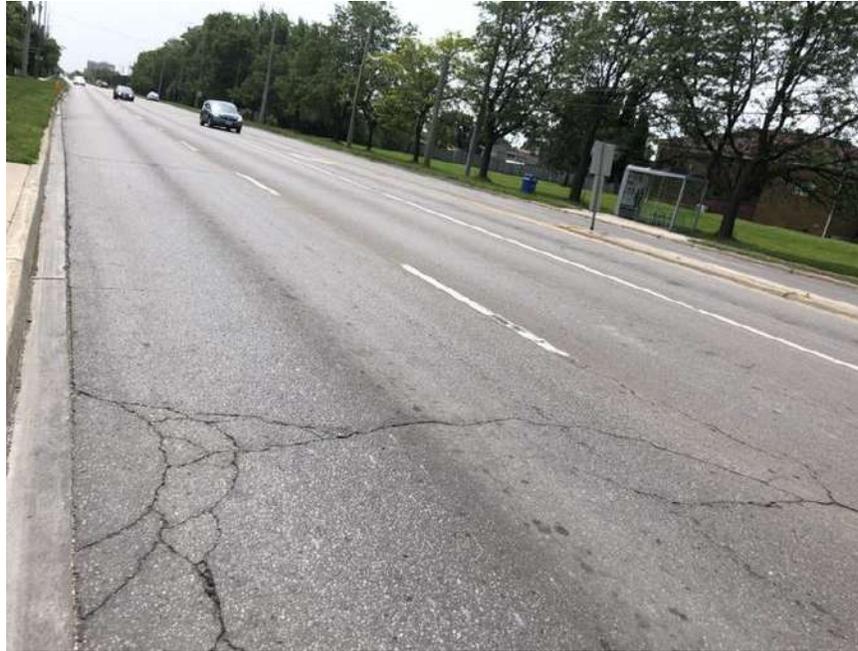
Photograph 27 – Bramalea Road, Northbound, looking South, near the intersection of Bramalea Road and Clark Boulevard, showing slight to moderate longitudinal and transverse cracking associated with moderate random cracking, slight to moderate alligator cracking, slight pavement raveling and slight to moderate pavement edge cracking.

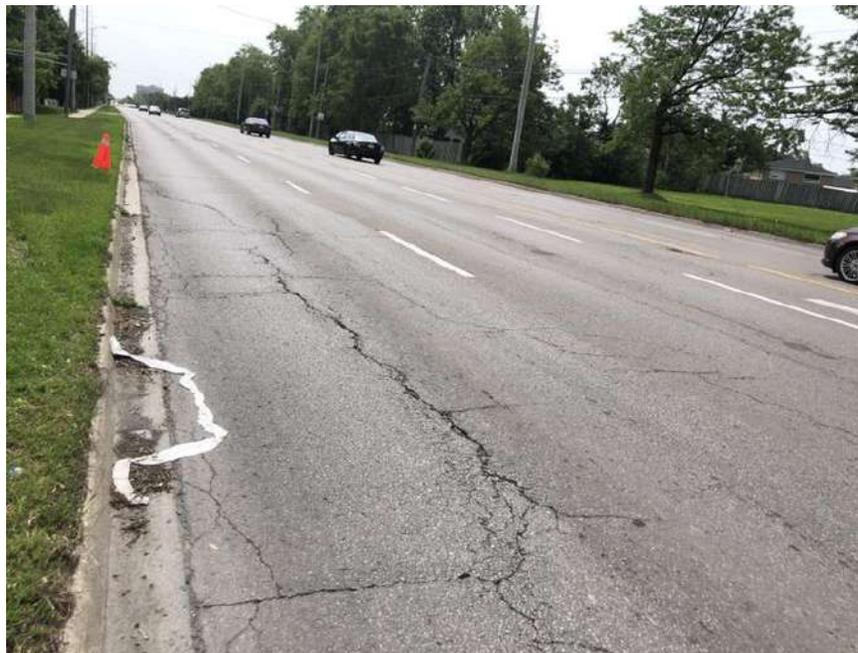
Photograph 28 – Bramalea Road, Northbound, looking South, approximately 90 m South of Clark Boulevard, showing moderate to severe longitudinal and transverse cracking associated with moderate to severe random cracking, slight to moderate alligator cracking, slight to moderate pavement raveling and moderate pavement edge cracking.

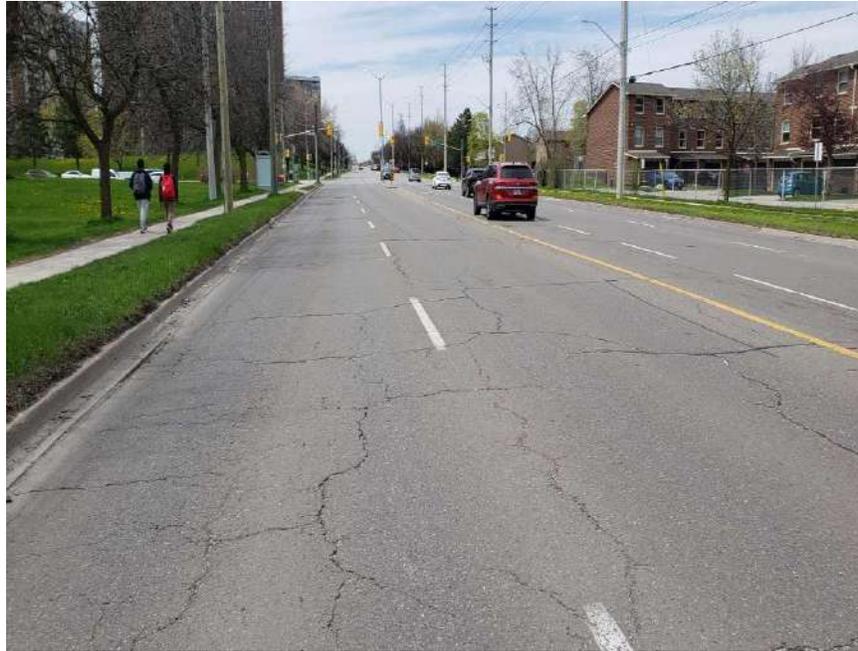
Photograph 29 – Bramalea Road, Southbound, looking North, approximately 100 m South of Clark Boulevard, showing severe block cracking associated with moderate to severe longitudinal and transverse cracking, moderate random cracking, slight pavement raveling and slight to moderate pavement edge cracking.

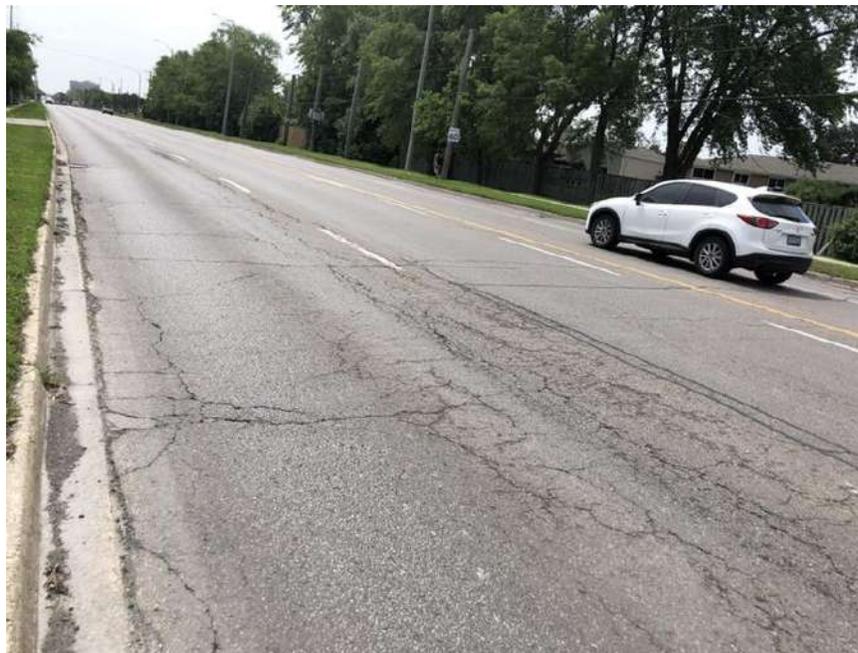
Photograph 30 – Bramalea Road, Northbound, looking South, approximately 120 m South of Clark Boulevard, showing severe alligator cracking associated with moderate to severe longitudinal and transverse cracking, moderate to severe random cracking, moderate pavement raveling, moderate block cracking, slight pavement depressions and moderate to severe pavement edge cracking.

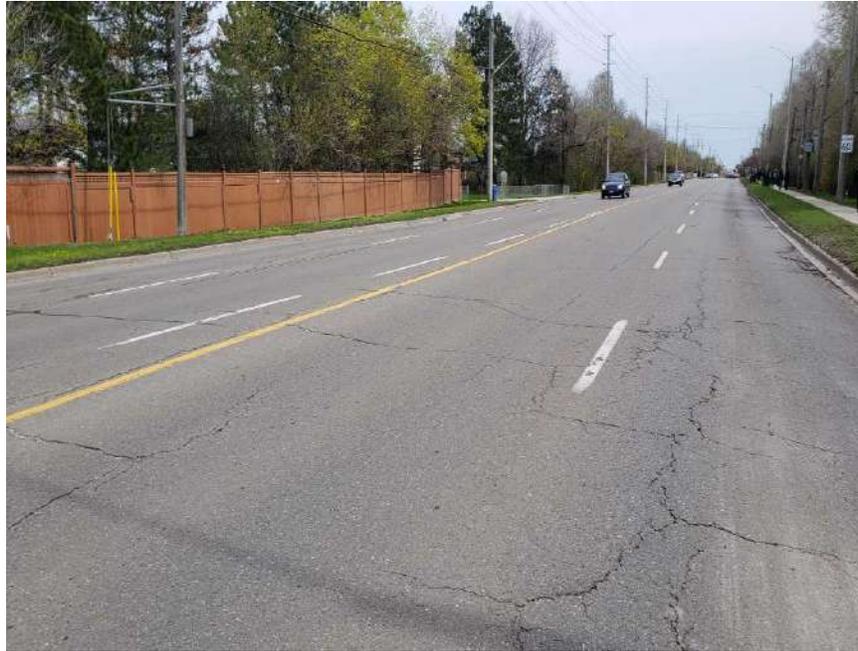
Photograph 31 – Bramalea Road, Southbound, looking South, approximately 130 m South of Clark Boulevard, showing severe longitudinal and transverse cracking associated with moderate block cracking, moderate random cracking, slight pavement raveling, slight pavement depressions, slight alligator cracking and moderate pavement edge cracking.

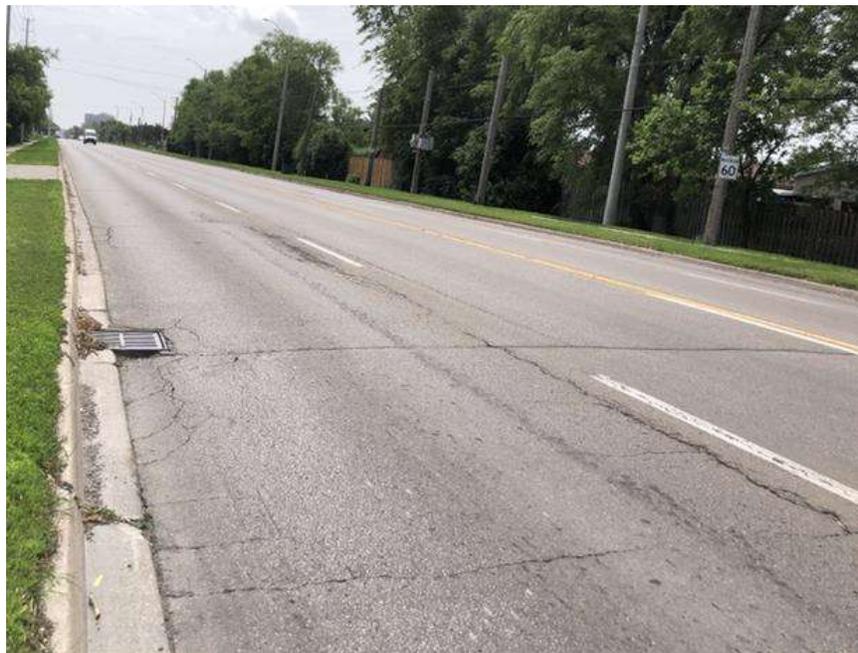
Photograph 32 – Bramalea Road, Northbound, looking South, approximately 145 m South of Clark Boulevard, showing severe longitudinal and transverse cracking associated with slight to moderate random cracking, slight alligator cracking, slight to moderate pavement raveling, slight potholes and moderate pavement edge cracking.

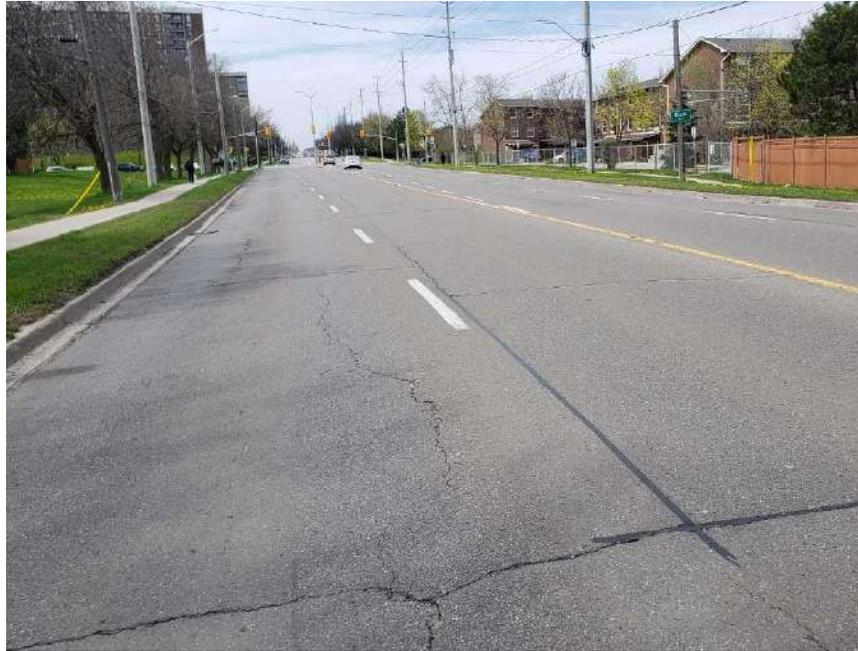
Photograph 33 – Bramalea Road, Southbound, looking North, approximately 170 m South of Clark Boulevard, showing moderate to severe longitudinal and transverse cracking associated with slight to moderate random cracking, slight pavement raveling and slight to moderate pavement edge cracking.

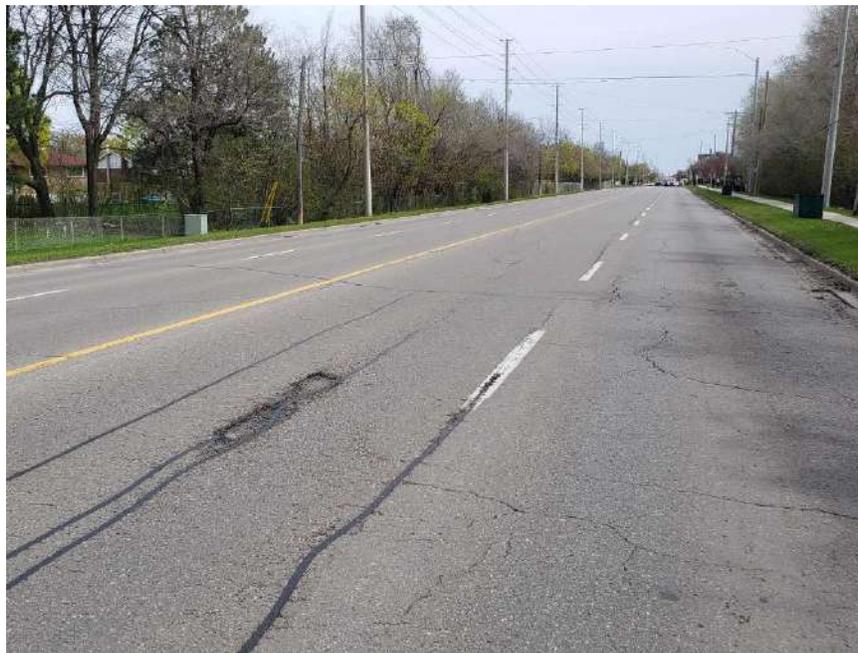
Photograph 34 – Bramalea Road, Southbound, looking South, approximately 175 m South of Clark Boulevard, showing moderate to severe longitudinal and transverse cracking associated with moderate random cracking, slight pavement raveling, slight potholes and moderate pavement edge cracking.

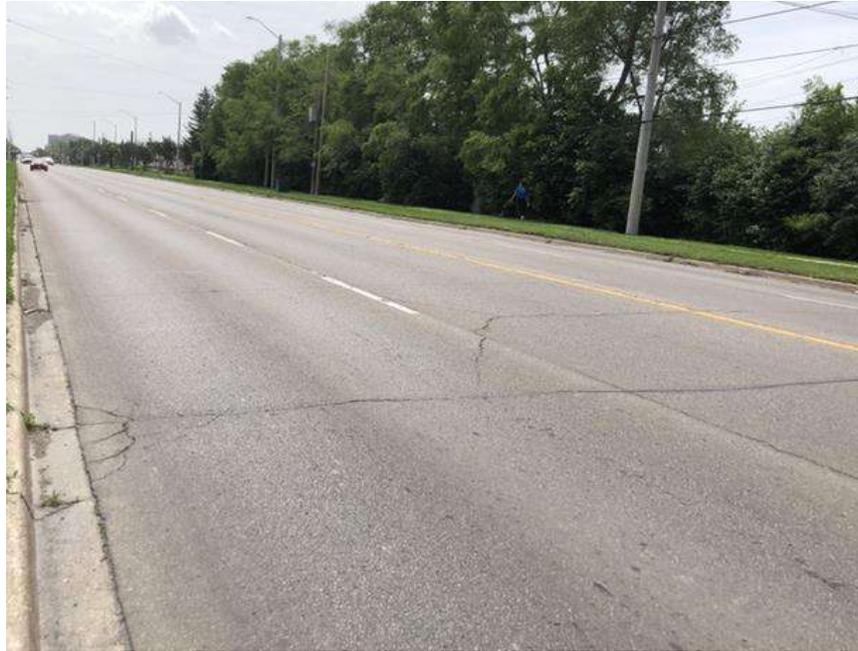
Photograph 35 – Bramalea Road, Northbound, looking South, approximately 200 m South of Clark Boulevard, showing moderate longitudinal and transverse cracking associated with slight to moderate random cracking, slight alligator cracking, slight pavement raveling and slight to moderate pavement edge cracking.

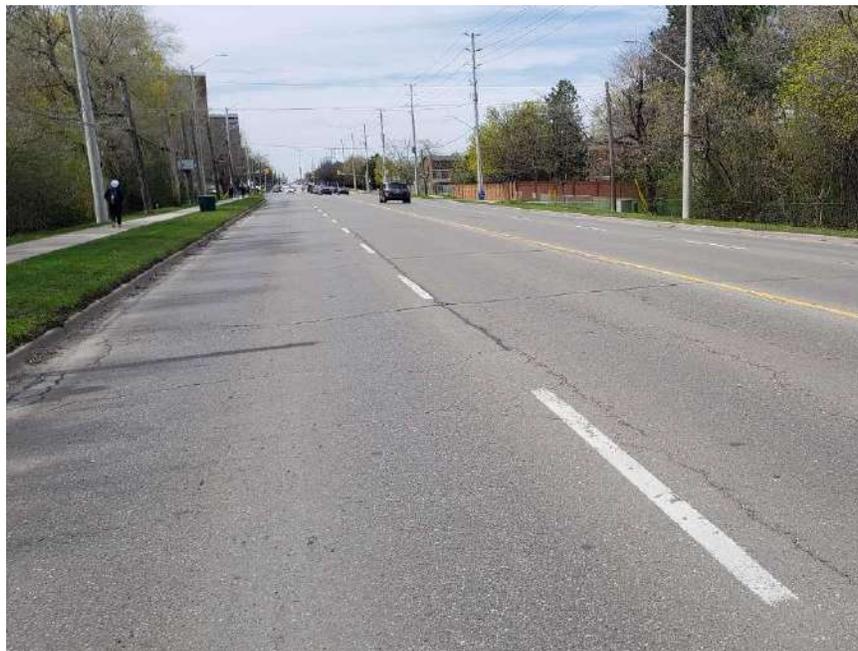
Photograph 36 – Bramalea Road, Southbound, looking North, approximately 250 m South of Clark Boulevard, showing moderate longitudinal and transverse cracking associated with slight to moderate random cracking, slight pavement raveling and slight to moderate pavement edge cracking.
