**BRAMALEA ROAD CORRIDOR IMPROVEMENTS, MUNICIPAL CLASS
ENVIRONMENTAL ASSESSMENT STUDY**

Geotechnical Investigation

Proposed Road Improvements

Bramalea Road from Queen Street to South City Limit

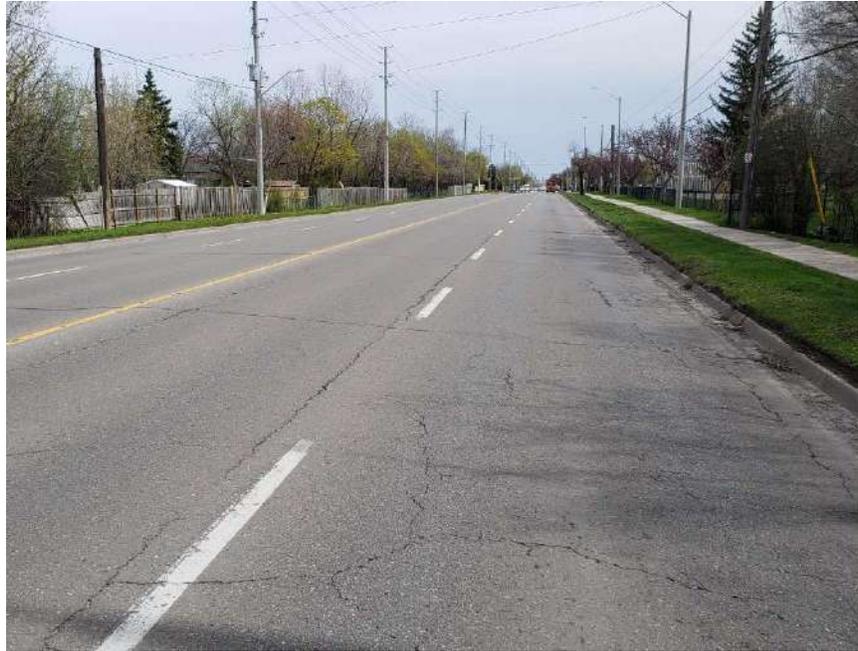
Photograph 37 – Bramalea Road, Southbound, looking South, approximately 280 m South of Bramalea Road and Clark Boulevard, showing moderate to severe longitudinal and transverse cracking associated with moderate random cracking, slight to moderate block cracking, slight pavement raveling and slight to moderate pavement edge cracking.

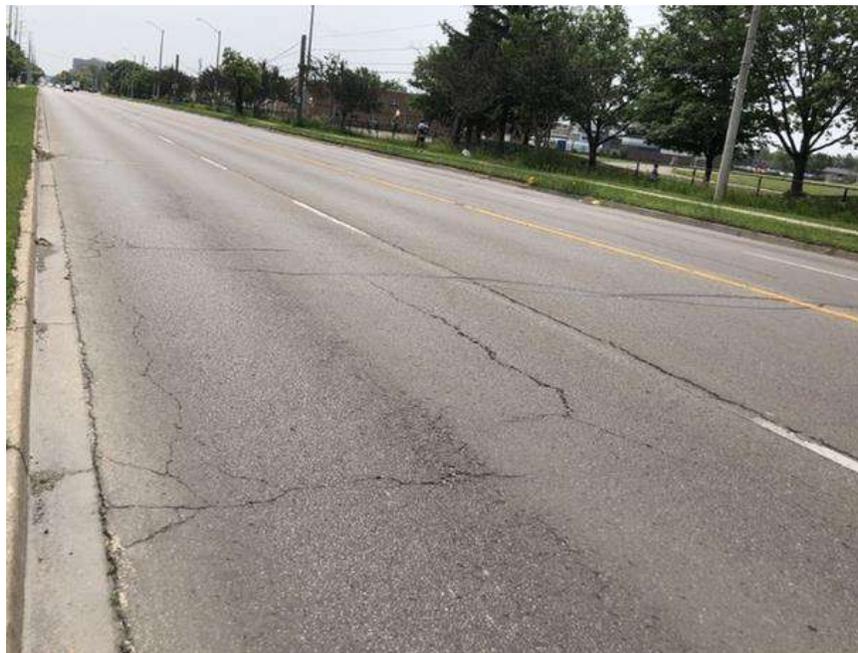
Photograph 38 – Bramalea Road, Northbound, looking South, approximately 300 m South of Clark Boulevard, showing moderate to severe longitudinal and transverse cracking associated with moderate random cracking, slight to moderate pavement raveling and slight to moderate pavement edge cracking.

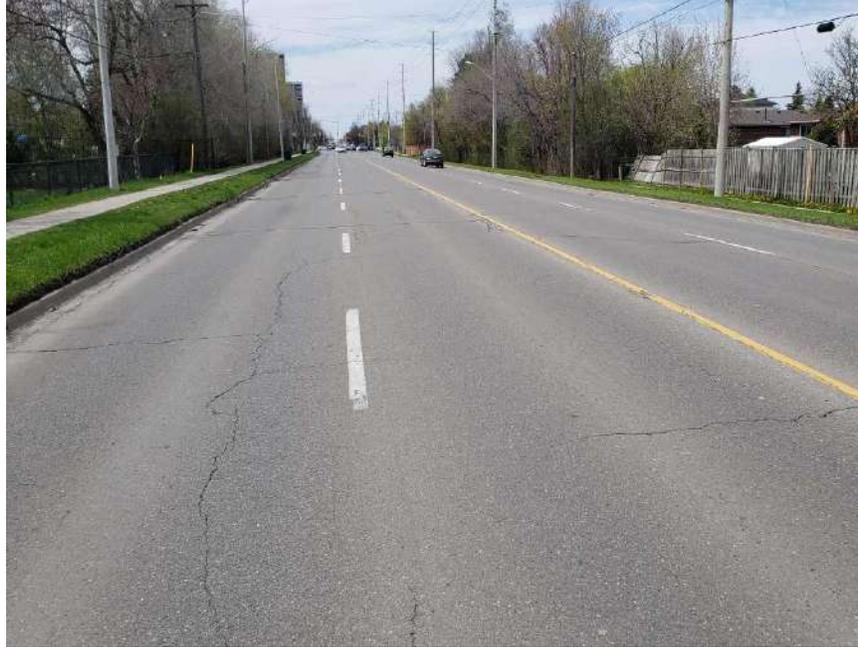
Photograph 39 – Bramalea Road, Southbound, looking North, approximately 325 m South of Clark Boulevard, showing moderate to severe longitudinal and transverse cracking associated with slight to moderate random cracking, slight pavement raveling and slight to moderate pavement edge cracking.

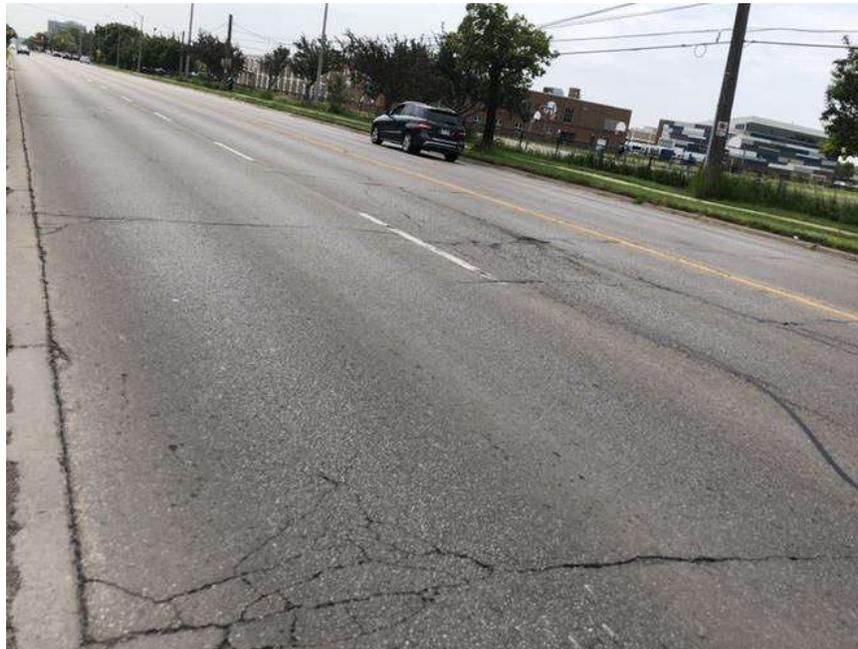
Photograph 40 – Bramalea Road, Northbound, looking South, approximately 320 m North of Balmoral Drive, showing moderate to severe longitudinal and transverse cracking associated with moderate random cracking, moderate alligator cracking, slight potholes, slight to moderate pavement raveling and slight to moderate pavement edge cracking.

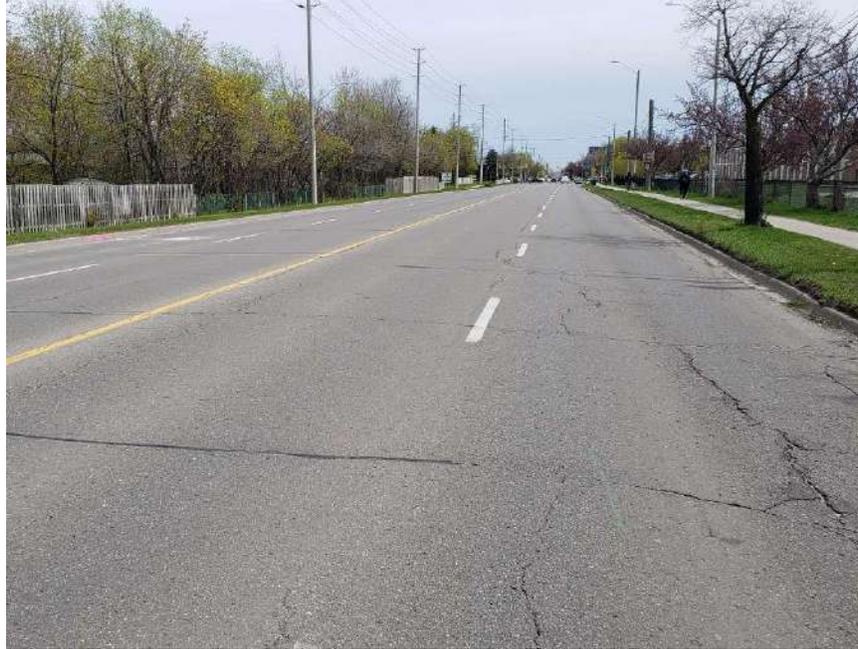
Photograph 41 – Bramalea Road, Southbound, looking South, approximately 305 m North of Balmoral Drive, showing moderate to severe longitudinal and transverse cracking associated with moderate random cracking, slight alligator cracking, slight pavement raveling and slight to moderate pavement edge cracking.

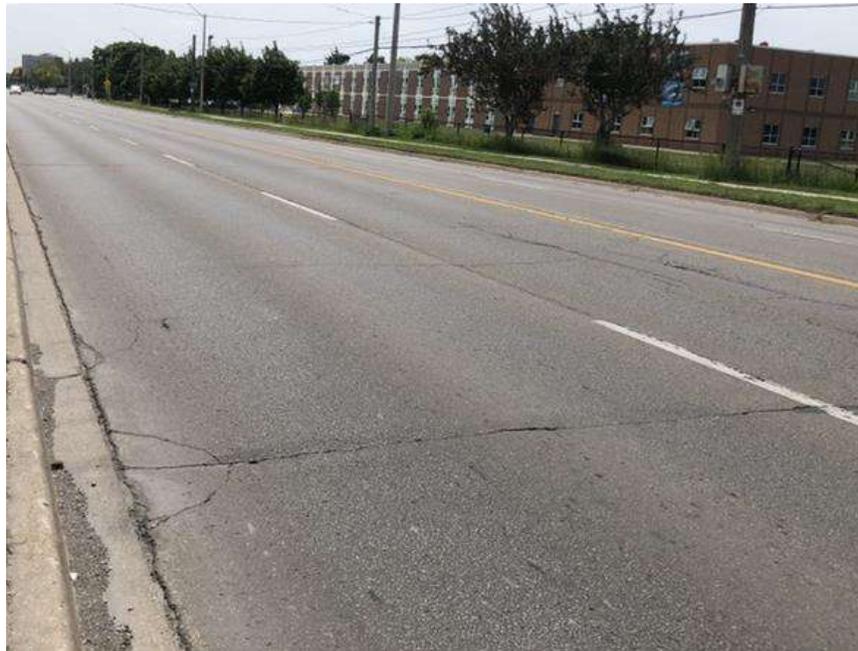
Photograph 42 – Bramalea Road, Northbound, looking South, approximately 235 m North of Balmoral Drive, showing moderate to severe longitudinal and transverse cracking associated with slight to moderate random cracking, slight pavement raveling and slight to moderate pavement edge cracking.

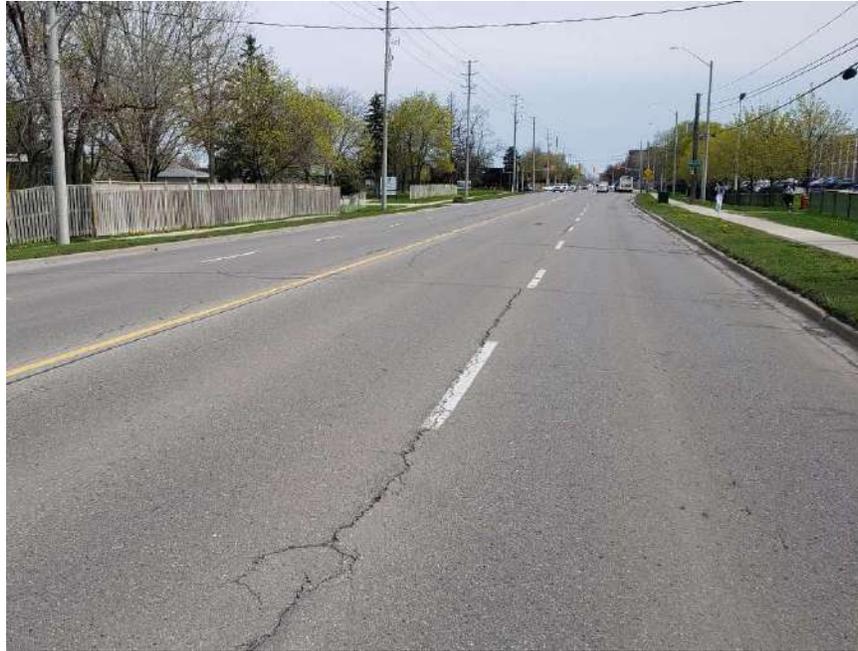
Photograph 43 – Bramalea Road, Southbound, looking South, approximately 210 m North of Balmoral Drive, showing moderate to severe longitudinal and transverse cracking associated with slight to moderate random cracking, slight pavement raveling and slight to moderate pavement edge cracking.

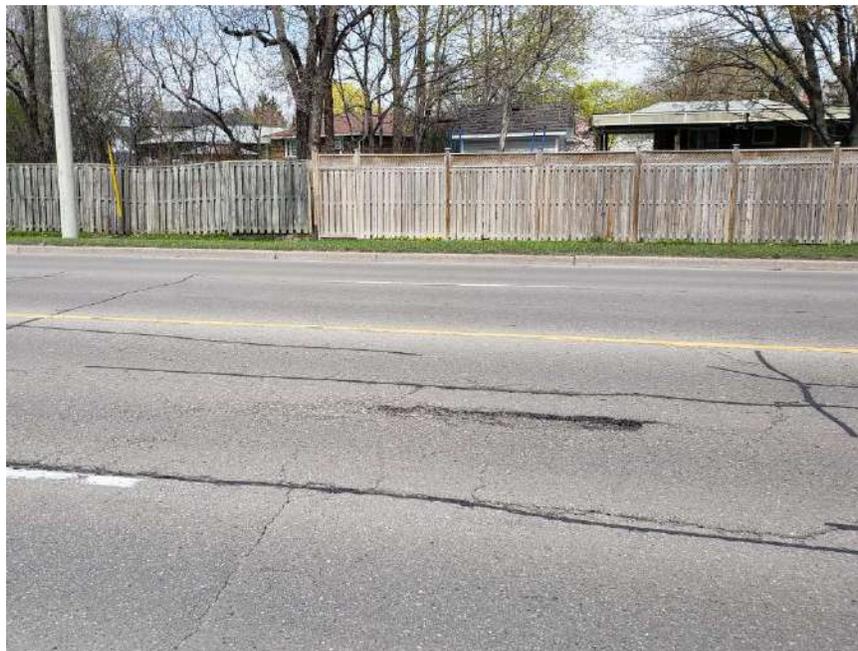
Photograph 44 – Bramalea Road, Southbound, looking East, approximately 205 m North of Balmoral Drive, showing severe longitudinal and transverse cracking associated with moderate random cracking, slight to moderate potholes and slight pavement raveling.

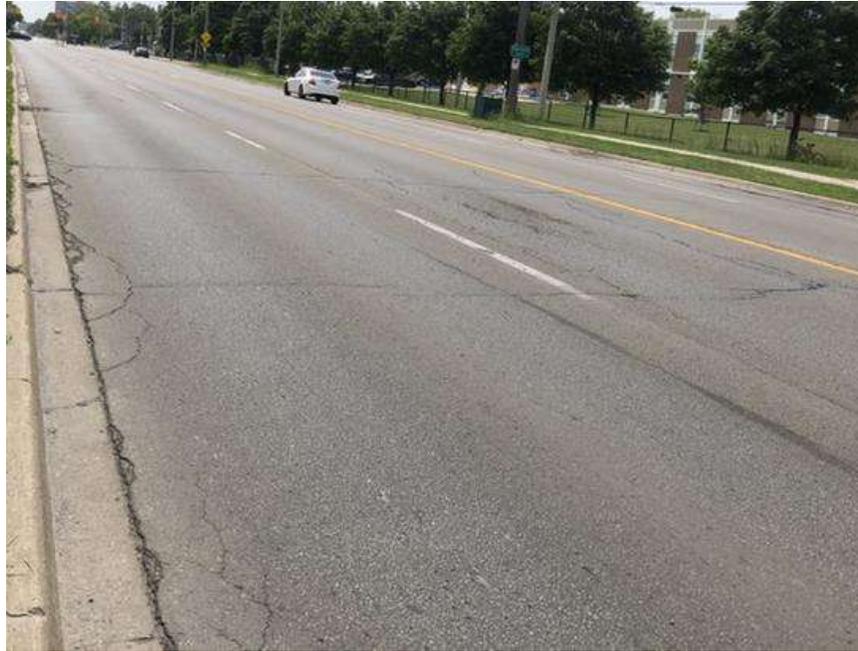
Photograph 45 – Bramalea Road, Northbound, looking South, approximately 200 m North of Balmoral Drive, showing moderate to severe longitudinal and transverse cracking associated with slight to moderate random cracking, slight pavement depressions, slight to moderate pavement raveling and moderate to severe pavement edge cracking.

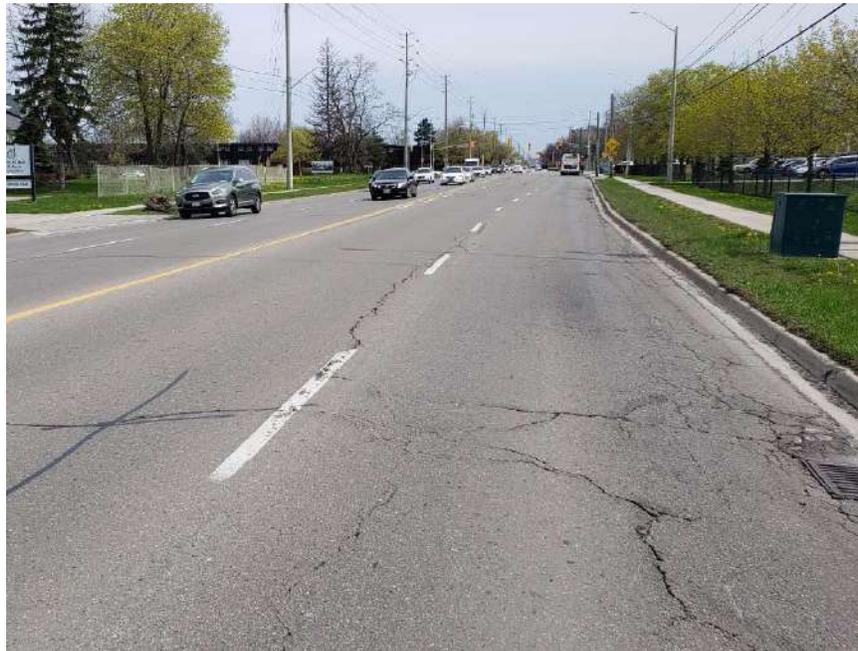
Photograph 46 – Bramalea Road, Southbound, looking South, approximately 180 m North of Balmoral Drive, showing moderate to severe longitudinal and transverse cracking associated with moderate random cracking, moderate to severe alligator cracking, slight pavement raveling, slight pavement depressions, and moderate pavement edge cracking. Noting severe alligator cracking around catch basin.

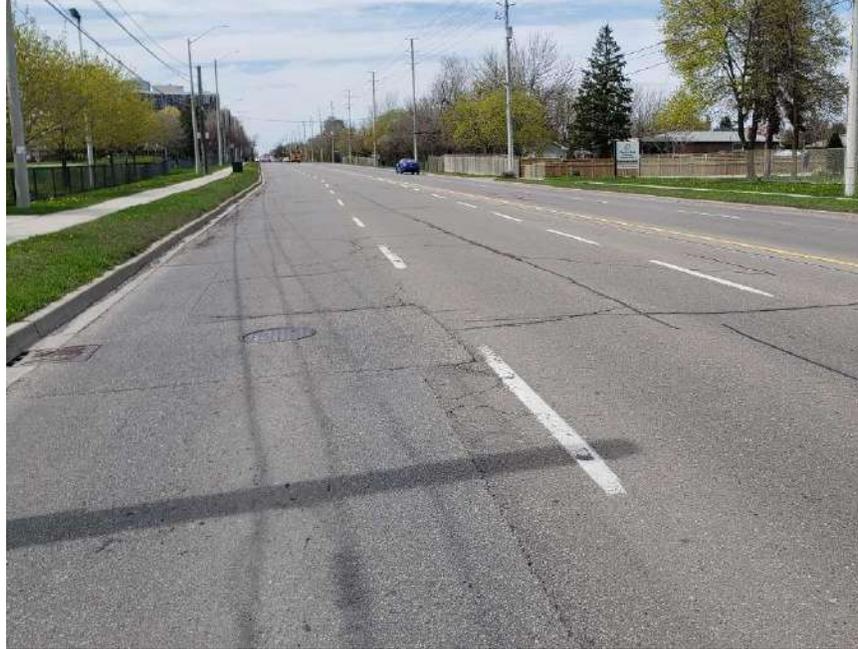
Photograph 47 – Bramalea Road, Southbound, looking North, approximately 100 m North of Balmoral Drive, showing moderate to severe longitudinal and transverse cracking associated with moderate random cracking, slight alligator cracking, slight pavement raveling and moderate to severe pavement edge cracking. Noting sections of patching.

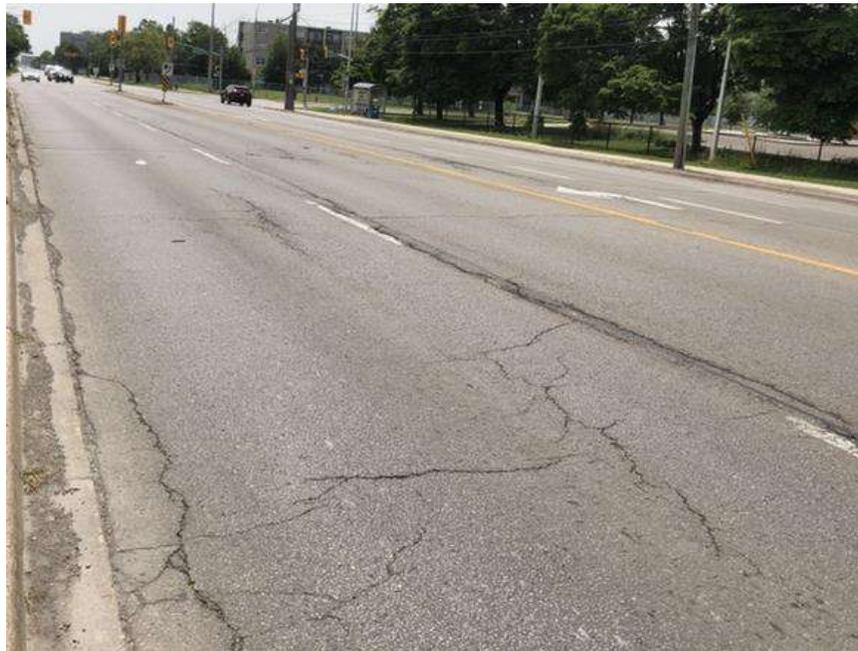
Photograph 48 – Bramalea Road, Northbound, looking South, approximately 95 m North of Balmoral Drive, showing severe longitudinal and transverse cracking associated with moderate random cracking, slight pavement depressions, slight to moderate pavement raveling and moderate pavement edge cracking.

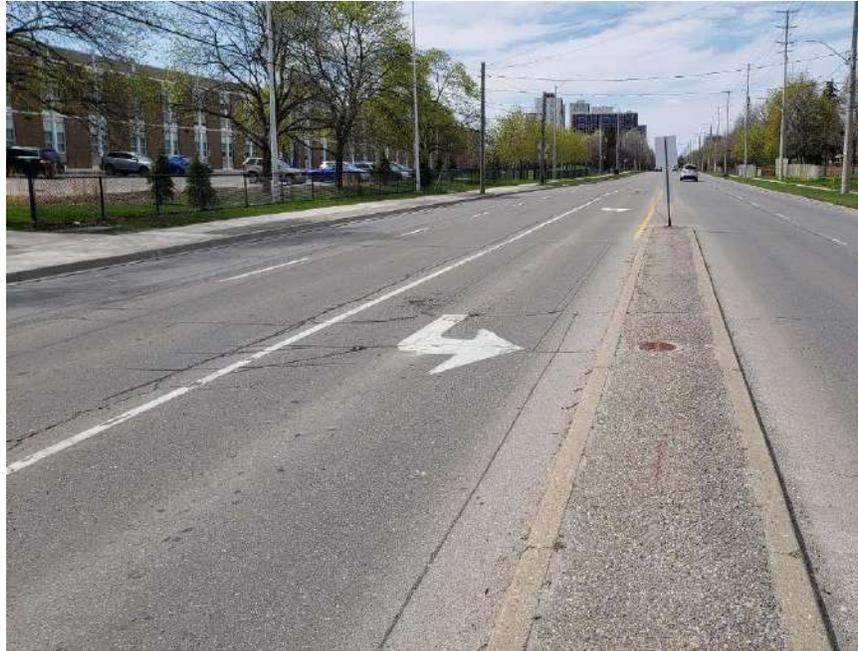
Photograph 49 – Bramalea Road, Southbound, looking North, near the intersection of Bramalea Road and Balmoral Drive, showing moderate to severe longitudinal and transverse cracking associated with moderate random cracking, moderate block cracking, slight to moderate potholes and slight pavement raveling.

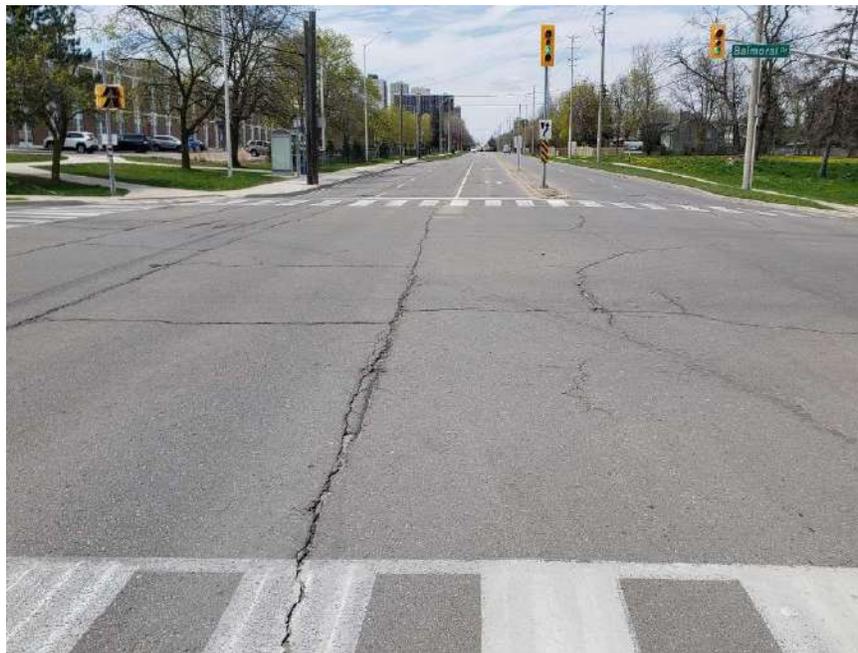
Photograph 50 – Bramalea Road, looking North, near the intersection of Bramalea Road and Balmoral Drive, showing severe longitudinal and transverse cracking associated with moderate random cracking, slight alligator cracking and slight pavement raveling.

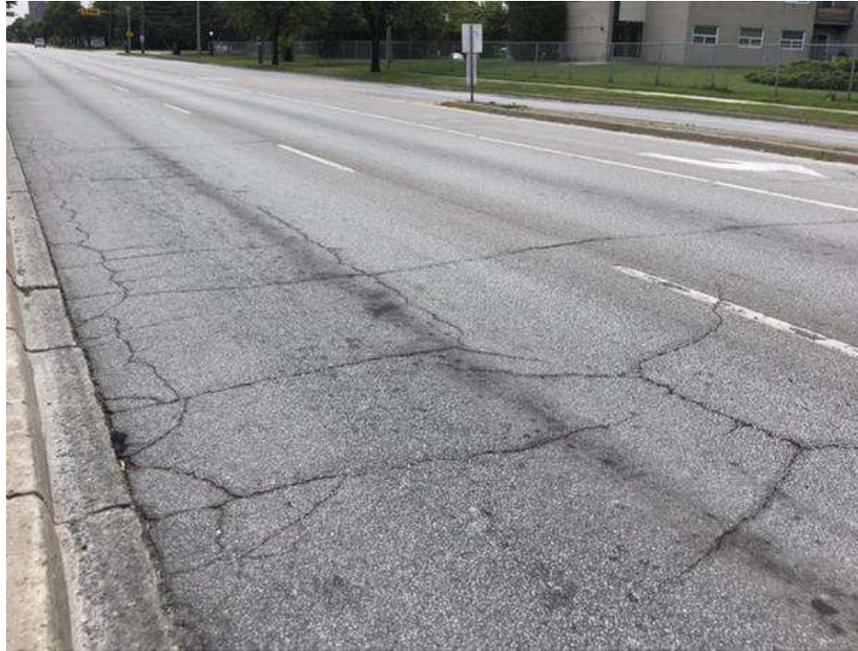
Photograph 51 – Bramalea Road, Northbound, looking South, near the intersection of Bramalea Road and Balmoral Drive, showing moderate to severe longitudinal and transverse cracking associated with moderate random cracking, slight to moderate alligator cracking, moderate to severe block cracking, slight pavement raveling and moderate to severe pavement edge cracking.

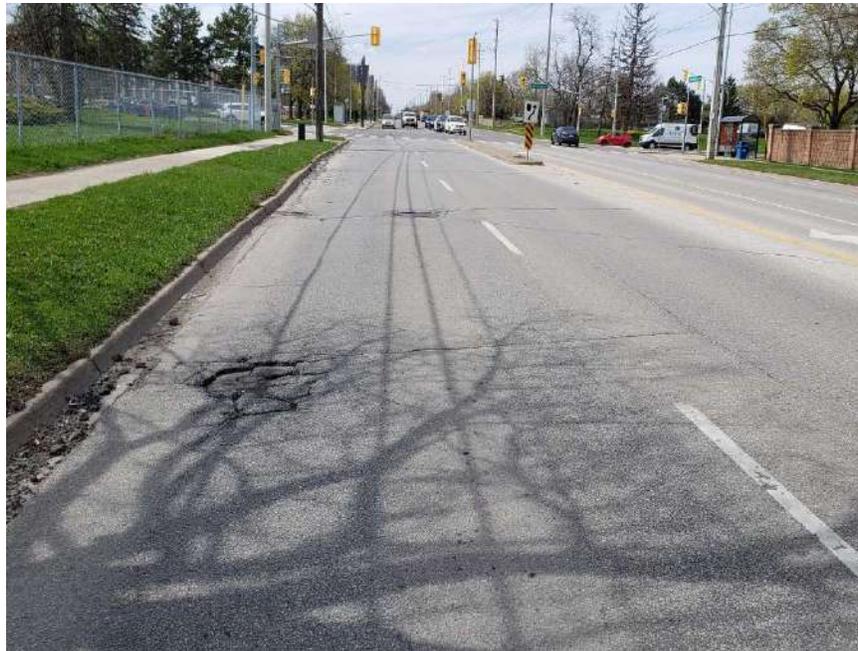
Photograph 52 – Bramalea Road, Southbound, looking North, approximately 70 m South of Balmoral Drive, showing moderate longitudinal and transverse cracking associated with moderate random cracking, severe alligator cracking, slight to moderate pavement raveling, slight to moderate potholes and severe pavement edge cracking.

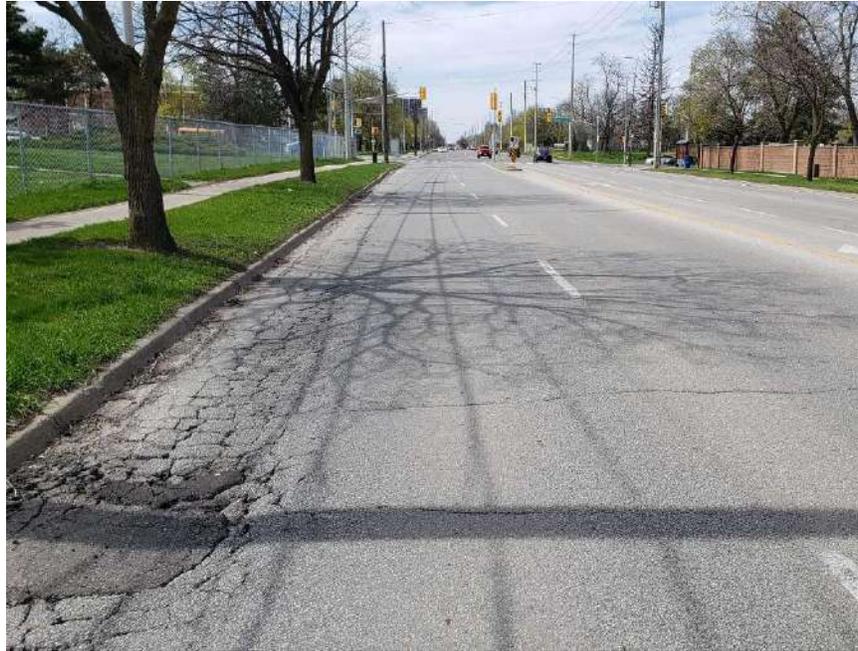
Photograph 53 – Bramalea Road, Southbound, looking North, approximately 95 m South of Balmoral Drive, showing slight to moderate longitudinal and transverse cracking associated with severe alligator cracking, moderate pavement depressions, slight to moderate pavement raveling, slight pavement patching, and moderate to severe pavement edge cracking.

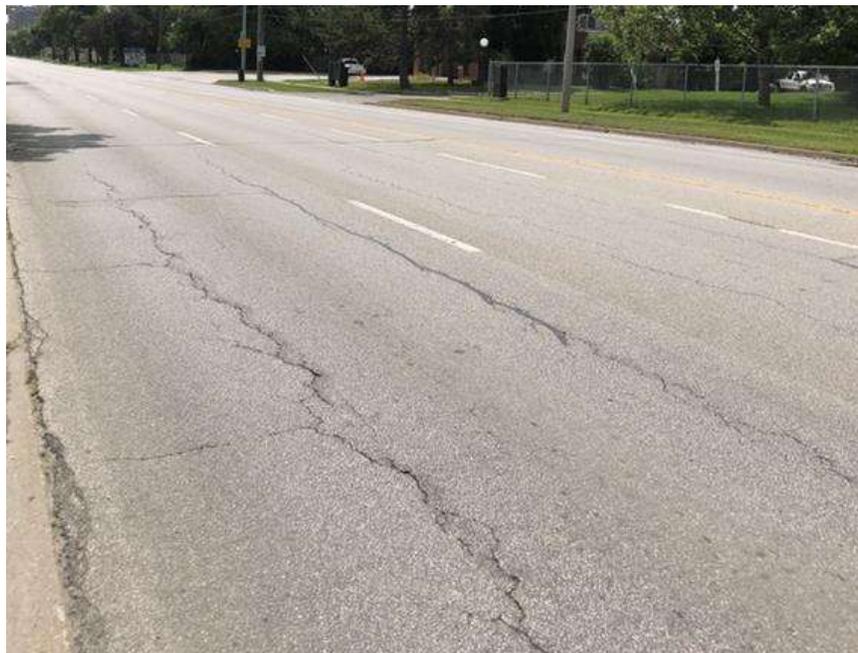
Photograph 54 – Bramalea Road, Northbound, looking South, approximately 100 m South of Bramalea Road, showing severe longitudinal and transverse cracking associated with moderate random cracking, slight to moderate pavement raveling and slight to moderate pavement edge cracking.

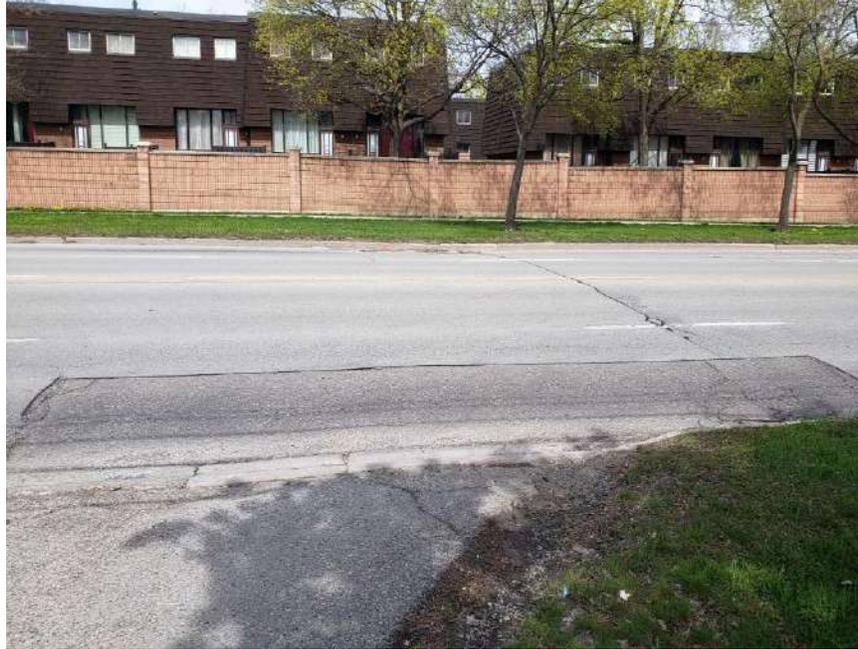
Photograph 55 – Bramalea Road, Southbound, looking East, approximately 145 m South of Balmoral Drive, showing moderate longitudinal and transverse cracking associated with slight to moderate random cracking, slight pavement raveling, and moderate pavement edge cracking. Noting severe alligator cracking around catch basin and sections of patching.

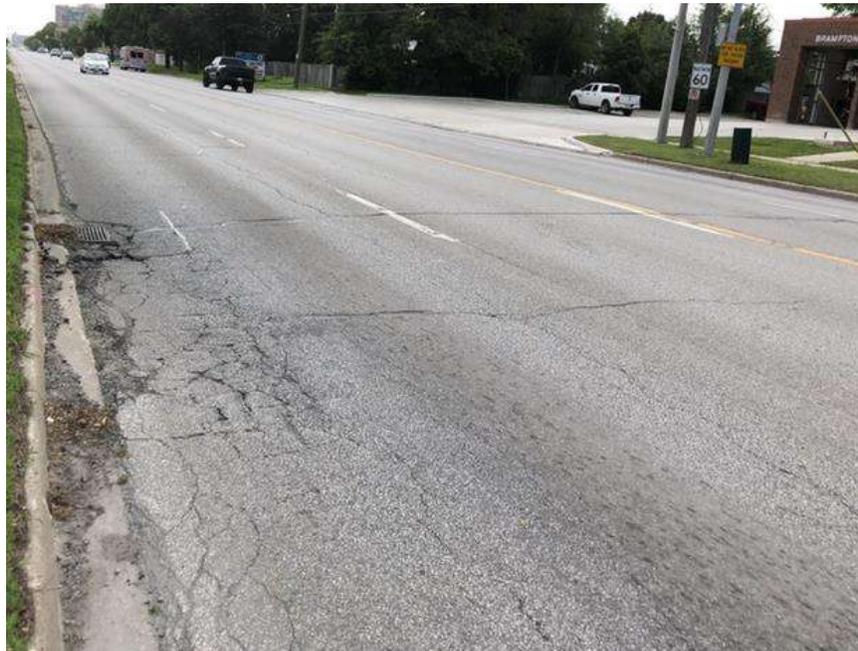
Photograph 56 – Bramalea Road, Northbound, looking South, approximately 60 m North of Darras Court, showing moderate to severe longitudinal and transverse cracking associated with slight to moderate random cracking, moderate alligator cracking, slight to moderate pavement raveling, slight pavement depressions, and moderate pavement edge cracking. Noting severe alligator cracking around catch basin.

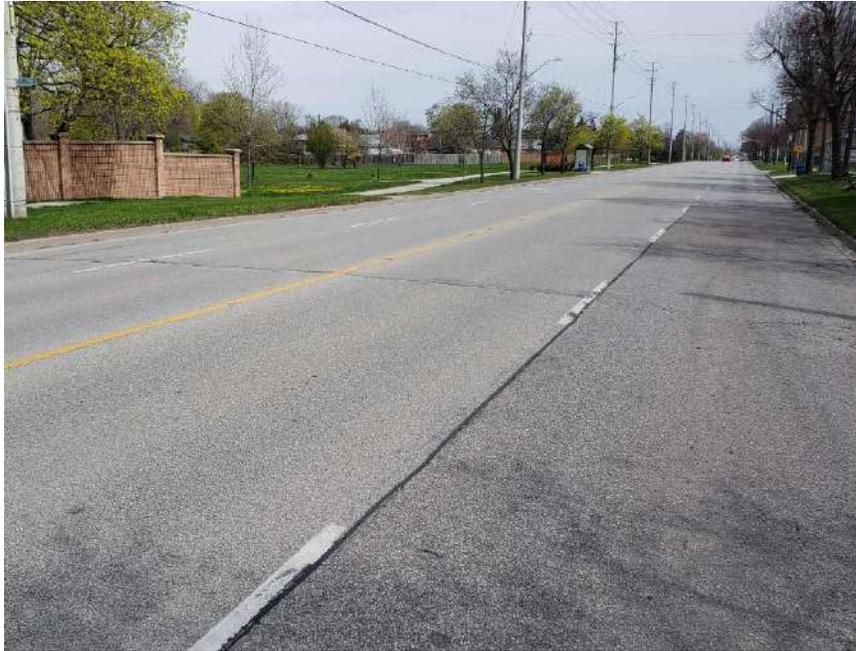
Photograph 57 – Bramalea Road, Southbound, looking South, near the intersection of Bramalea Road and Darras Court, showing moderate longitudinal and transverse cracking associated with slight random cracking, slight to moderate pavement raveling and slight pavement edge cracking. Noting severe alligator cracking around catch basin and sections of patching.

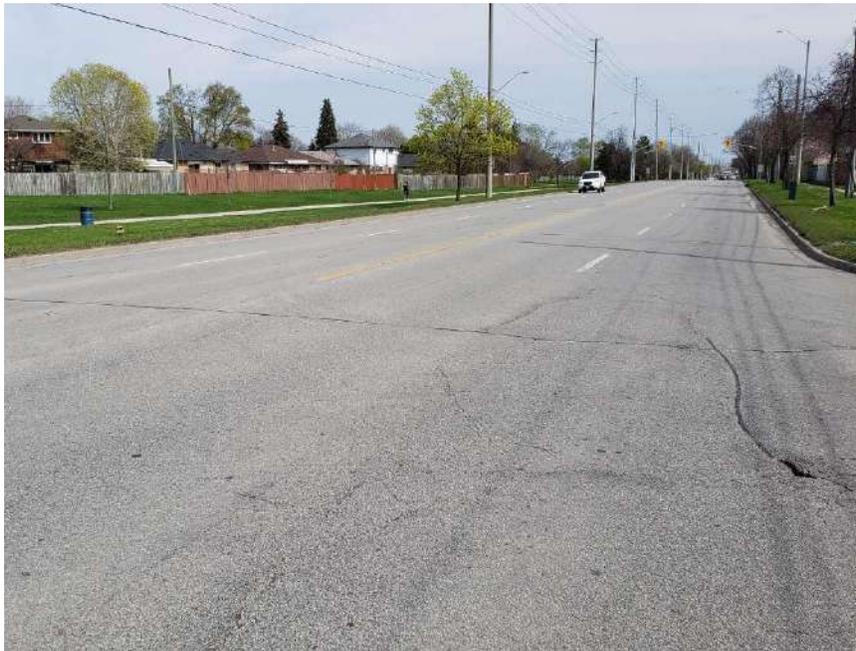
Photograph 58 – Bramalea Road, Southbound, looking South, near the intersection of Bramalea Road and Algonquin Boulevard, showing moderate longitudinal and transverse cracking associated with slight to moderate random cracking and slight to moderate pavement raveling.

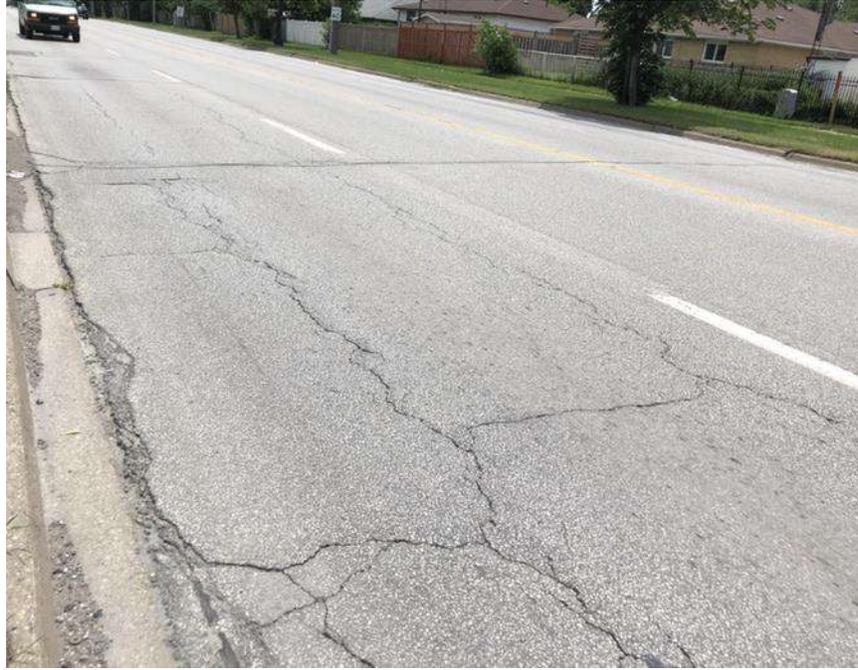
Photograph 59 – Bramalea Road, Northbound, looking South, approximately 50 m South of Algonquin Boulevard, showing severe longitudinal and transverse cracking associated with moderate random cracking, moderate block cracking, slight pavement raveling and moderate to severe pavement edge cracking.

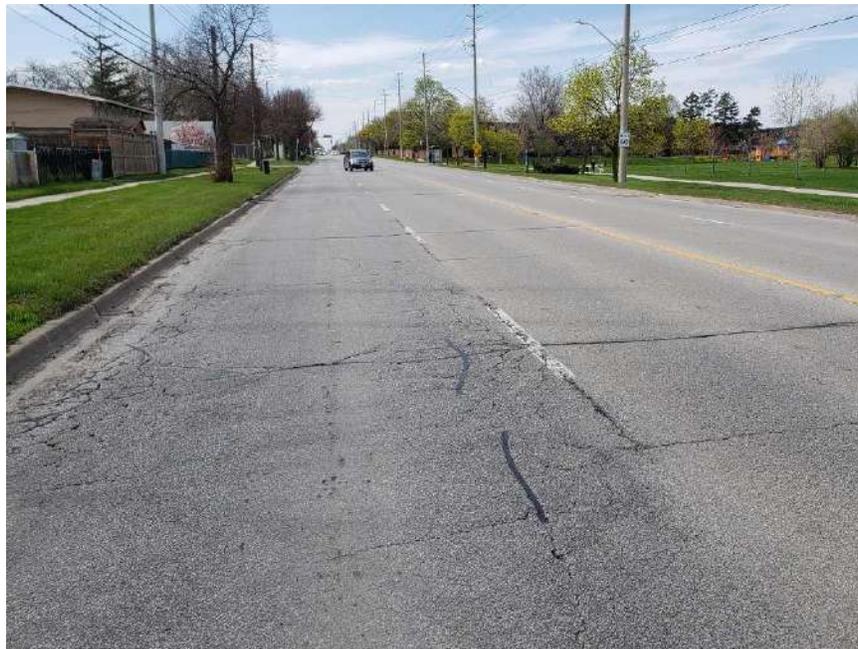
Photograph 60 – Bramalea Road, Southbound, looking North, approximately 75 m South of Algonquin Boulevard, showing moderate to severe longitudinal and transverse cracking associated with moderate random cracking, slight pavement depressions, moderate pavement raveling, severe alligator cracking and moderate to severe pavement edge cracking.

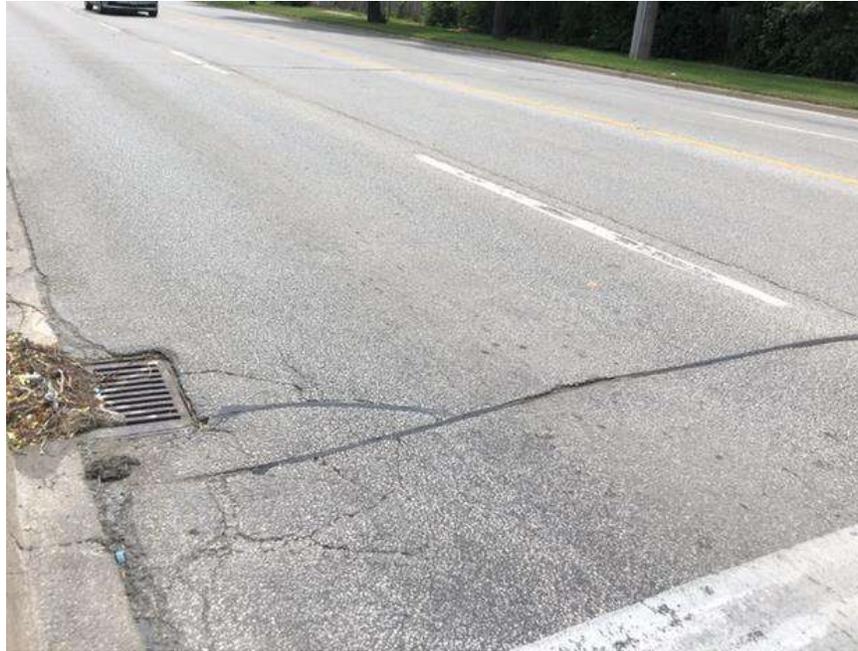
Photograph 61 – Bramalea Road, Northbound, looking South, approximately 155 m South of Algonquin Boulevard, showing moderate longitudinal and transverse cracking associated with slight to moderate random cracking, slight to moderate pavement raveling and slight to moderate pavement edge cracking. Noting severe random cracking around catch basin.

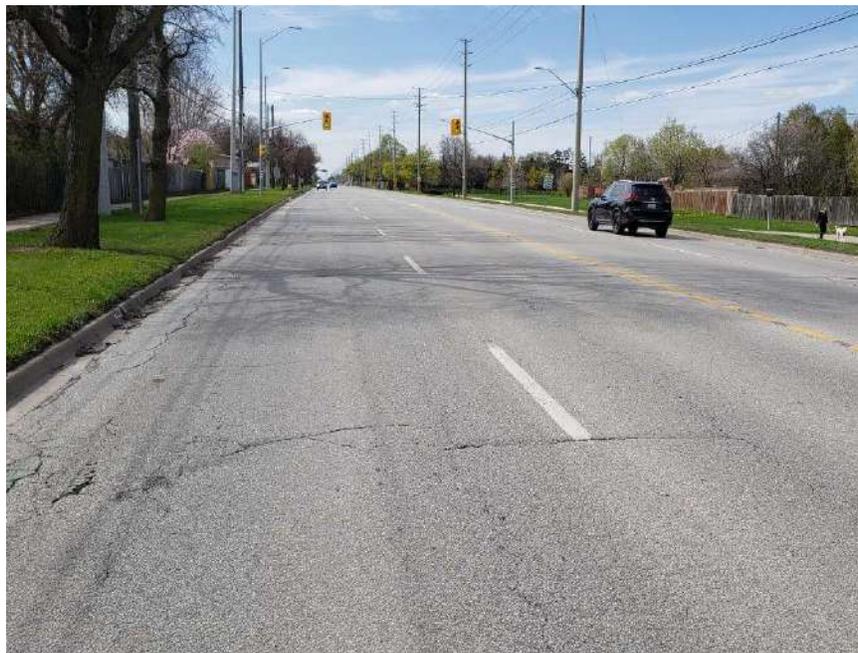
Photograph 62 – Bramalea Road, Southbound, looking North, approximately 150 m North of Alexandria Gate, showing moderate longitudinal and transverse cracking associated with moderate random cracking, moderate pavement raveling, moderate alligator cracking and moderate to severe pavement edge cracking.

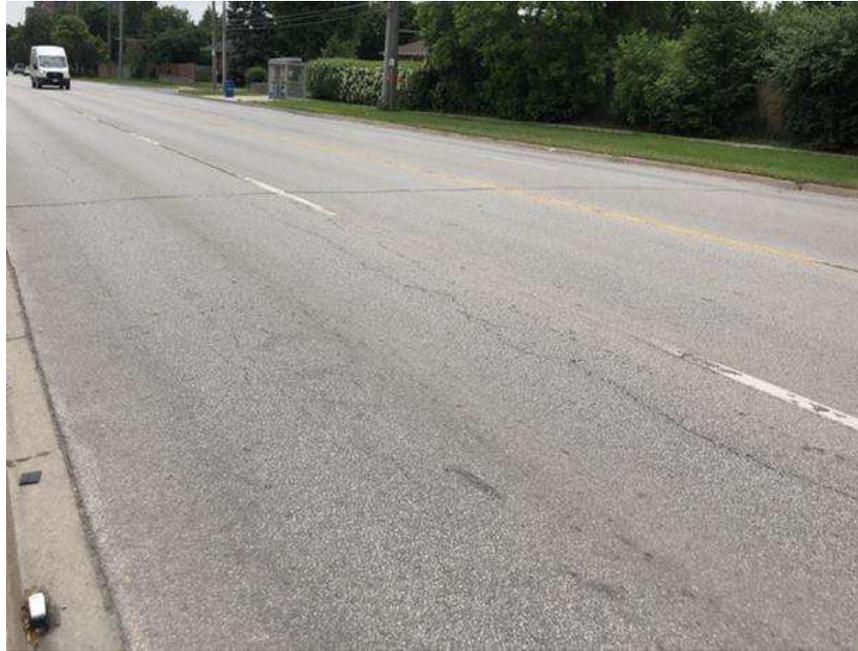
Photograph 63 – Bramalea Road, Northbound, looking South, approximately 75 m North of Alexandria Gate, showing moderate longitudinal and transverse cracking associated with slight random cracking, slight alligator cracking, slight pavement raveling and slight pavement edge cracking.

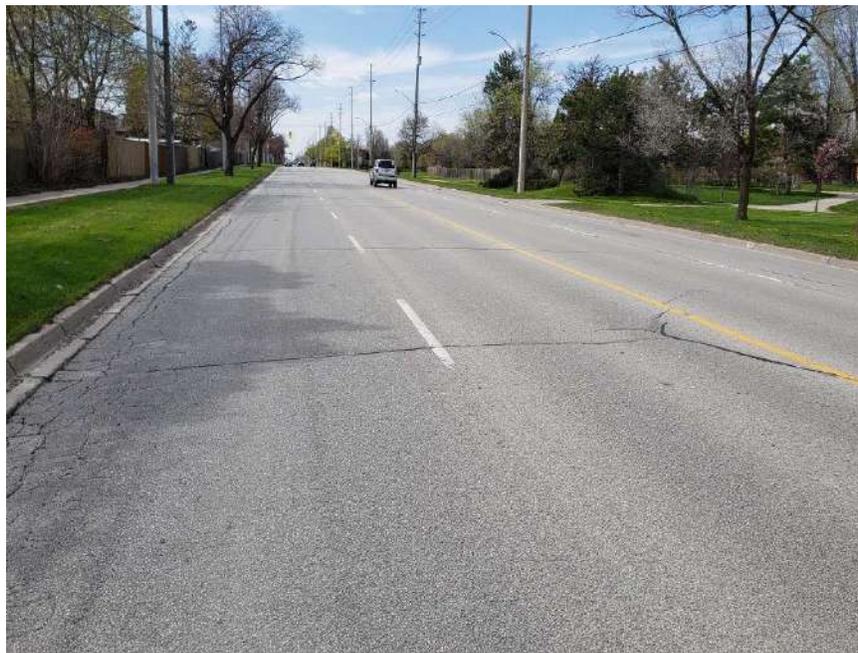
Photograph 64 – Bramalea Road, Southbound, looking North, approximately 40 m North of Alexandria Gate, showing moderate longitudinal and transverse cracking associated with slight to moderate random cracking, slight to moderate pavement raveling, moderate to severe alligator cracking, and moderate to severe pavement edge cracking.

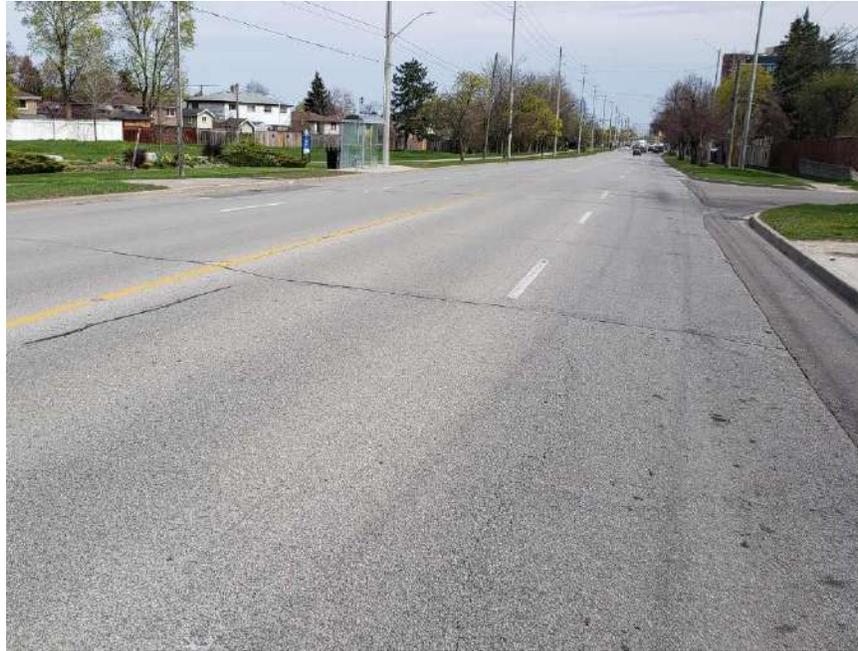
Photograph 65 – Bramalea Road, Southbound, looking South, near the intersection of Bramalea Road and Alexandria Gate, showing moderate longitudinal and transverse cracking associated with slight random cracking and slight pavement raveling. Noting sections of patching along the pavement edge.

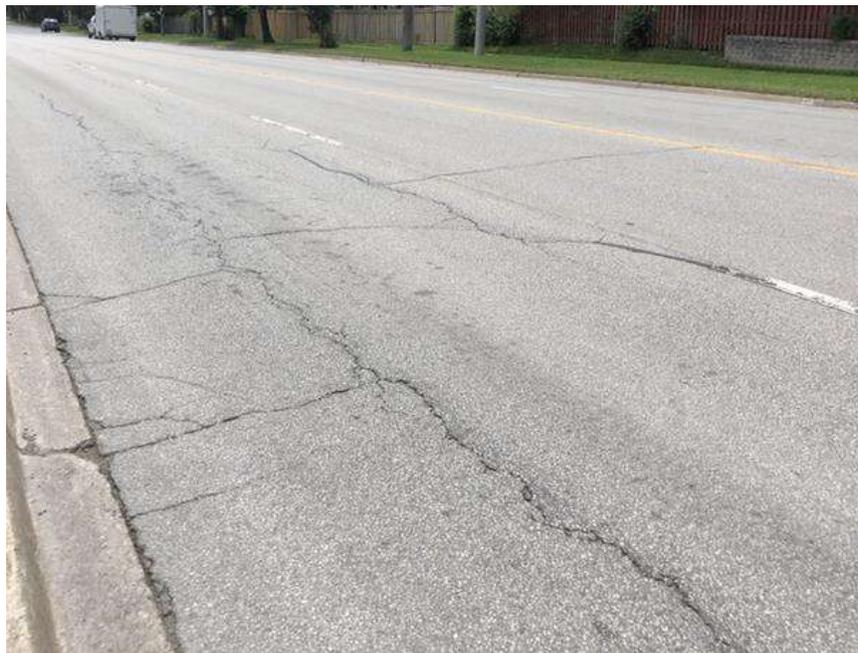
Photograph 66 – Bramalea Road, Northbound, looking South, near the intersection of Bramalea Road and Alexandria Gate, showing severe longitudinal and transverse cracking associated with moderate random cracking, moderate block cracking, slight alligator cracking, and slight pavement raveling.

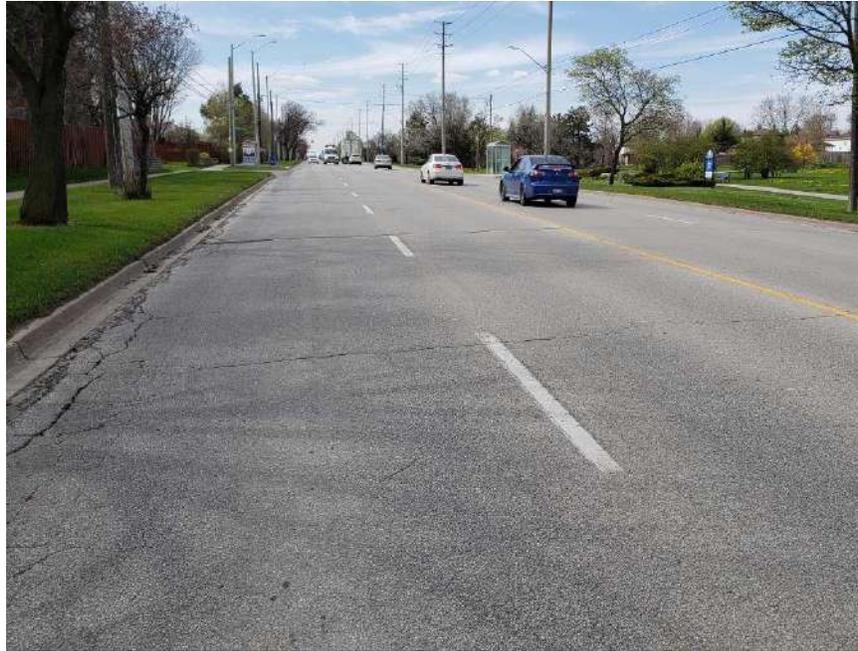
Photograph 67 – Bramalea Road, Southbound, looking North, approximately 60 m South of Alexandria Gate, showing moderate longitudinal and transverse cracking associated with slight random cracking, slight to moderate pavement raveling and severe pavement edge cracking.

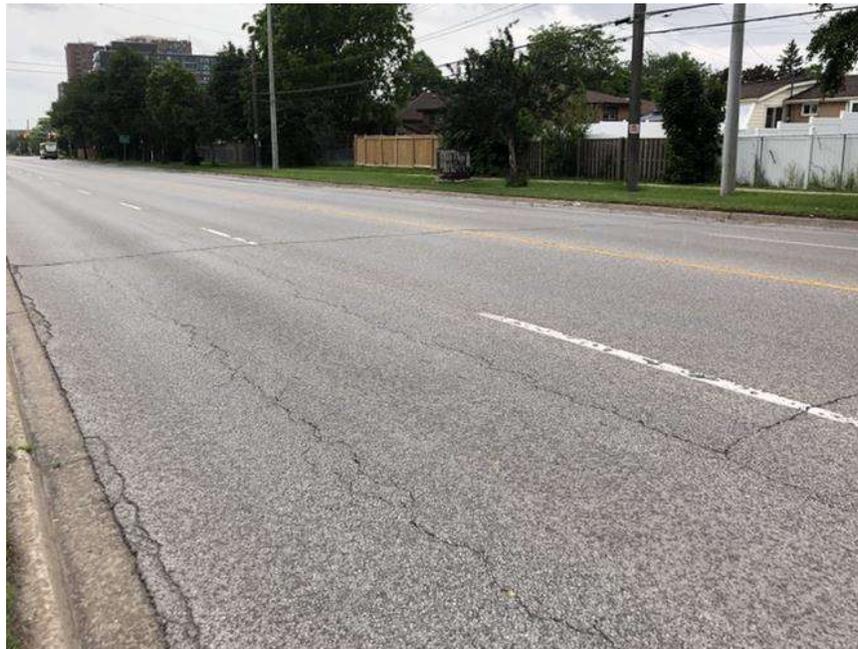
Photograph 68 – Bramalea Road, Northbound, looking South, approximately 100 m South of Alexandria Gate, showing moderate longitudinal and transverse cracking associated with slight random cracking, moderate pavement raveling, slight alligator cracking, slight to moderate block cracking and moderate pavement edge cracking.

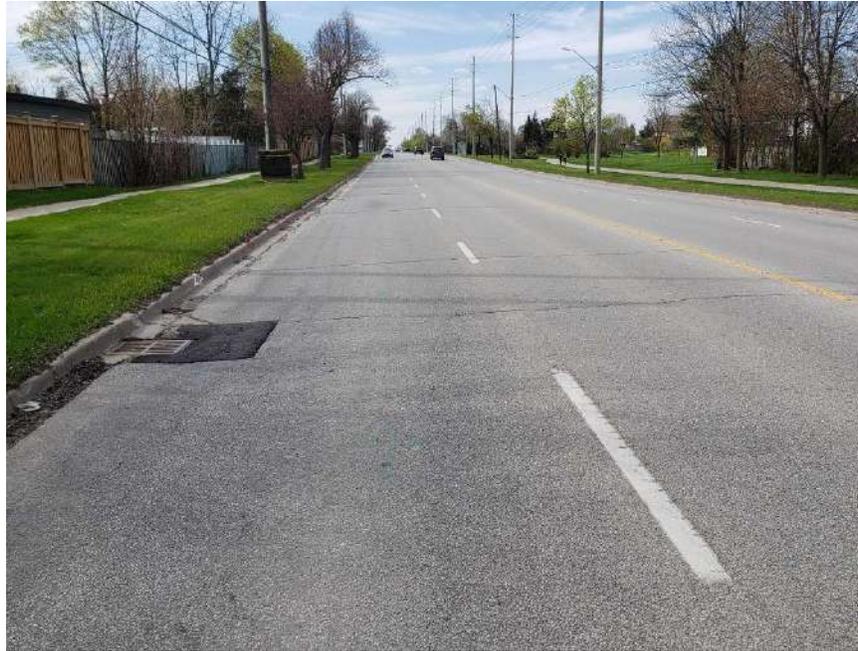
Photograph 69 – Bramalea Road, Southbound, looking North, approximately 170 m South of Alexandria Gate, showing moderate longitudinal and transverse cracking associated with slight random cracking, slight to moderate pavement raveling and moderate pavement edge cracking. Noting patching around catch basin.

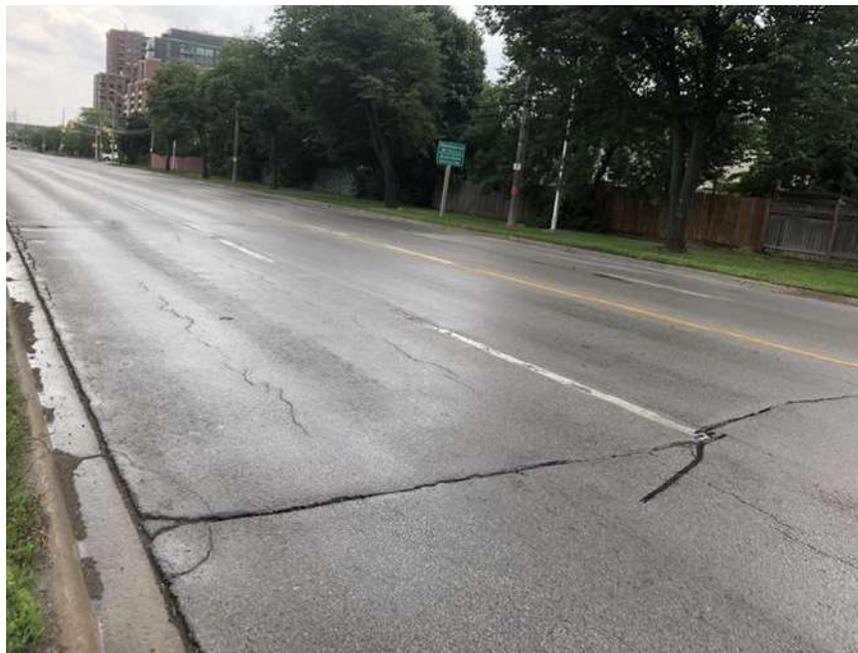
Photograph 70 – Bramalea Road, Northbound, looking South, approximately 155 m North of Avondale Boulevard, showing moderate to severe longitudinal and transverse cracking associated with slight to moderate random cracking, slight pavement raveling and slight to moderate pavement edge cracking.

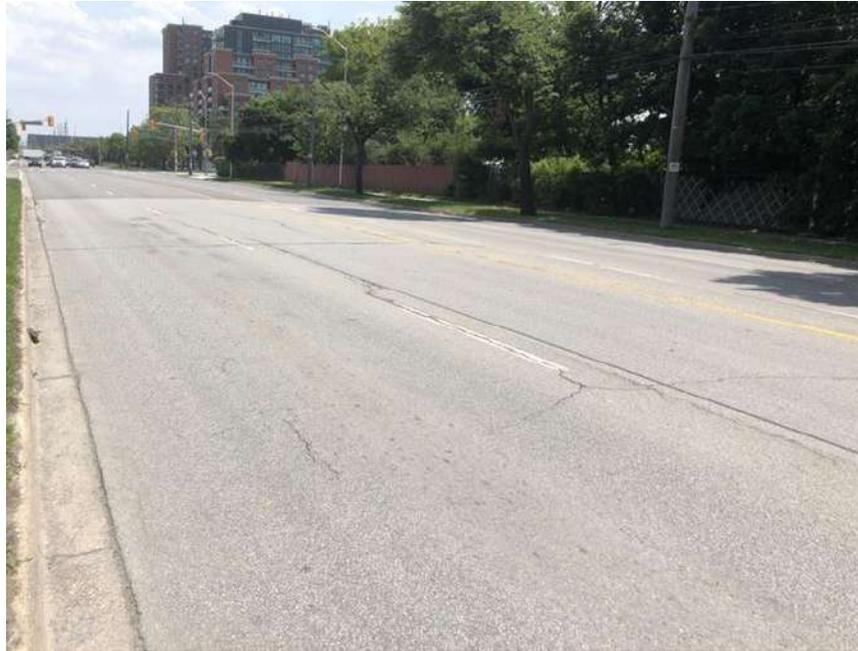
Photograph 71 – Bramalea Road, Northbound, looking South, approximately 115 m North of Avondale Boulevard, showing moderate longitudinal and transverse cracking associated with slight random cracking, slight to moderate pavement raveling and slight pavement edge cracking.
