**BRAMALEA ROAD CORRIDOR IMPROVEMENTS, MUNICIPAL CLASS
ENVIRONMENTAL ASSESSMENT STUDY**

Geotechnical Investigation

Proposed Road Improvements

Bramalea Road from Queen Street to South City Limit

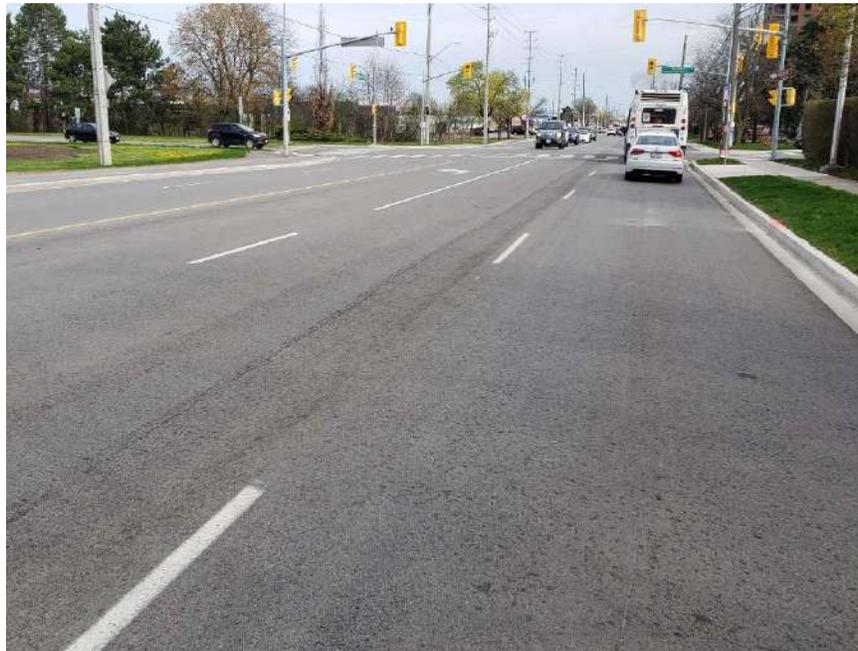
Photograph 72 – Bramalea Road, Southbound, looking South, near the intersection of Bramalea Road and Avondale Boulevard, showing slight longitudinal cracking associated with slight random cracking.

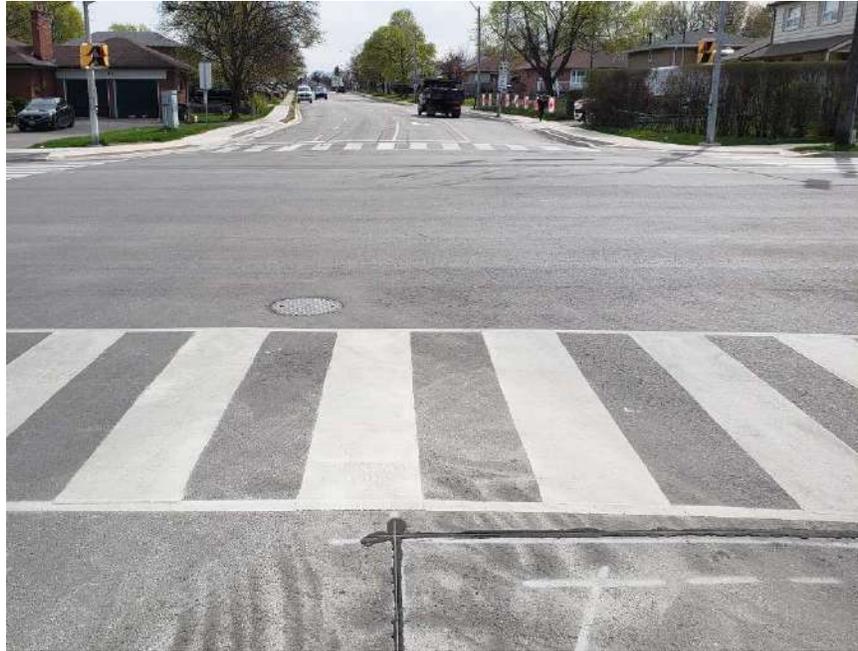
Photograph 73 – Bramalea Road, looking West, near the intersection of Bramalea Road and Avondale Boulevard, showing slight longitudinal and transverse cracking associated with slight random cracking. Noting sections of patching.

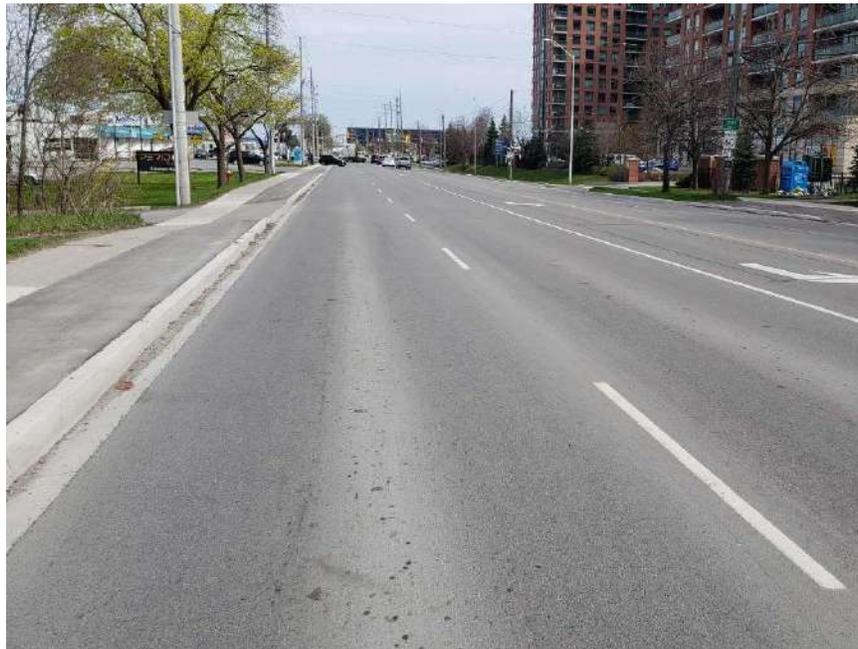
Photograph 74 – Bramalea Road, Northbound, looking South, near the intersection of Bramalea Road and Avondale Boulevard, showing relatively newly paved asphalt concrete.

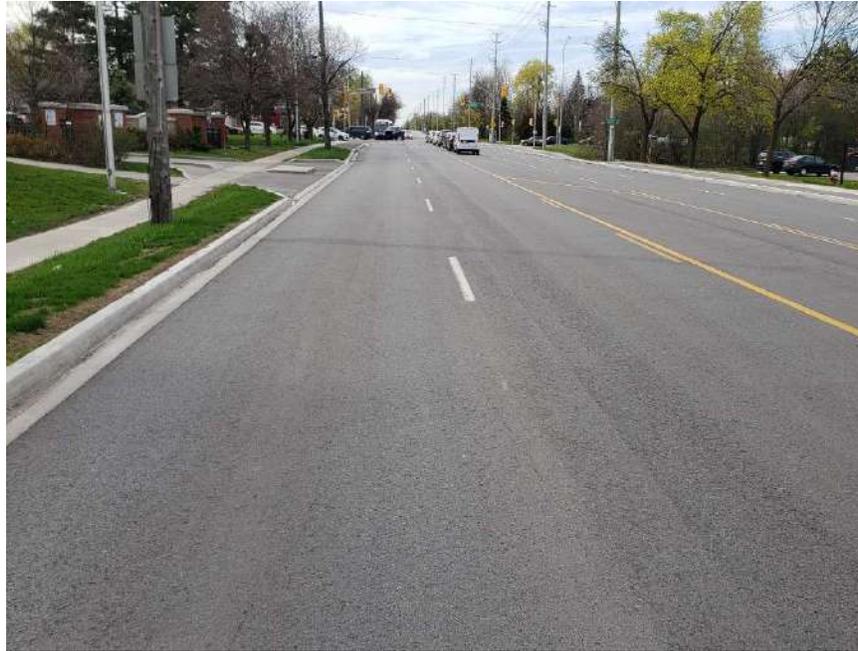
Photograph 75 – Bramalea Road, Southbound, looking North, approximately 105 m South of Avondale Boulevard, showing relatively newly paved asphalt concrete.

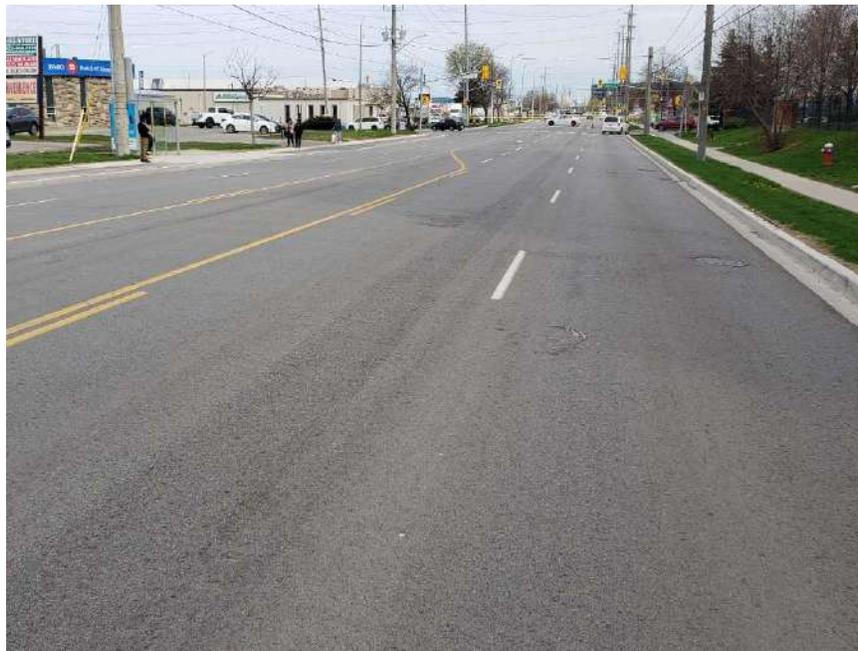
Photograph 76 – Bramalea Road, Southbound, looking South, approximately 75 m north of East Drive, showing relatively newly paved asphalt concrete.

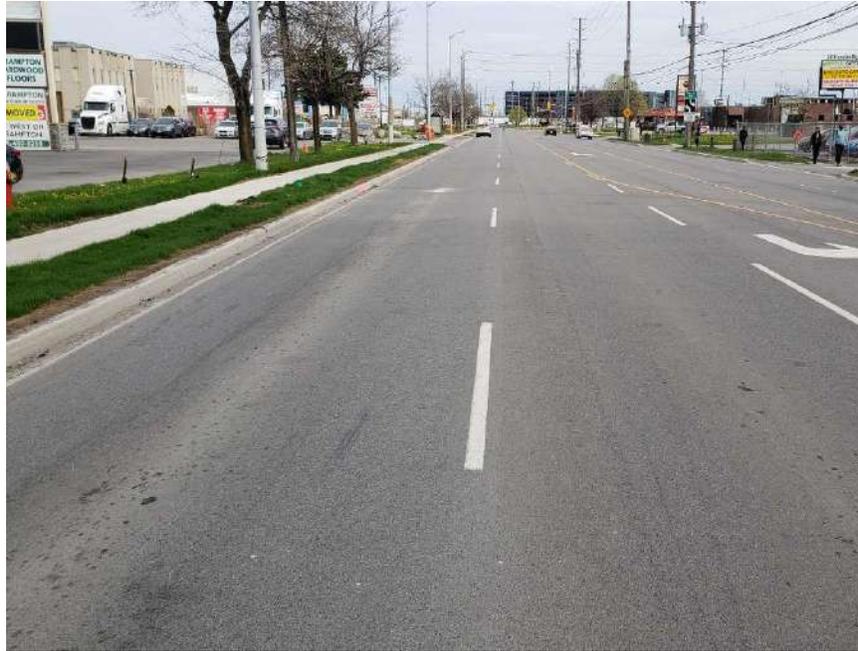
Photograph 77 – Bramalea Road, Northbound, looking South, near the intersection of Bramalea Road and East Drive, showing slight relatively newly paved asphalt concrete.

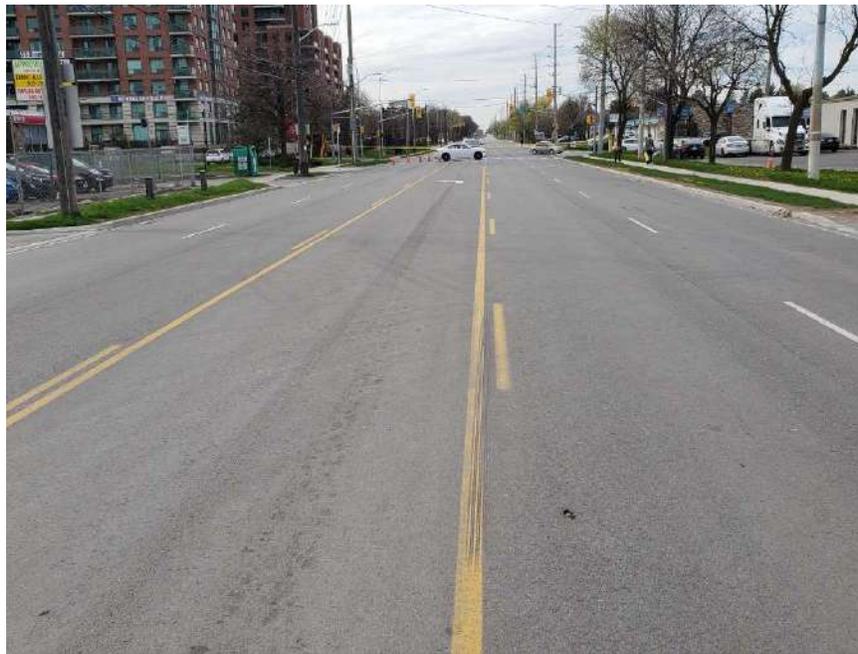
Photograph 78 – Bramalea Road, looking North, approximately 90 m South of Bramalea Road/East Drive, showing relatively newly paved asphalt concrete.

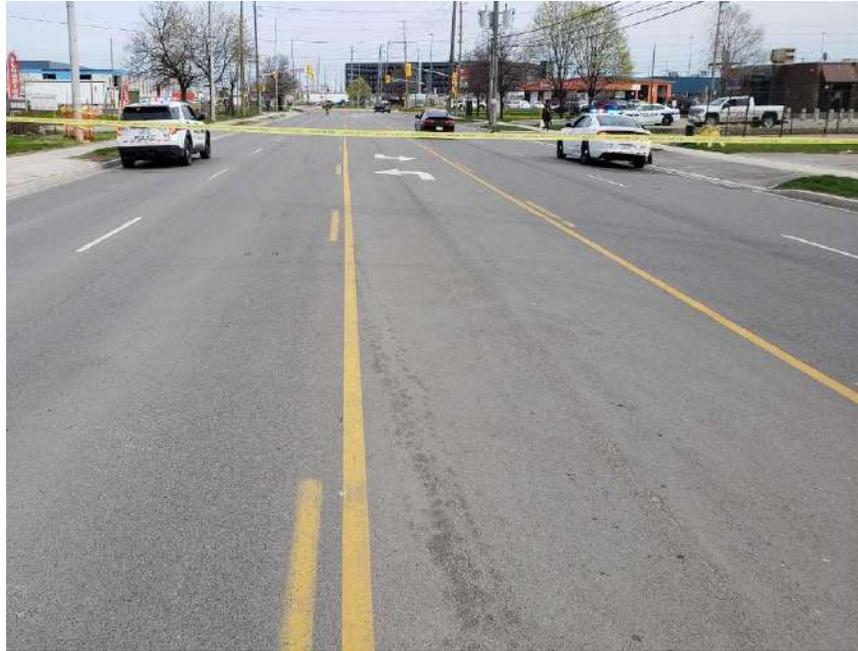
Photograph 79 – Bramalea Road, Southbound, looking South, approximately 120 m South of East Drive, showing relatively newly paved asphalt concrete.

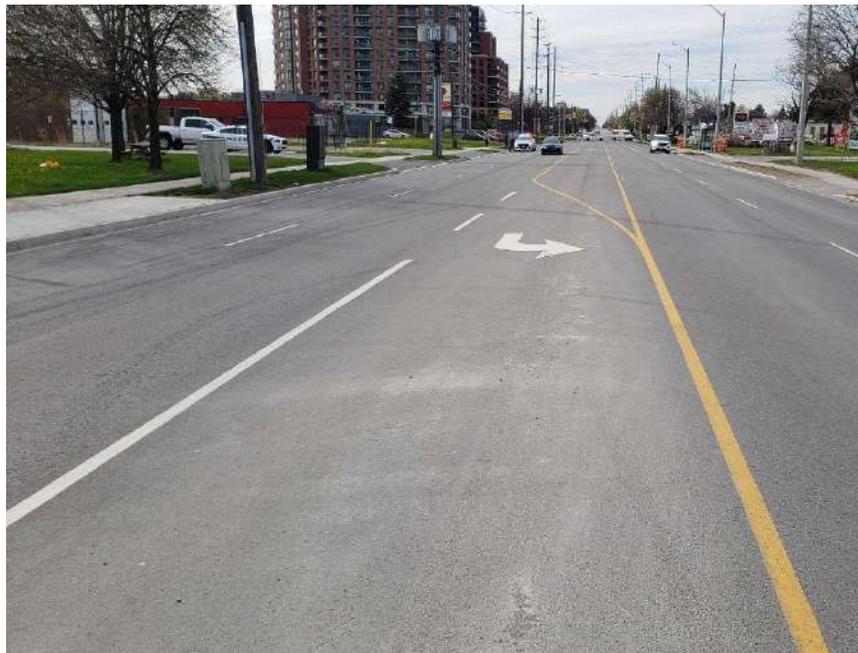
Photograph 80 – Bramalea Road, Southbound, looking North, approximately 35 m North of Orenda Road, showing relatively newly paved asphalt concrete.

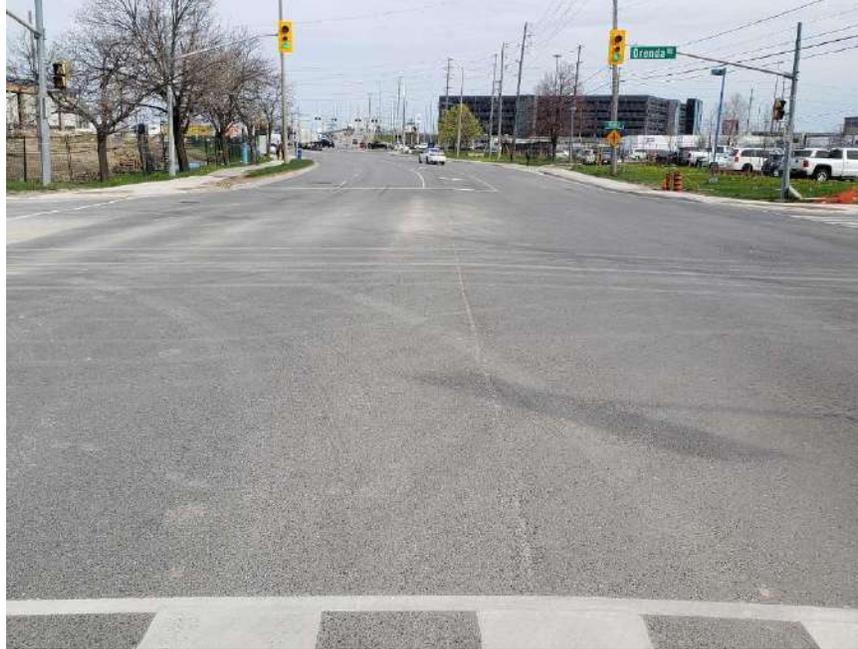
Photograph 81 – Bramalea Road, looking South, near the intersection of Bramalea Road and Oronda Road, showing slight to moderate longitudinal and transverse cracking associated with slight random cracking and slight pavement raveling.

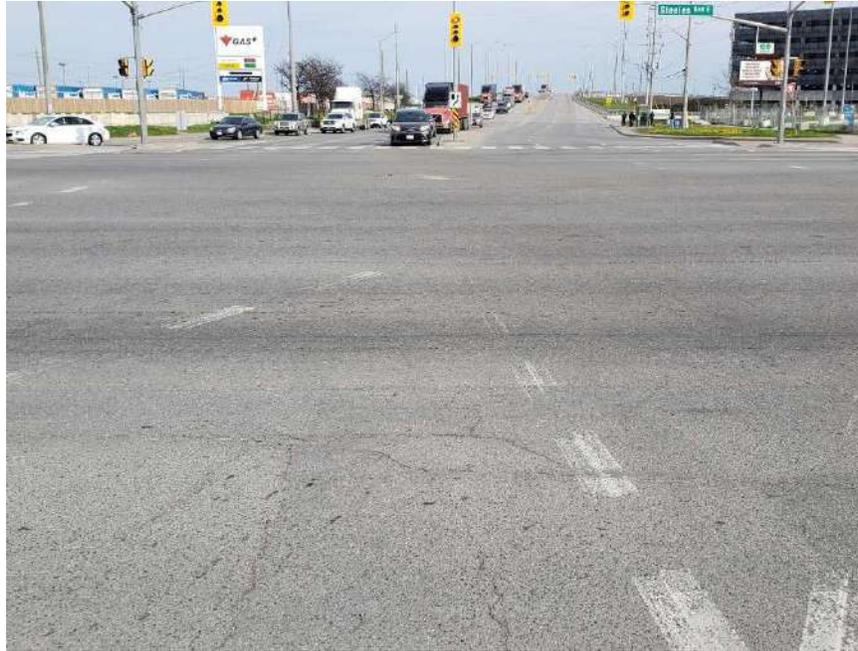
Photograph 83 – Bramalea Road, Southbound, looking South, near the intersection of Bramalea Road and Steeles Avenue East, showing moderate longitudinal and transverse cracking associated with moderate random cracking, slight block cracking and slight pavement raveling.

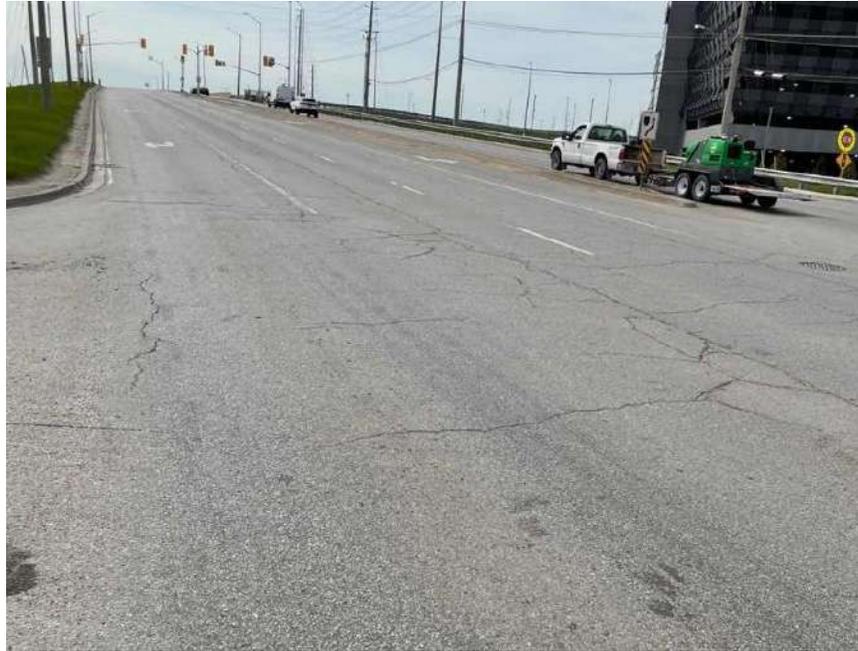
Photograph 85 – Bramalea Road, Northbound, looking South, approximately 120 m South of Steeles Avenue East, showing moderate to severe longitudinal and transverse cracking associated with moderate to severe random cracking, moderate to severe block cracking and slight pavement raveling.

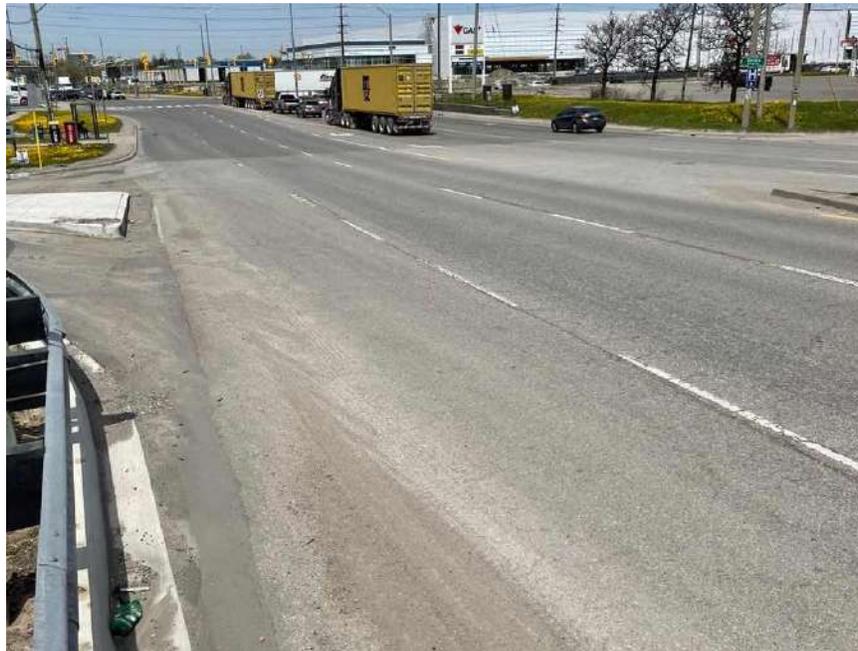
Photograph 86 – Bramalea Road, Southbound, looking North, approximately 140 m South of Steeles Avenue East, showing moderate longitudinal and transverse cracking associated with slight to moderate random cracking, slight block cracking and slight to moderate pavement raveling.

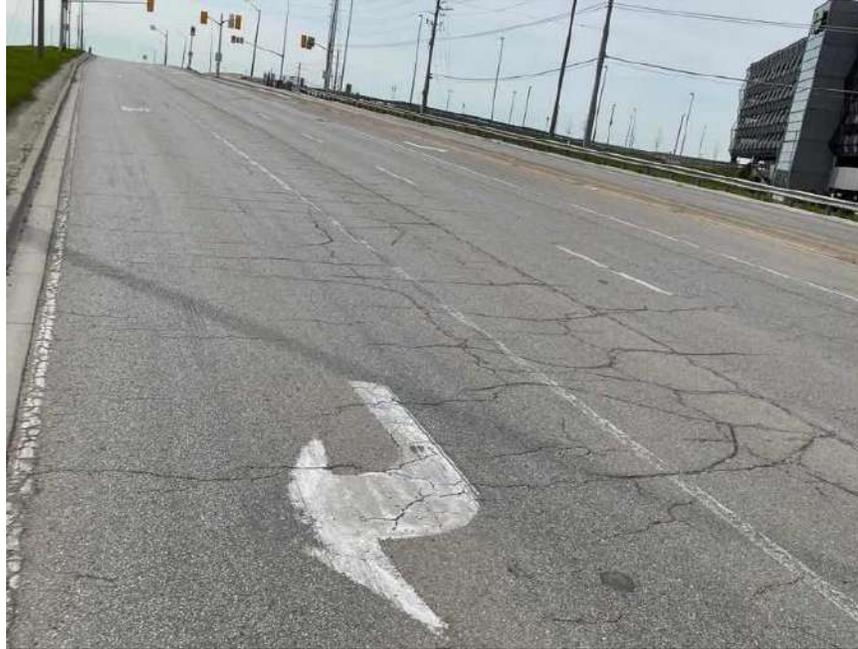
Photograph 87 – Bramalea Road, Northbound, looking South, approximately 160 m South of Steeles Avenue East, showing severe longitudinal and transverse cracking associated with severe random cracking, severe block cracking, moderate alligator cracking, moderate pavement edge cracking and slight to moderate pavement raveling.

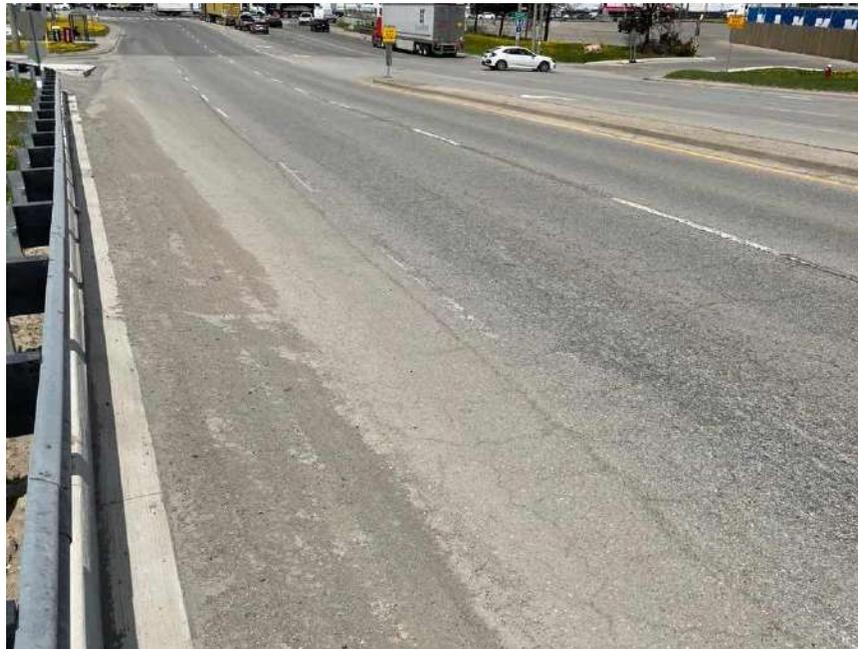
Photograph 88 – Bramalea Road, Southbound, looking North, approximately 170 m South of Steeles Avenue East, showing moderate to severe longitudinal and transverse cracking associated with severe random cracking, severe block cracking, moderate alligator cracking, moderate pavement edge cracking and moderate pavement raveling.

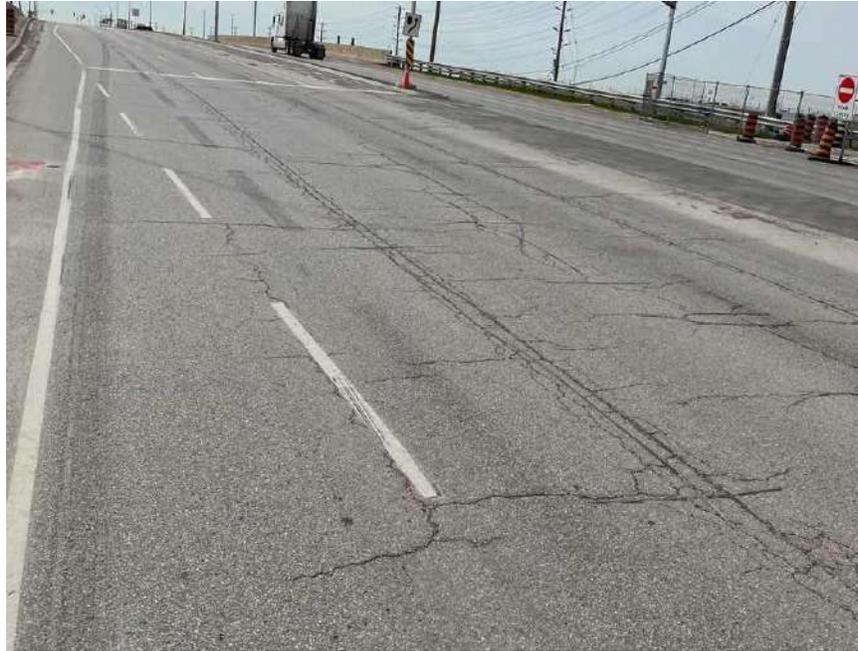
Photograph 89 – Bramalea Road, Northbound, looking South, approximately 150 m North of Railway, showing severe longitudinal and transverse cracking associated with severe random cracking, severe block cracking, moderate alligator cracking and moderate pavement raveling.

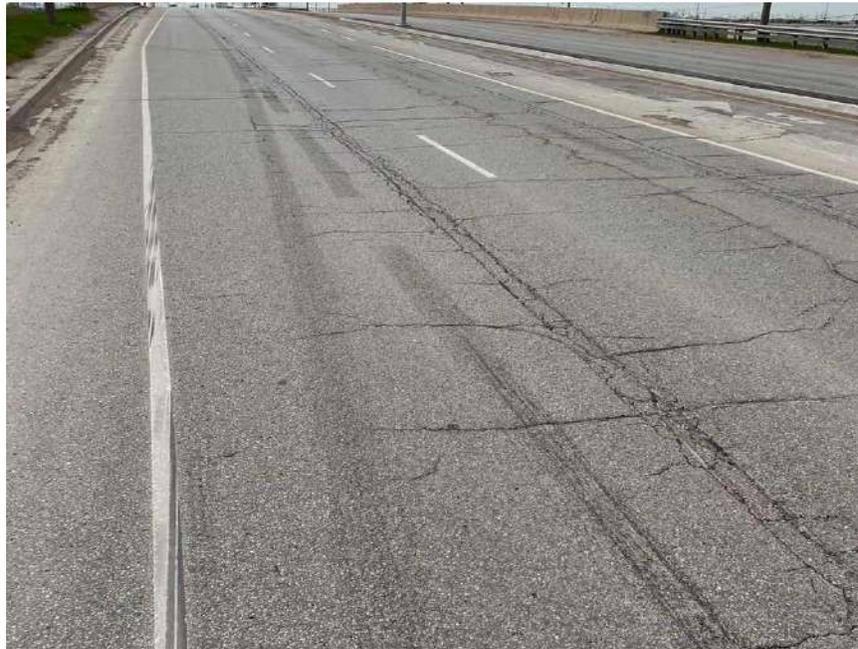
Photograph 90 – Bramalea Road, Northbound, looking South, approximately 100 m North of Railway, showing severe longitudinal and transverse cracking associated with severe random cracking, severe block cracking, moderate alligator cracking and moderate pavement raveling.

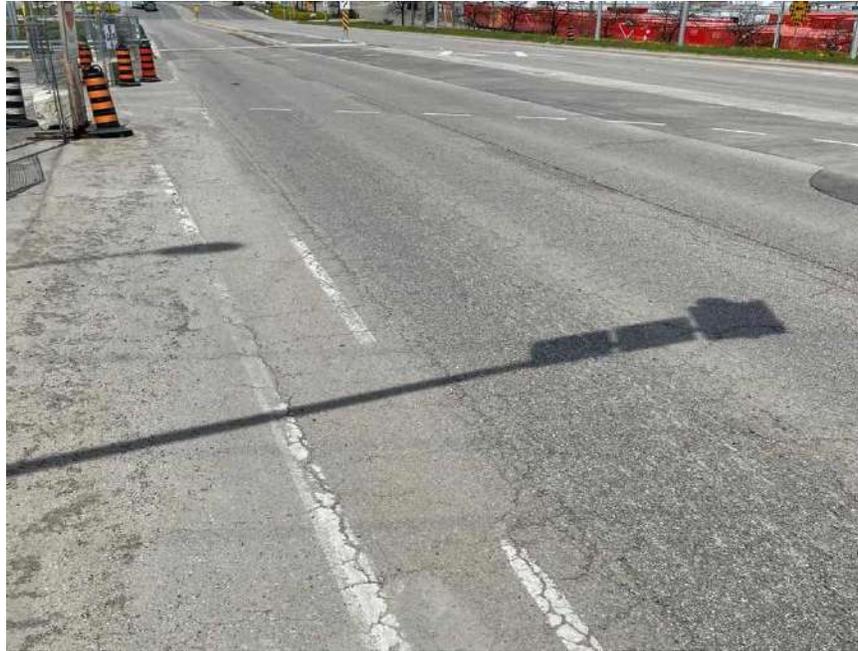
Photograph 91 – Bramalea Road, Southbound, looking North, approximately 100 m North of Railway, showing moderate to severe longitudinal and transverse cracking associated with moderate random cracking, moderate to severe block cracking, moderate alligator cracking and moderate pavement raveling.

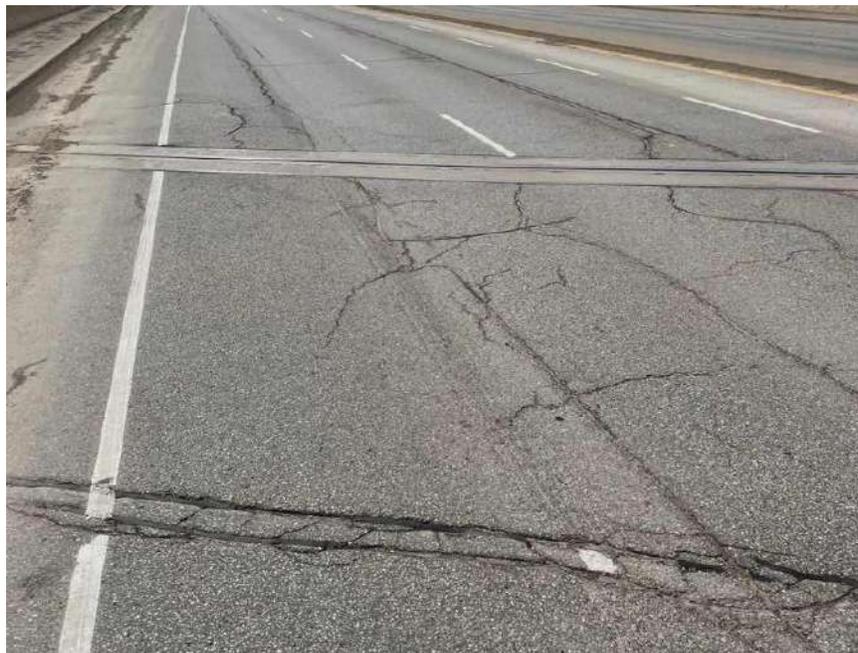
Photograph 92 – Bramalea Road, Northbound, looking South, near Railway, showing severe longitudinal and transverse cracking associated with severe random cracking, moderate block cracking, moderate alligator cracking, moderate pavement raveling and slight pavement edge cracking.

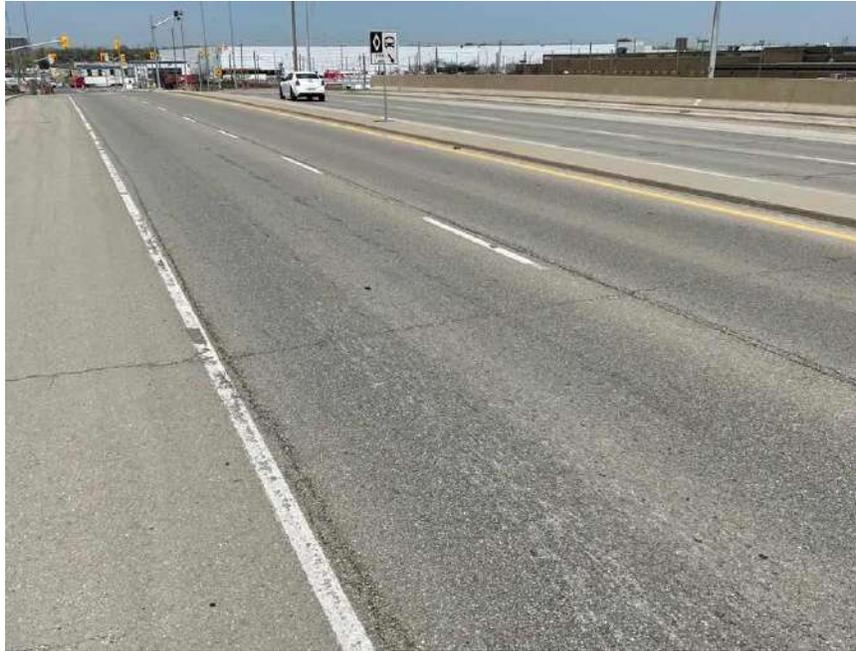
Photograph 93 – Bramalea Road, Southbound, looking North, approximately 55 m South of Railway, showing moderate longitudinal and transverse cracking associated with slight random cracking and moderate pavement raveling.

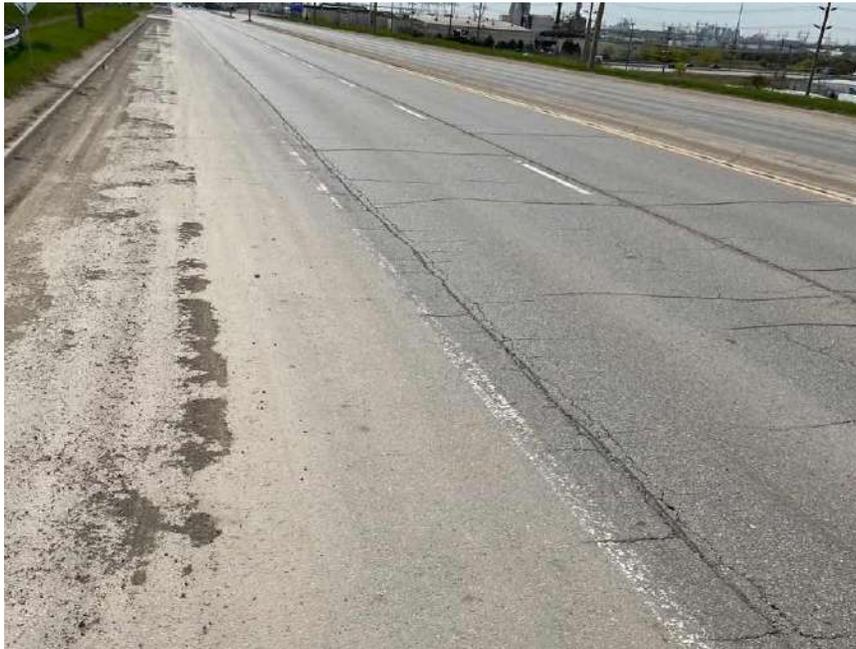
Photograph 94 – Bramalea Road, Northbound, looking South, approximately 100 m South of Railway, showing severe longitudinal and transverse cracking associated with moderate random cracking, moderate block cracking, moderate pavement raveling and moderate pavement edge cracking.

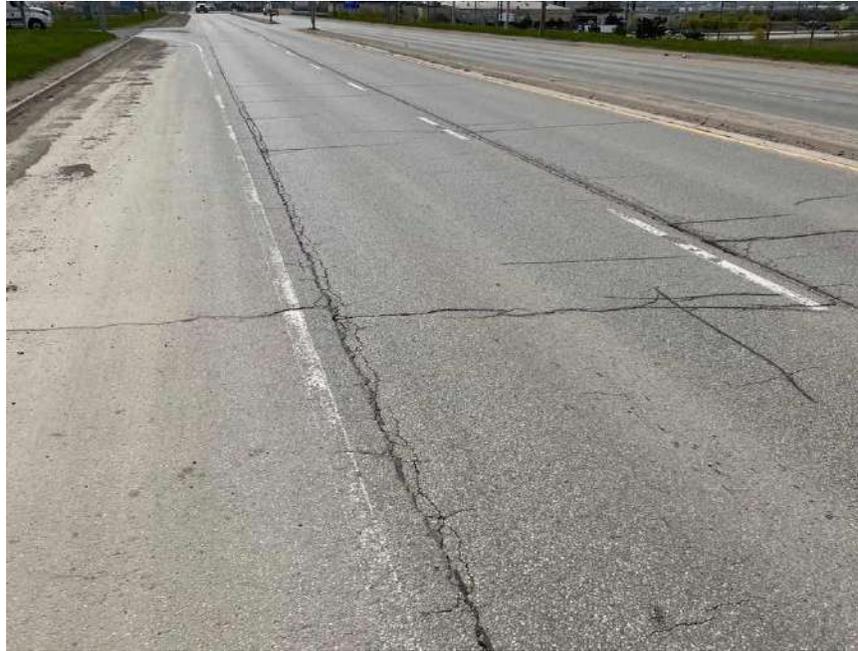
Photograph 95 – Bramalea Road, Northbound, looking South, approximately 130 m South of Railway, showing severe longitudinal and transverse cracking associated with moderate random cracking, moderate pavement raveling and slight block cracking.

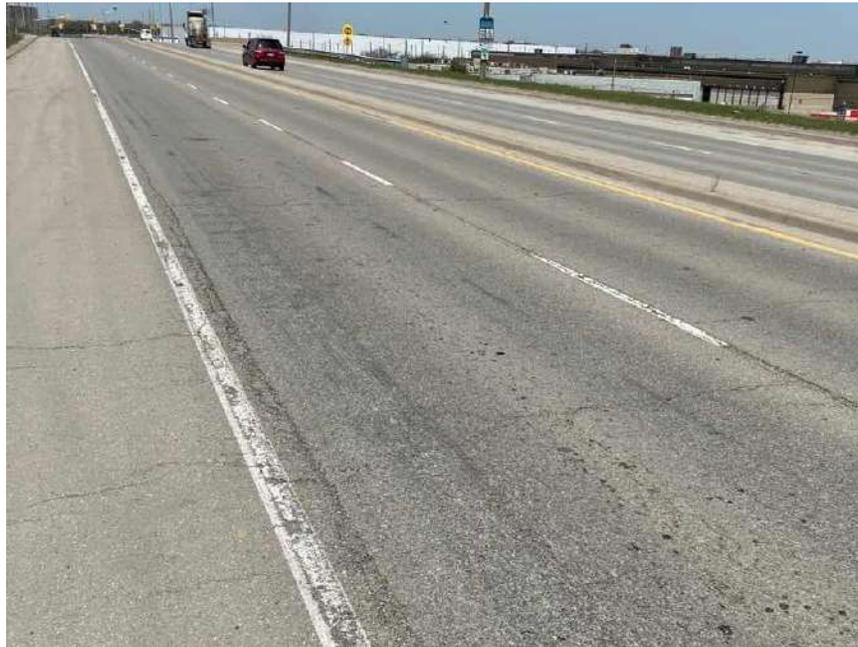
Photograph 96 – Bramalea Road, Southbound, looking North, approximately 170 m South of Railway, showing moderate to severe longitudinal and transverse cracking associated with moderate random cracking, moderate pavement raveling, slight block cracking and slight alligator cracking.

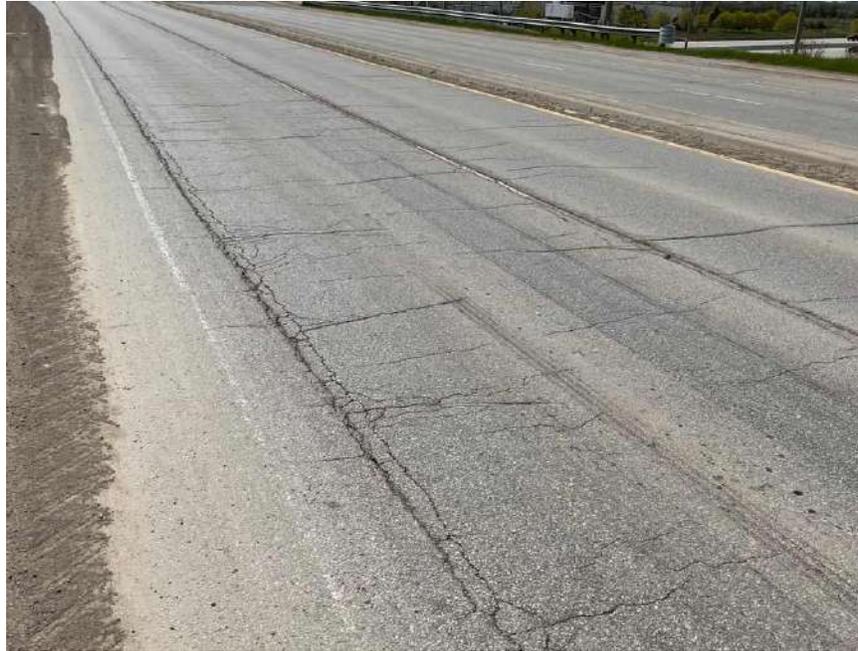
Photograph 97 – Bramalea Road, Northbound, looking South, approximately 120 m North of the crossing over Highway 407, showing severe longitudinal and transverse cracking associated with severe random cracking, moderate alligator cracking, moderate block cracking and moderate pavement raveling.

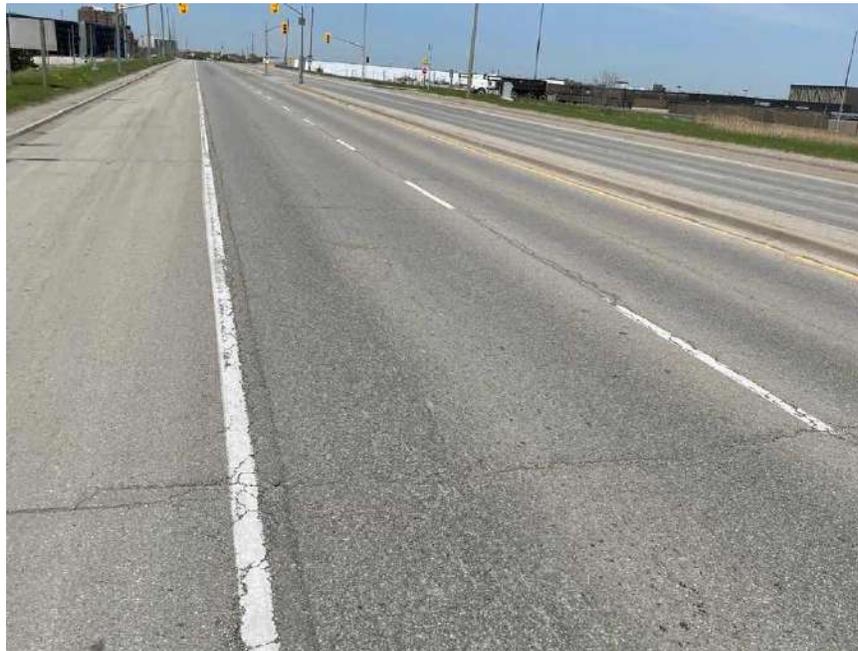
Photograph 98 – Bramalea Road, Southbound, looking North, approximately 80 m North of the crossing over Highway 407, showing moderate longitudinal and transverse cracking associated with moderate random cracking, moderate pavement raveling and slight alligator cracking.

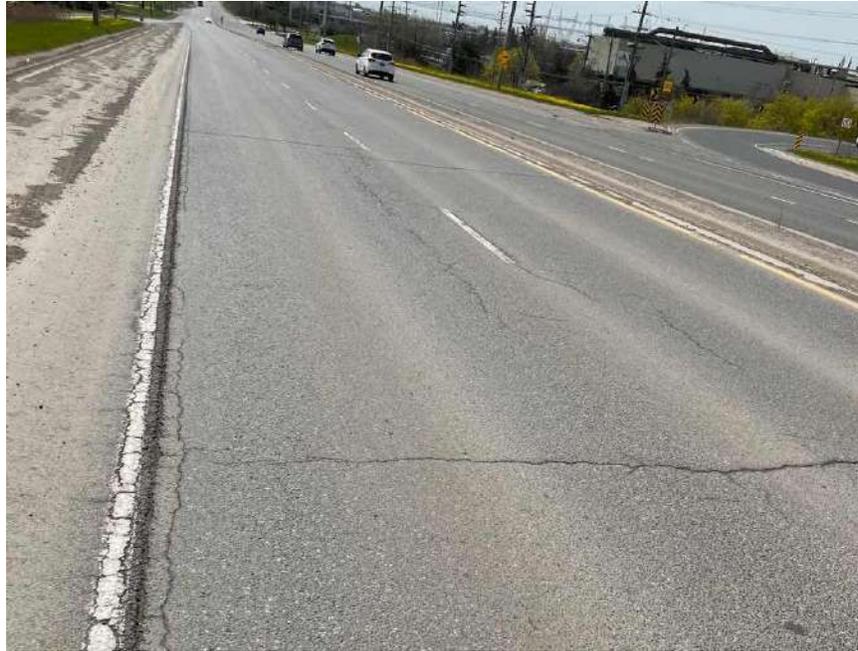
Photograph 99 – Bramalea Road, Northbound, looking South, approximately 90 m South of Highway 407, showing moderate to severe longitudinal and transverse cracking associated with moderate to severe random cracking, moderate alligator cracking, severe pavement edge cracking and moderate pavement raveling.

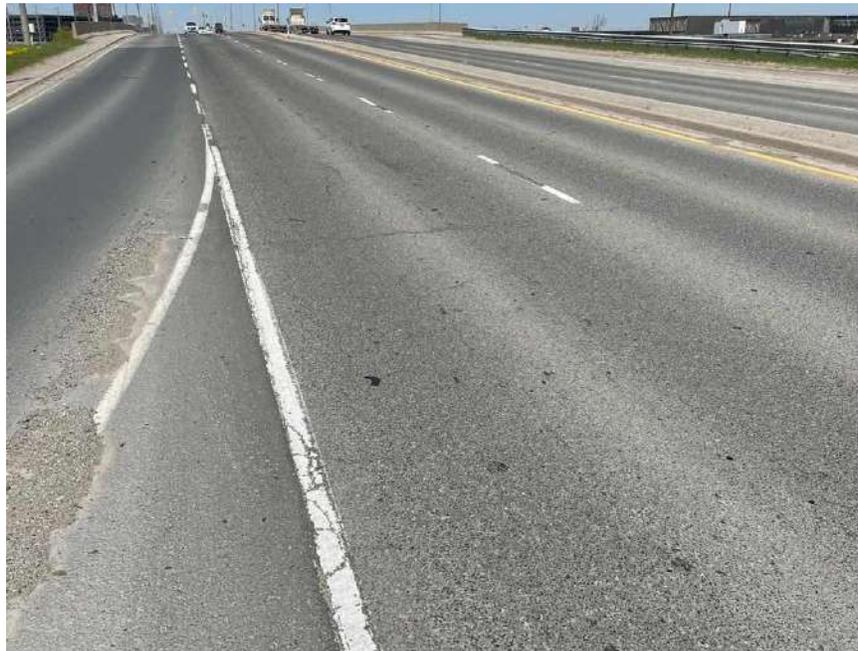
Photograph 100 – Bramalea Road, Southbound, looking North, near West-South Ramp of Highway 407, showing slight longitudinal and transverse cracking associated with slight to moderate random cracking, slight alligator cracking, and moderate pavement raveling.

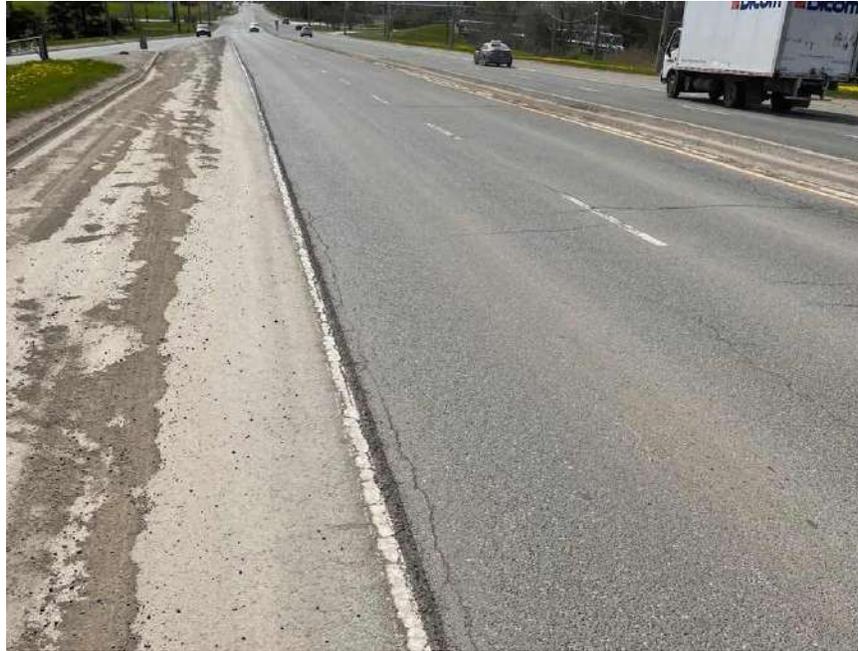
Photograph 101 – Bramalea Road, Northbound, looking South, near East-South ramp of Highway 407, showing moderate longitudinal and transverse cracking associated with moderate random cracking, moderate pavement edge cracking and slight to moderate pavement raveling.

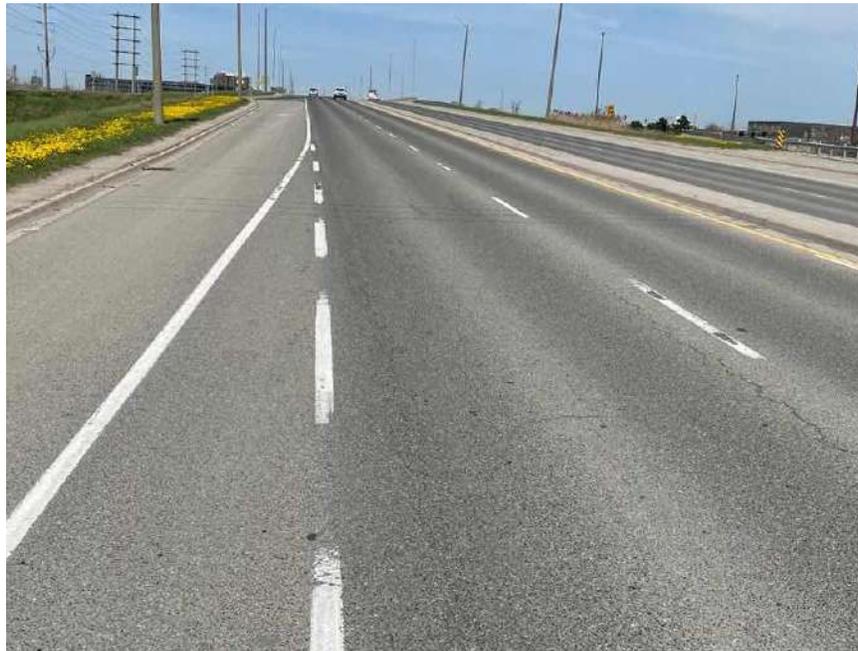
Photograph 102 – Bramalea Road, Southbound, looking North, approximately 235 m South of Highway 407, showing slight to moderate longitudinal and transverse cracking associated with slight to moderate random cracking and slight to moderate pavement raveling.

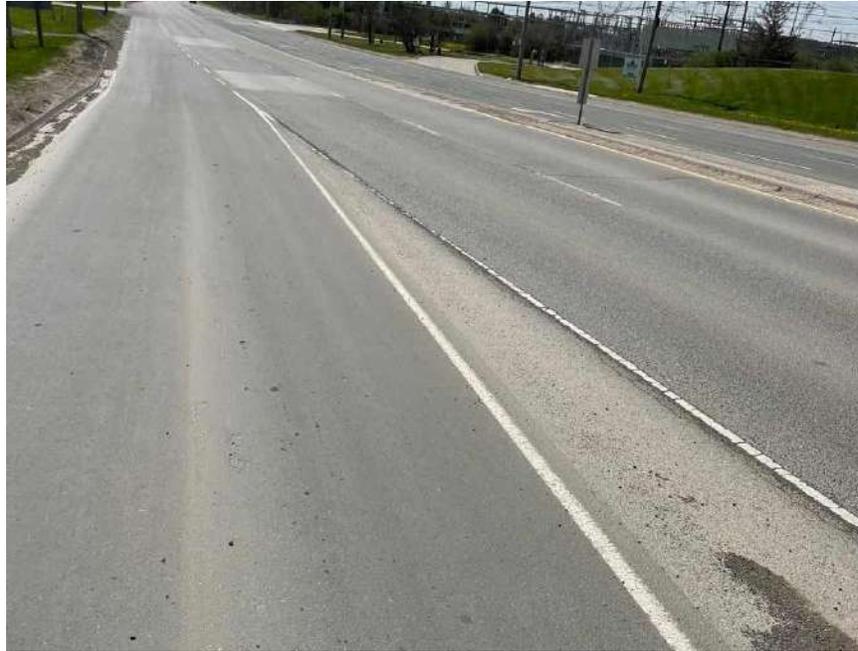
Photograph 103 – Bramalea Road, Northbound, looking South, approximately 290 m South of Highway 407, showing slight to moderate longitudinal and transverse cracking associated with slight random cracking, slight alligator cracking and slight pavement raveling.

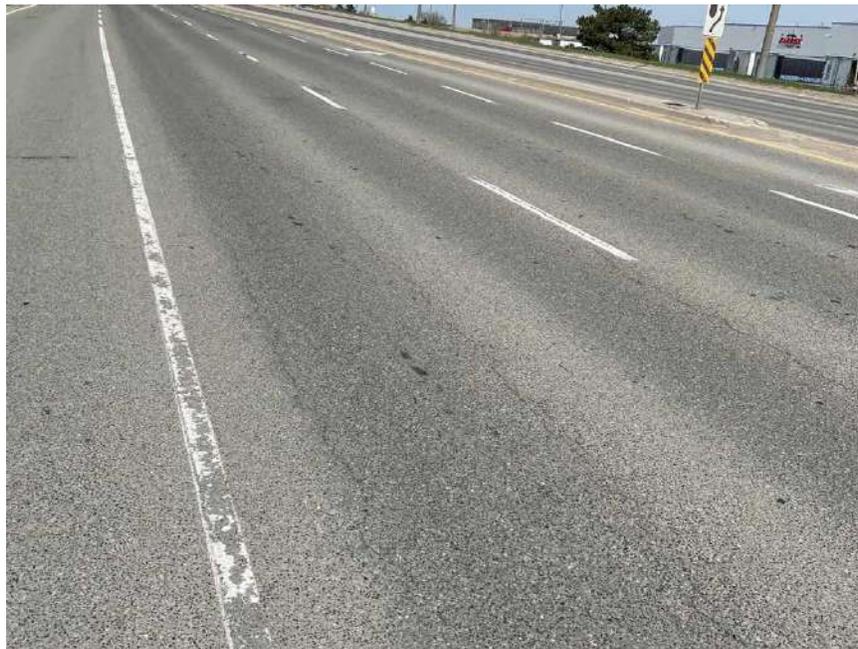
Photograph 104 – Bramalea Road, Southbound, looking North, approximately 320 m South of Highway 407, showing slight to moderate longitudinal cracking associated with slight random cracking and slight to moderate pavement raveling.

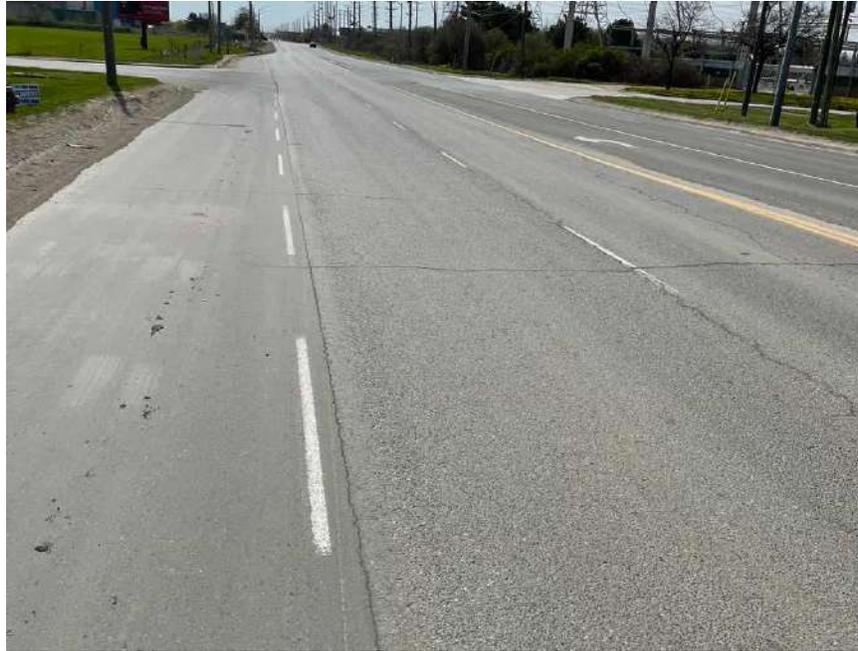
Photograph 105 – Bramalea Road, Northbound, looking South, approximately 370 m South of Highway 407, showing moderate longitudinal and transverse cracking associated with slight random cracking, slight longitudinal construction joint and slight to moderate pavement raveling.

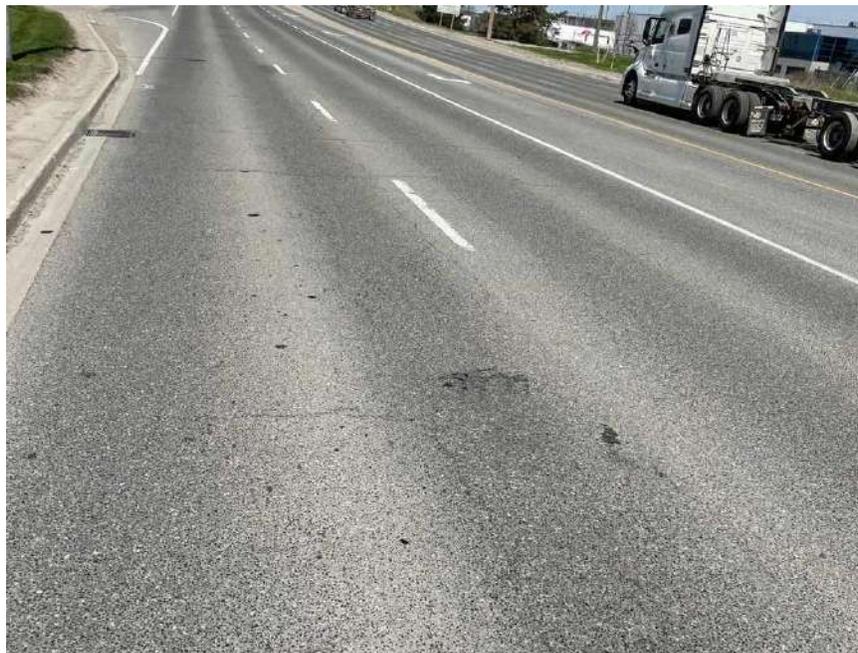
Photograph 106 – Bramalea Road, Southbound, looking North, approximately 420 m South of Highway 407, showing moderate longitudinal and transverse cracking associated with slight to moderate random cracking and slight to moderate pavement raveling.

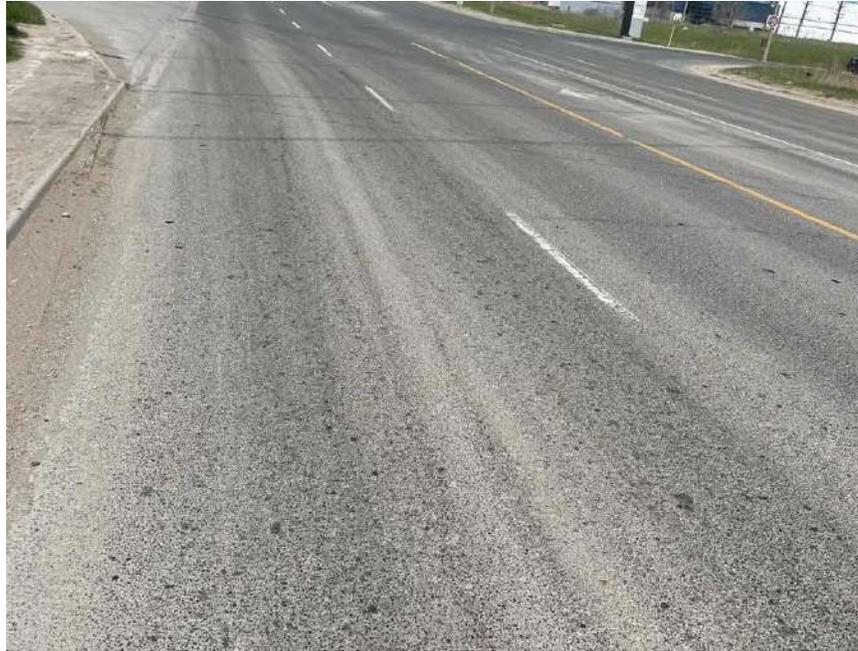
Photograph 107 – Bramalea Road, Southbound, looking North, approximately 445 m South of Highway 407, showing slight longitudinal and transverse cracking associated with slight random cracking and slight to moderate pavement raveling.

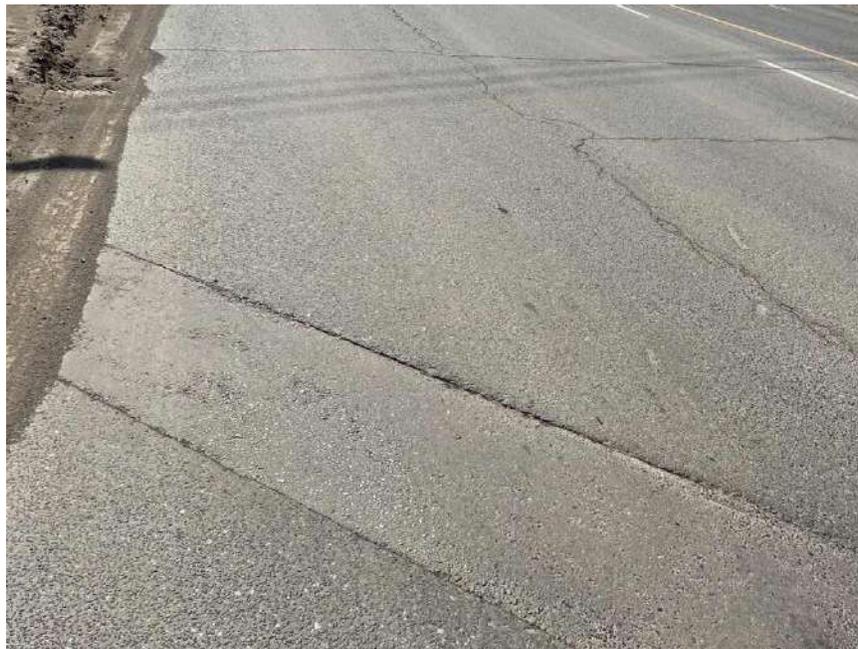
Photograph 108 – Bramalea Road, Northbound, looking South, approximately 515 m South of Highway 407, showing moderate longitudinal and transverse cracking associated with moderate random cracking and slight to moderate pavement raveling. Noting utility patching.

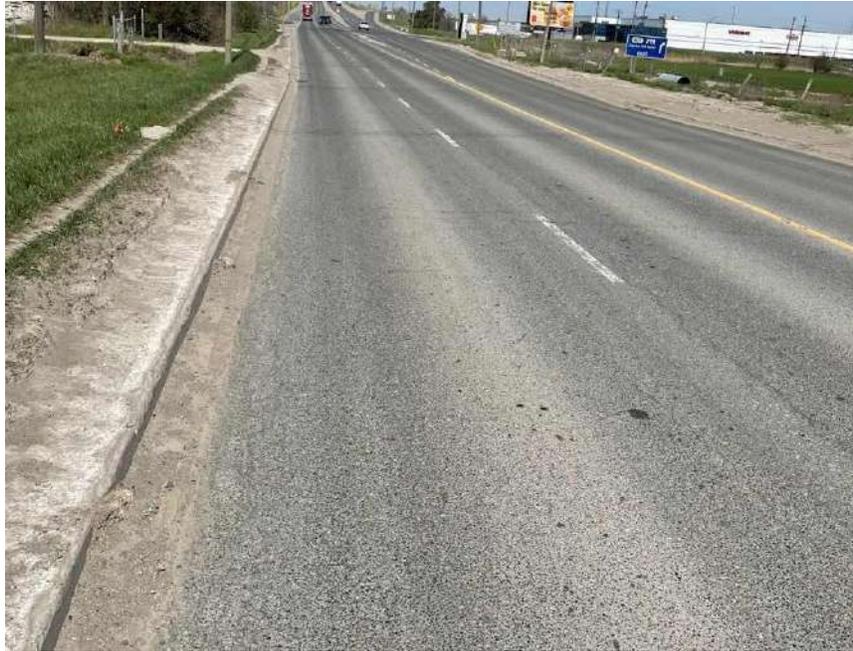
Photograph 109 – Bramalea Road, Southbound, looking North, approximately 570 m South of Highway 407, showing slight to moderate longitudinal and transverse cracking associated with slight to moderate random cracking and slight to moderate pavement raveling.
