**BRAMALEA ROAD CORRIDOR IMPROVEMENTS, MUNICIPAL CLASS
ENVIRONMENTAL ASSESSMENT STUDY**

Geotechnical Investigation

Proposed Road Improvements

Bramalea Road from Queen Street to South City Limit

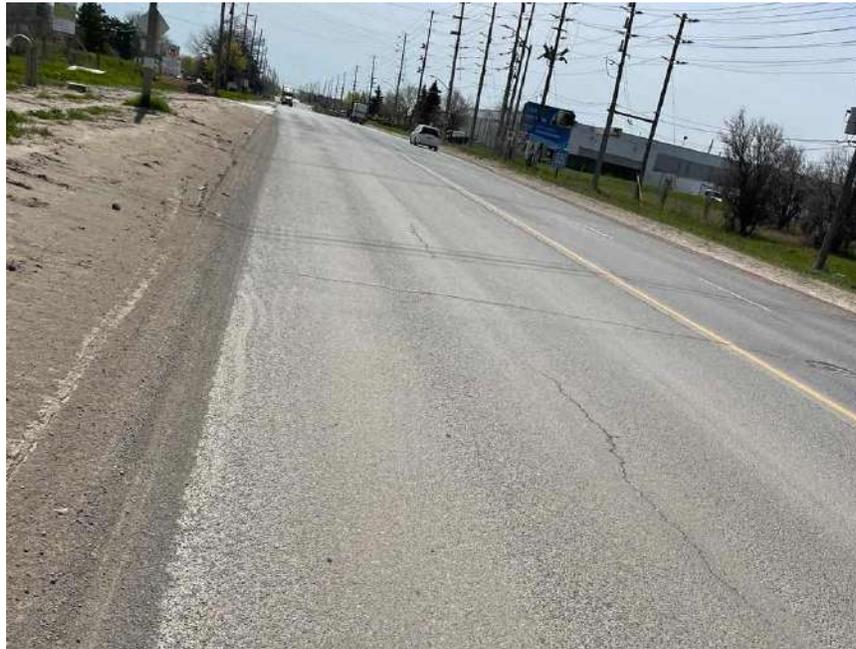
Photograph 110 – Bramalea Road, Northbound, looking South, approximately 645 m South of Highway 407, showing moderate longitudinal and transverse cracking associated with slight to moderate random cracking and moderate pavement raveling.

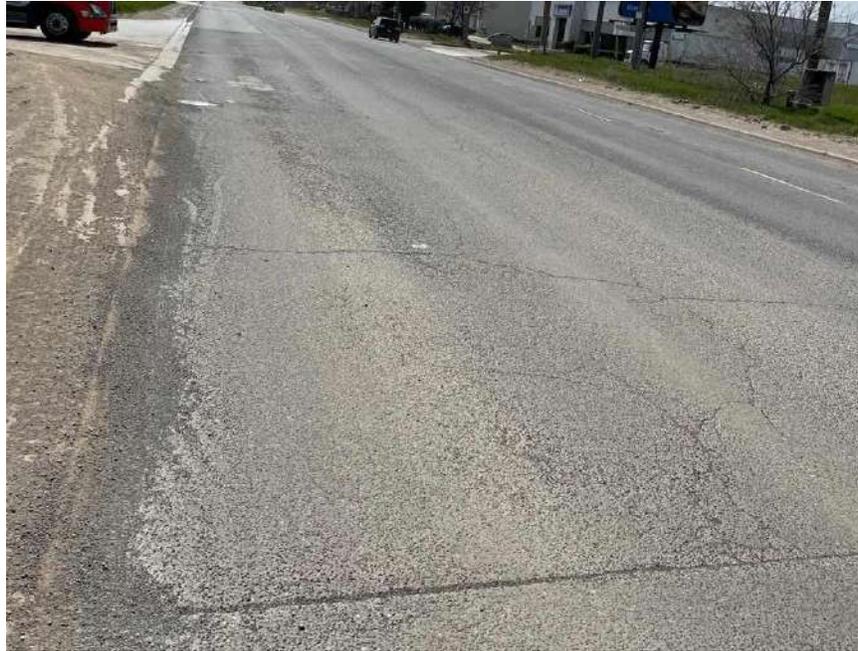
Photograph 111 – Bramalea Road, Northbound, looking South, approximately 700 m South of Highway 407, showing moderate longitudinal and transverse cracking associated with moderate random cracking, slight block cracking and moderate to severe pavement raveling.

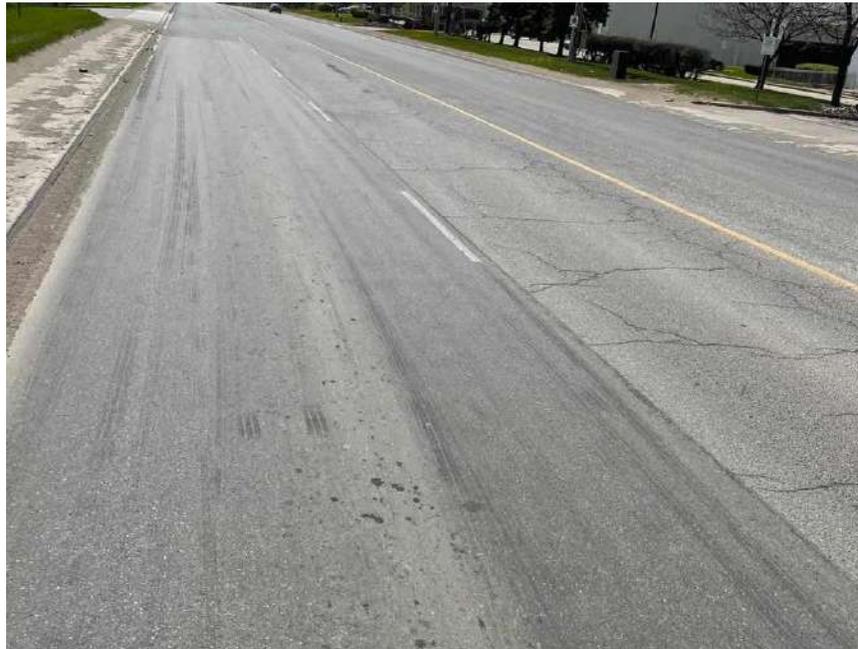
Photograph 112 – Bramalea Road, Northbound, looking South, approximately 720 m South of Highway 407, showing severe longitudinal and transverse cracking associated with moderate to severe random cracking, severe blocking cracking, slight longitudinal construction joint and moderate pavement raveling. Noting sections of patching.

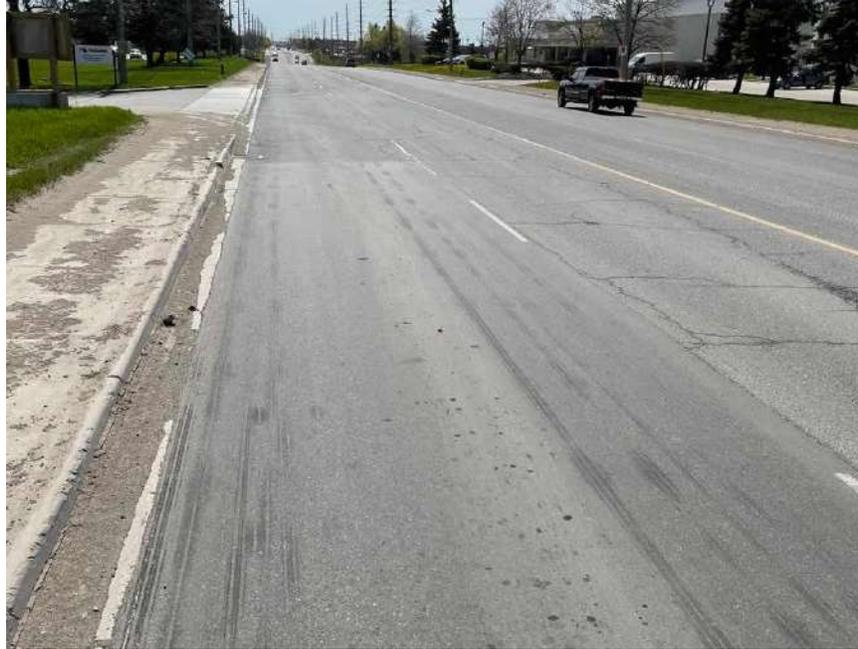
Photograph 113 – Bramalea Road, Northbound, looking South, approximately 790 m South of Highway 407, showing severe longitudinal and transverse cracking associated with moderate to severe random cracking, severe block cracking, slight longitudinal construction joint and moderate pavement raveling. Noting sections of patching.

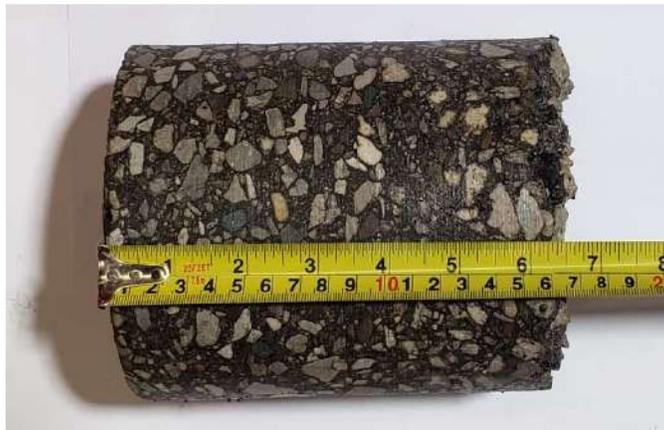
Photograph 14 : CH14

Photograph 14 – Bramalea Road, looking North, near the intersection of Fleetwood Crescent and Bramalea Road, showing moderate longitudinal and transverse cracking associated with slight random cracking, slight pavement edge cracking and slight pavement raveling. Noting utility patching.

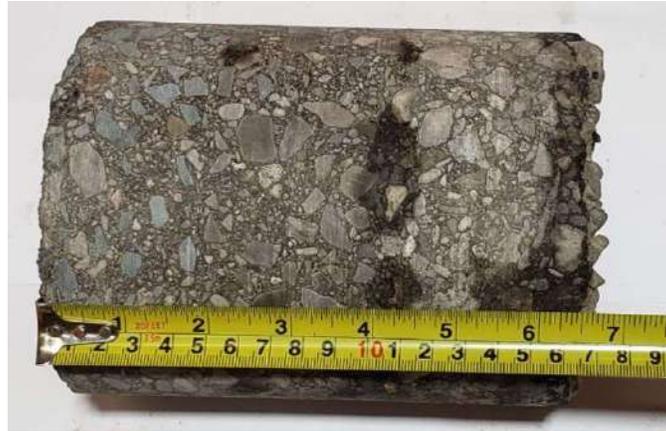
Photograph 15 : CH15

Photograph 15 – Bramalea Road, Southbound, looking North, in the vicinity of the intersection of Bramalea Road and Fleetwood Crescent, showing moderate to severe longitudinal and transverse cracking associated with moderate random cracking, slight potholes, slight to moderate pavement raveling and moderate pavement edge cracking.

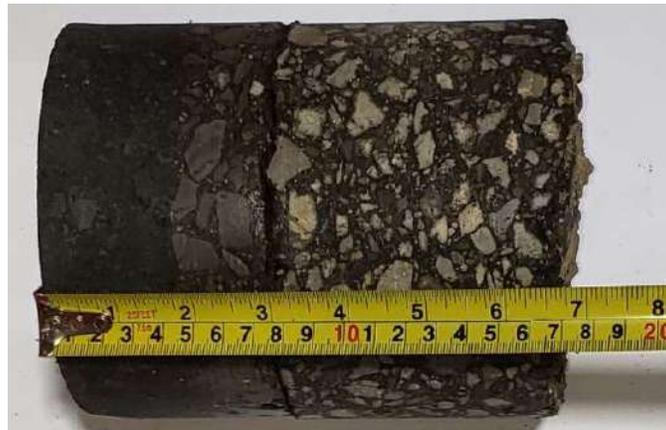
Photograph 16 : CH16

Photograph 16 – Bramalea Road, Southbound, looking South, approximately 70 m South of Fleetwood Crescent, showing moderate to severe longitudinal and transverse cracking associated with slight to moderate random cracking, slight pavement depressions, slight to moderate pavement raveling and slight to moderate pavement edge cracking.

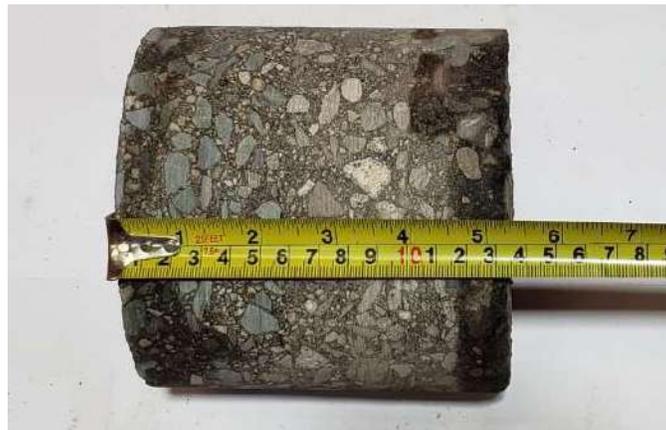
Photograph 17 : CH17

Photograph 17 – Bramalea Road, Southbound, looking North, approximately 105 m South of Fleetwood Crescent, showing moderate longitudinal and transverse cracking associated with slight to moderate random cracking, slight pavement raveling, slight alligator cracking and moderate pavement edge cracking.

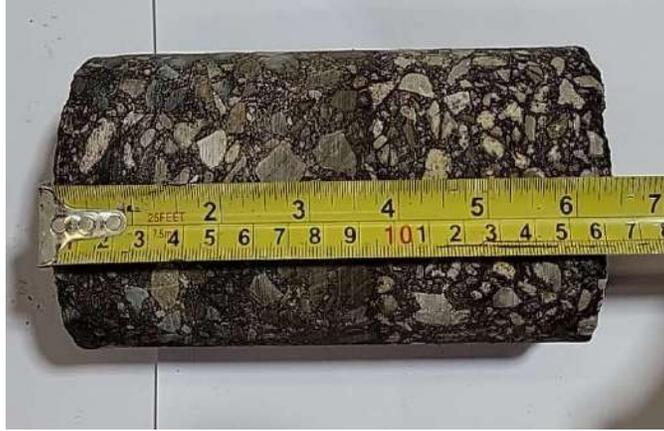
Photograph 18 : CH18

Photograph 18 – Bramalea Road, Southbound, looking North, approximately 125 m South of Fleetwood Crescent, showing moderate to severe longitudinal and transverse cracking associated with moderate random cracking, slight to moderate pavement raveling and slight to moderate pavement edge cracking.

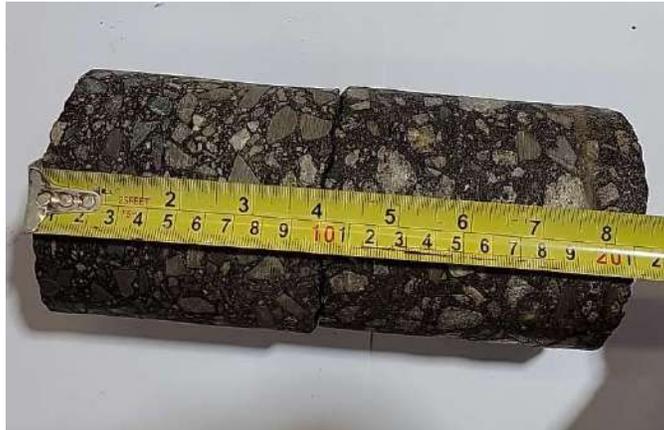
Photograph 19 : CH19

Photograph 19 – Bramalea Road, Southbound, looking South, approximately 150 m South of Fleetwood Crescent, showing moderate to severe longitudinal and transverse cracking associated with moderate random cracking, slight pavement depressions, slight to moderate pavement raveling and slight pavement edge cracking.
