Memorandum

Project #: 1400343

Re: Denison Avenue EA Study – Tree Evaluation Report and Natural Heritage Features Assessment

PROJECT: Denison Ave Natural Heritage Features Assessment

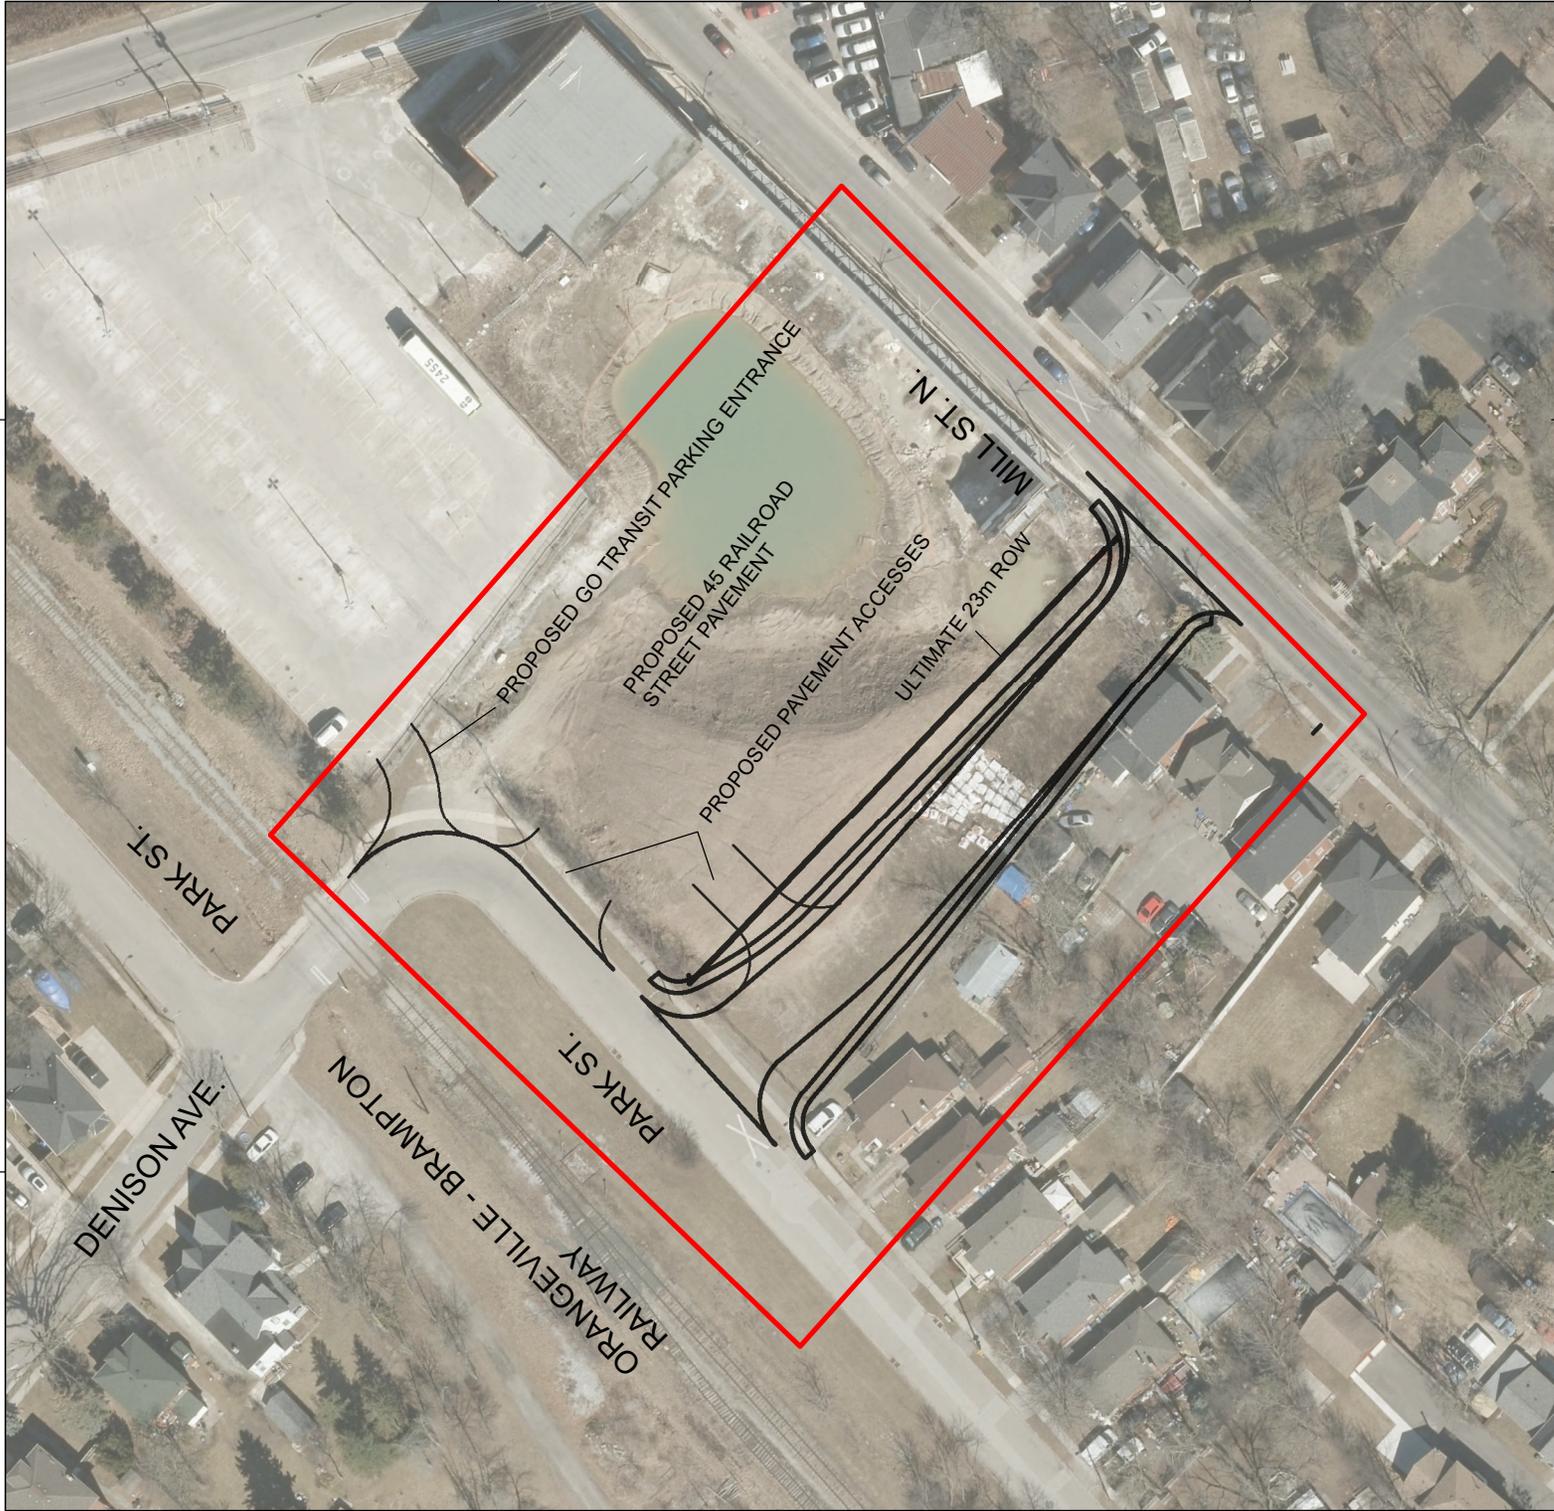
Figure 1

TITLE: **Site Location**

This Technical Memo is prepared in support of the municipal road extension design prepared by Associated Engineering for submission as part of the EA approval and permitting process. Towards this objective, a review of applicable policy has been provided. This memo also describes the background review and field investigations undertaken to support the characterization of existing natural environmental conditions, identifies potential impacts and provides recommendations for general and site-specific mitigation. Palmer's assessment or "study area" was scoped to focus on the lands located immediately adjacent to the proposed development works (**Figure 1**).

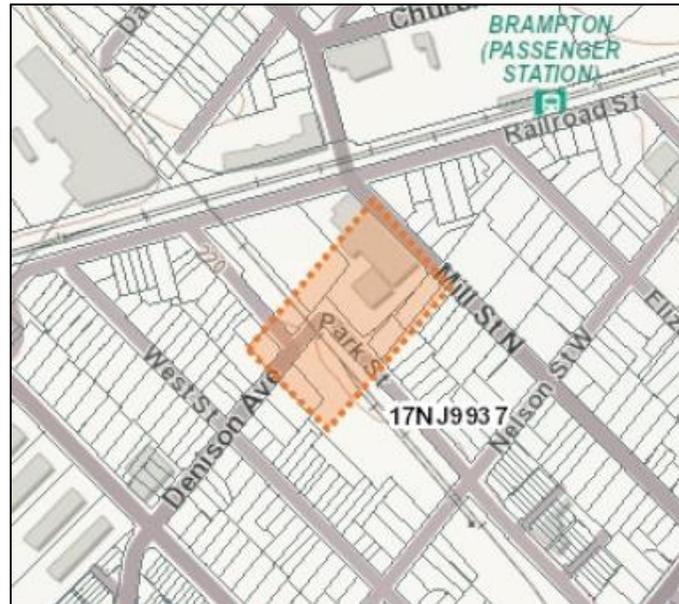
Map A. MNR mapping for the general vicinity of the study area.

As identified upon a review of the Ministry of Natural Resources and Forestry (MNRF) online "Make-A-Map: Natural Heritage Areas" mapping application (**Map A**), no provincially significant environmental features are identified within the study area.

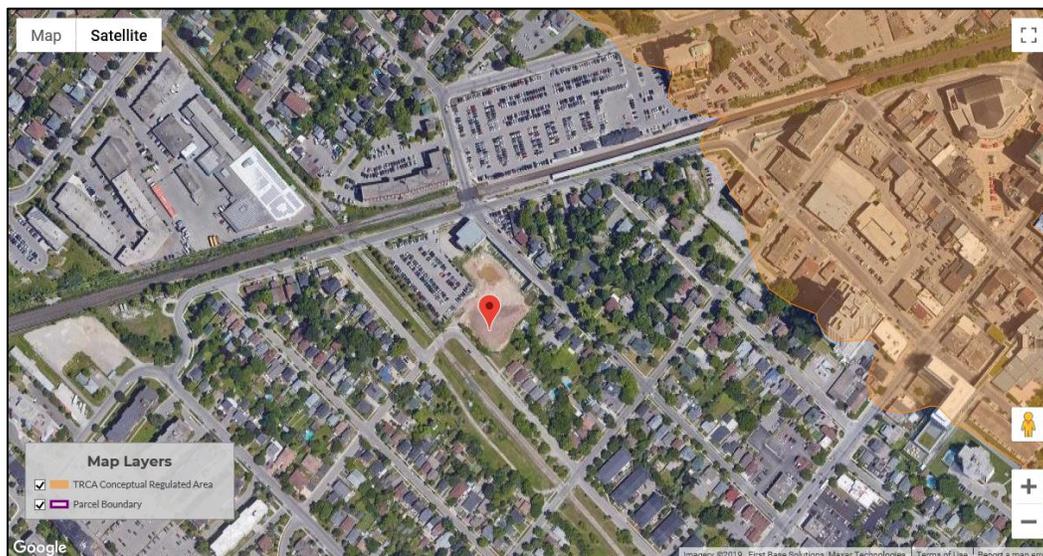
Map B. TRCA Conceptual Regulated Area (source: www.trca.on.ca)

Although the study area is located within the Toronto and Region Conservation Authority (TRCA)'s overall jurisdiction, no components of the TRCA Regulated Area exist within the immediate study area (**Map B**). As such, a development permit from the TRCA is not required. The study area is located just east outside of Credit Valley Conservation (CVC)'s watershed boundary; as such, authorization from CVC is also not required.

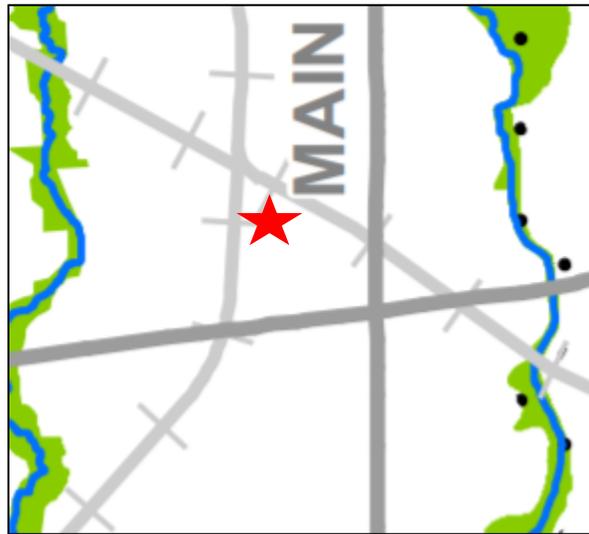
Map C. Regional Greenlands System mapping (Official Plan Schedule A).

As depicted on Schedule A (**Map C**), the study area is located entirely outside of the Regional Greenlands System. As such, no Greenlands System related policies will apply to the proposed development.

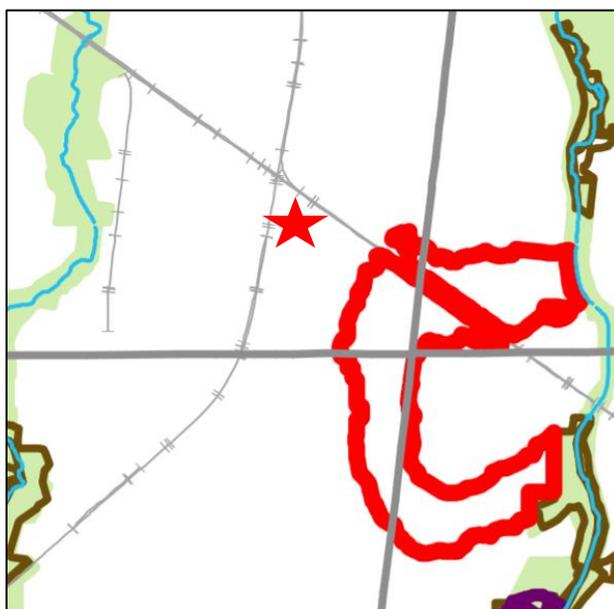
Map D. City Natural Heritage System mapping (Official Plan Schedule D) (Valleyland/Watercourse Corridor = green polygon, Special Policy Area = red outline, Woodland = brown outline)

The City of Brampton identifies “Natural Heritage Features and Areas” on *Schedule D* of its OP. These features include Valleylands/Watercourse Corridors, Woodlands, Wetlands (Provincially Significant Wetlands and Other Wetlands), Environmentally Sensitive/Significant Areas, Areas of Natural and Scientific Interest and the Provincial Greenbelt Plan area.

These features, along with “Fish and Wildlife Habitat” are considered the components of the City’s natural heritage system Natural Heritage System. Development and site alteration are generally not permitted in significant natural heritage features. A review of the study area indicates that it does not contain any of the above listed components of the City’s Natural Heritage System, such as those mapped on Schedule D (**Map D**). As such, no natural heritage policies of the OP pertain to the proposed development.

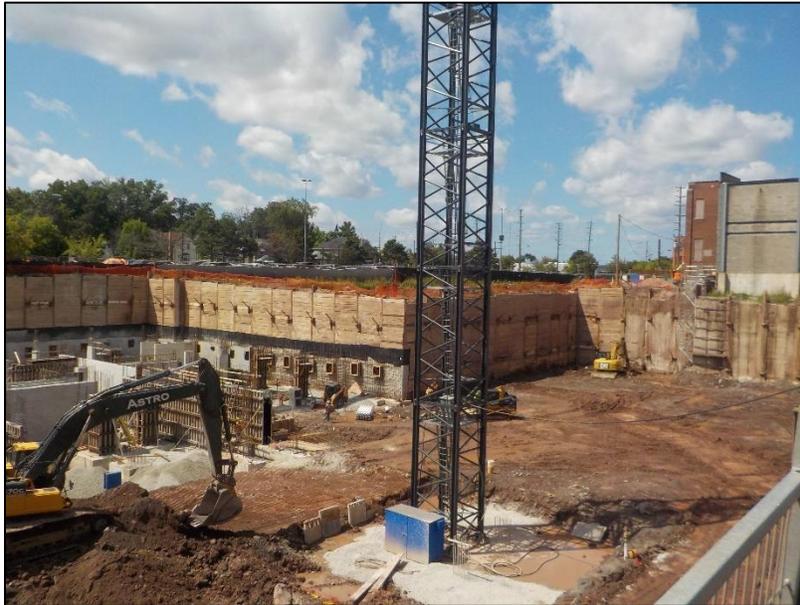
Photo 1. Active construction lands within the study area.

The overall study area is characterized by past and current disturbance and is dominated by culturally influenced communities. The majority of the study area is currently under construction for future high-density residential use (**Photo 1**). ELC community boundaries of the remaining study area lands are illustrated on **Figure 2**, with descriptions based on field investigations provided below (**Table 1**). Although two area of open water appear within the current active construction portions of the study area in the aerial imagery used for the report figures, these features no longer exist on-site (**Photo 1**).

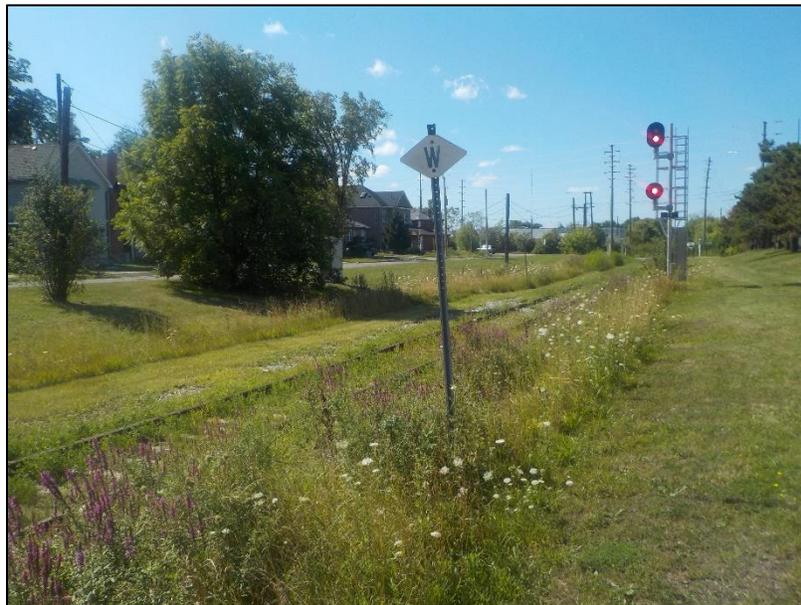
Photo 2. General view of railway line located immediately west adjacent to the study area.

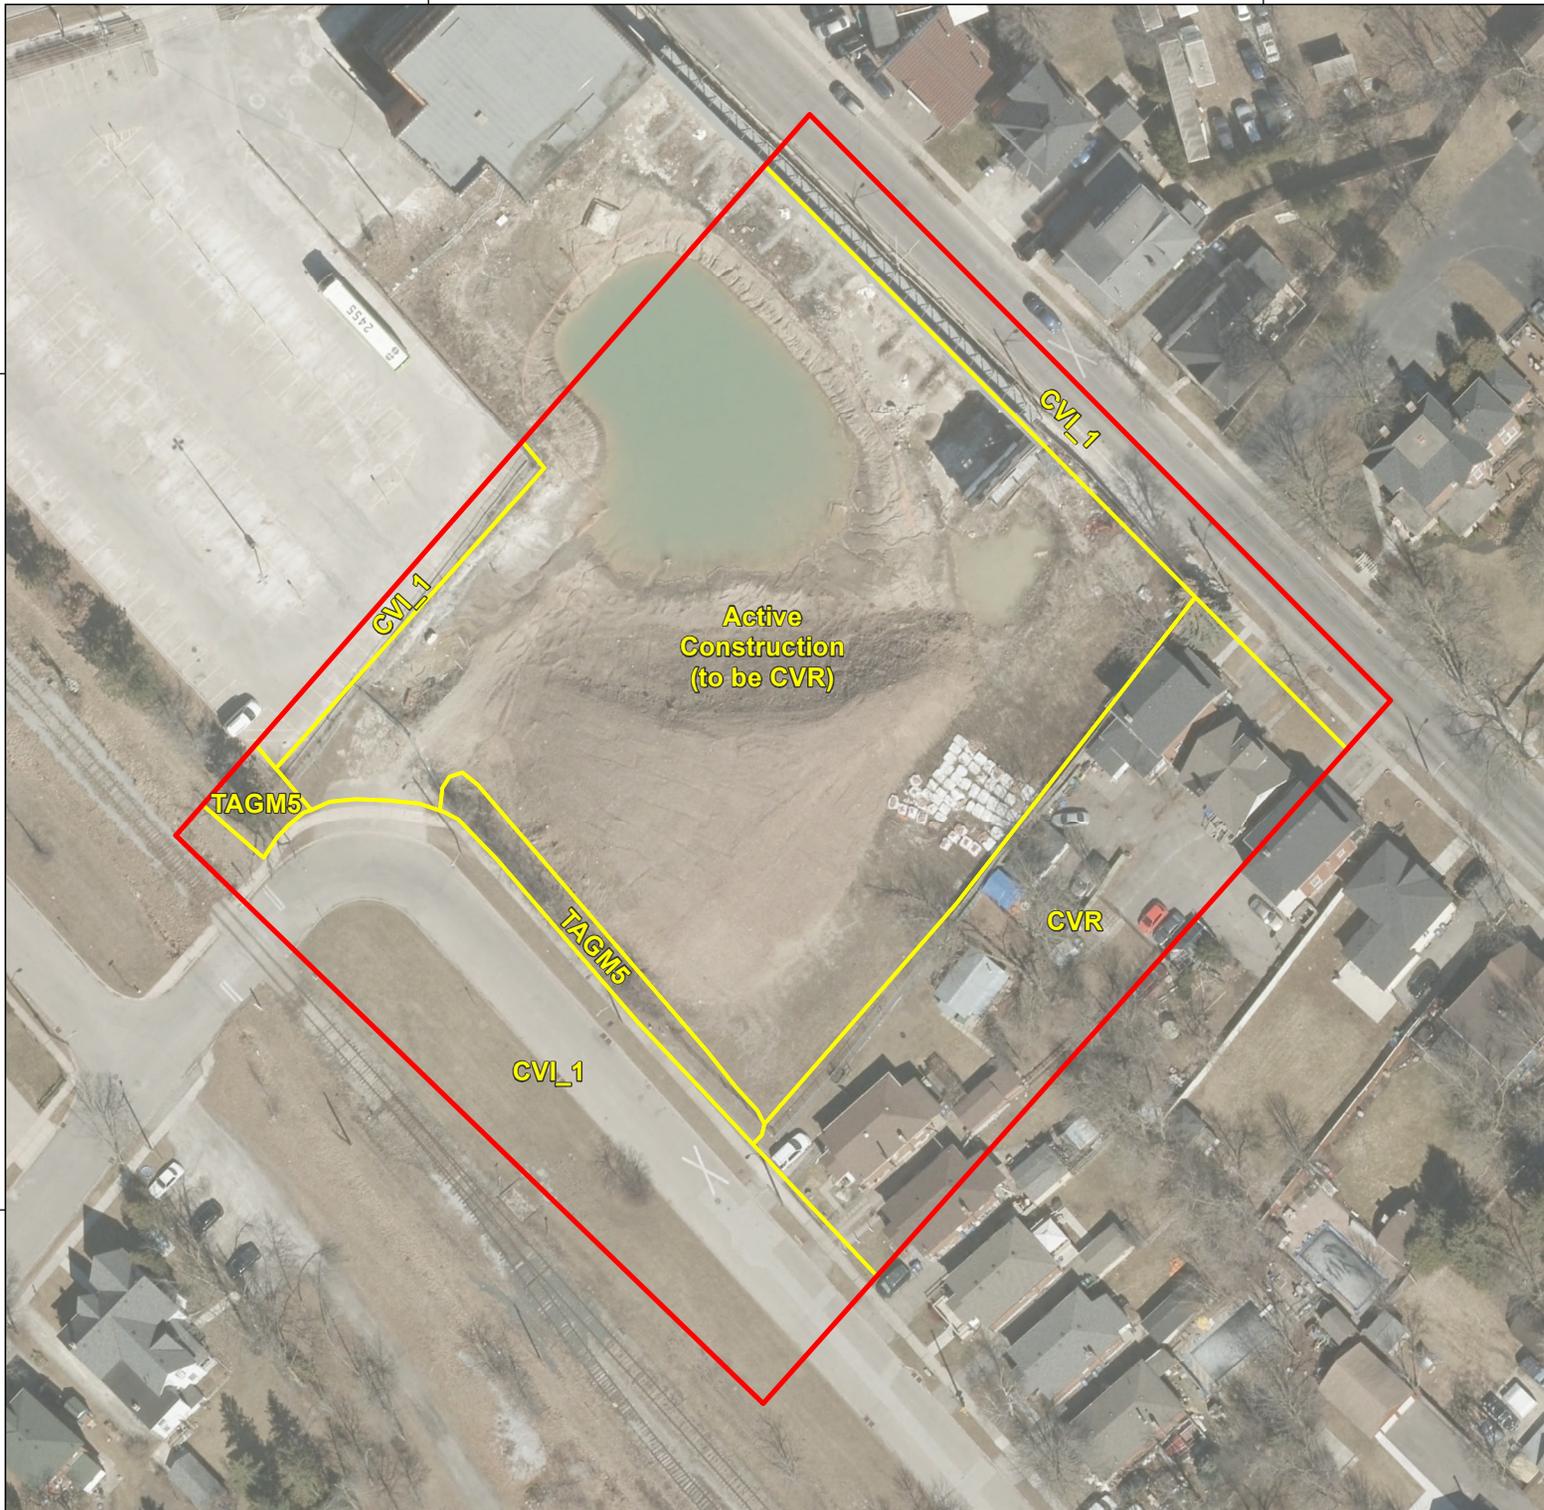
Figure 2

ELC Communities
 CVL_1: Transportation
 CVR: Residential
 TAGM5: Fencerow

TITLE: **Existing Environmental Conditions**

ELC Community	ELC Community Description
CVI_1: Transportation	These lands are associated with municipal roadways, railway line and associated constructed sidewalks and boulevards (Photo 2). Boulevard areas support mainly mowed lawn with occasional planted trees. This classification also includes a portion of an existing parking lot currently used by GO Transit users, located immediately northwest of the study area.
CVR: Residential	Detached residential homes with typical landscaped gardens, manicured lawn and scattered planted trees (Photo 3). As per the tree inventory, tree species mainly include Manitoba Maple (<i>Acer negundo</i>).

TAGM5 - Fencerow	Planted fencerows exist within two locations within the study area: along the eastern side of Park Street (Photo 4) and extending north out of the study area along the western boundary of the existing GO Transit parking lot.
------------------	---

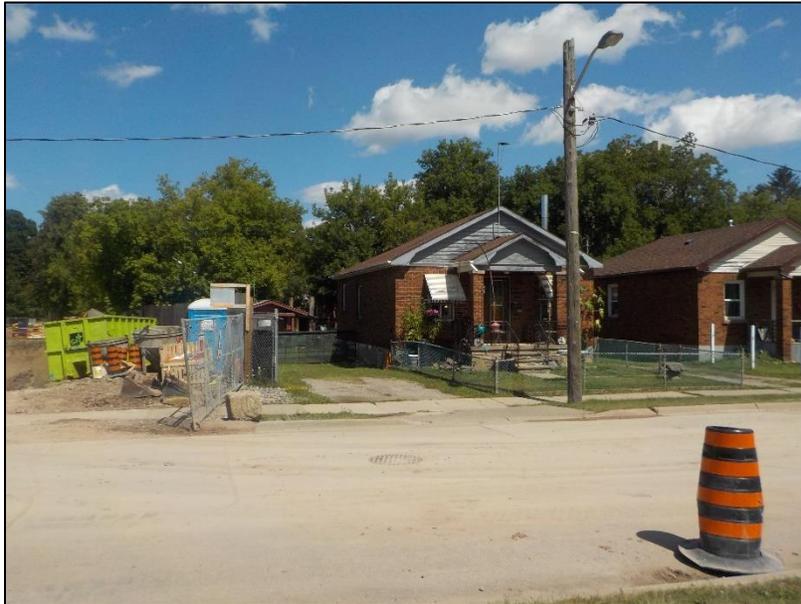
Photo 3. View of residential lands comprising the southern portion of the study area.

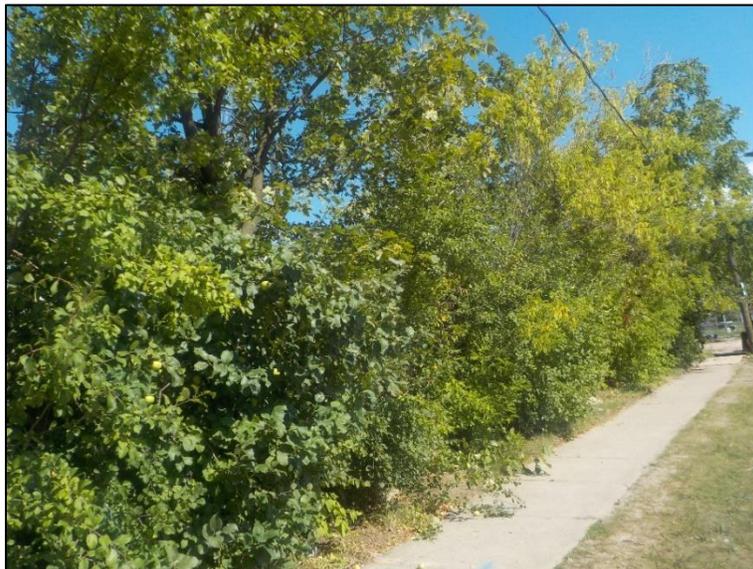
Photo 4. General southern view along treed fencerow on east side of Park Street.

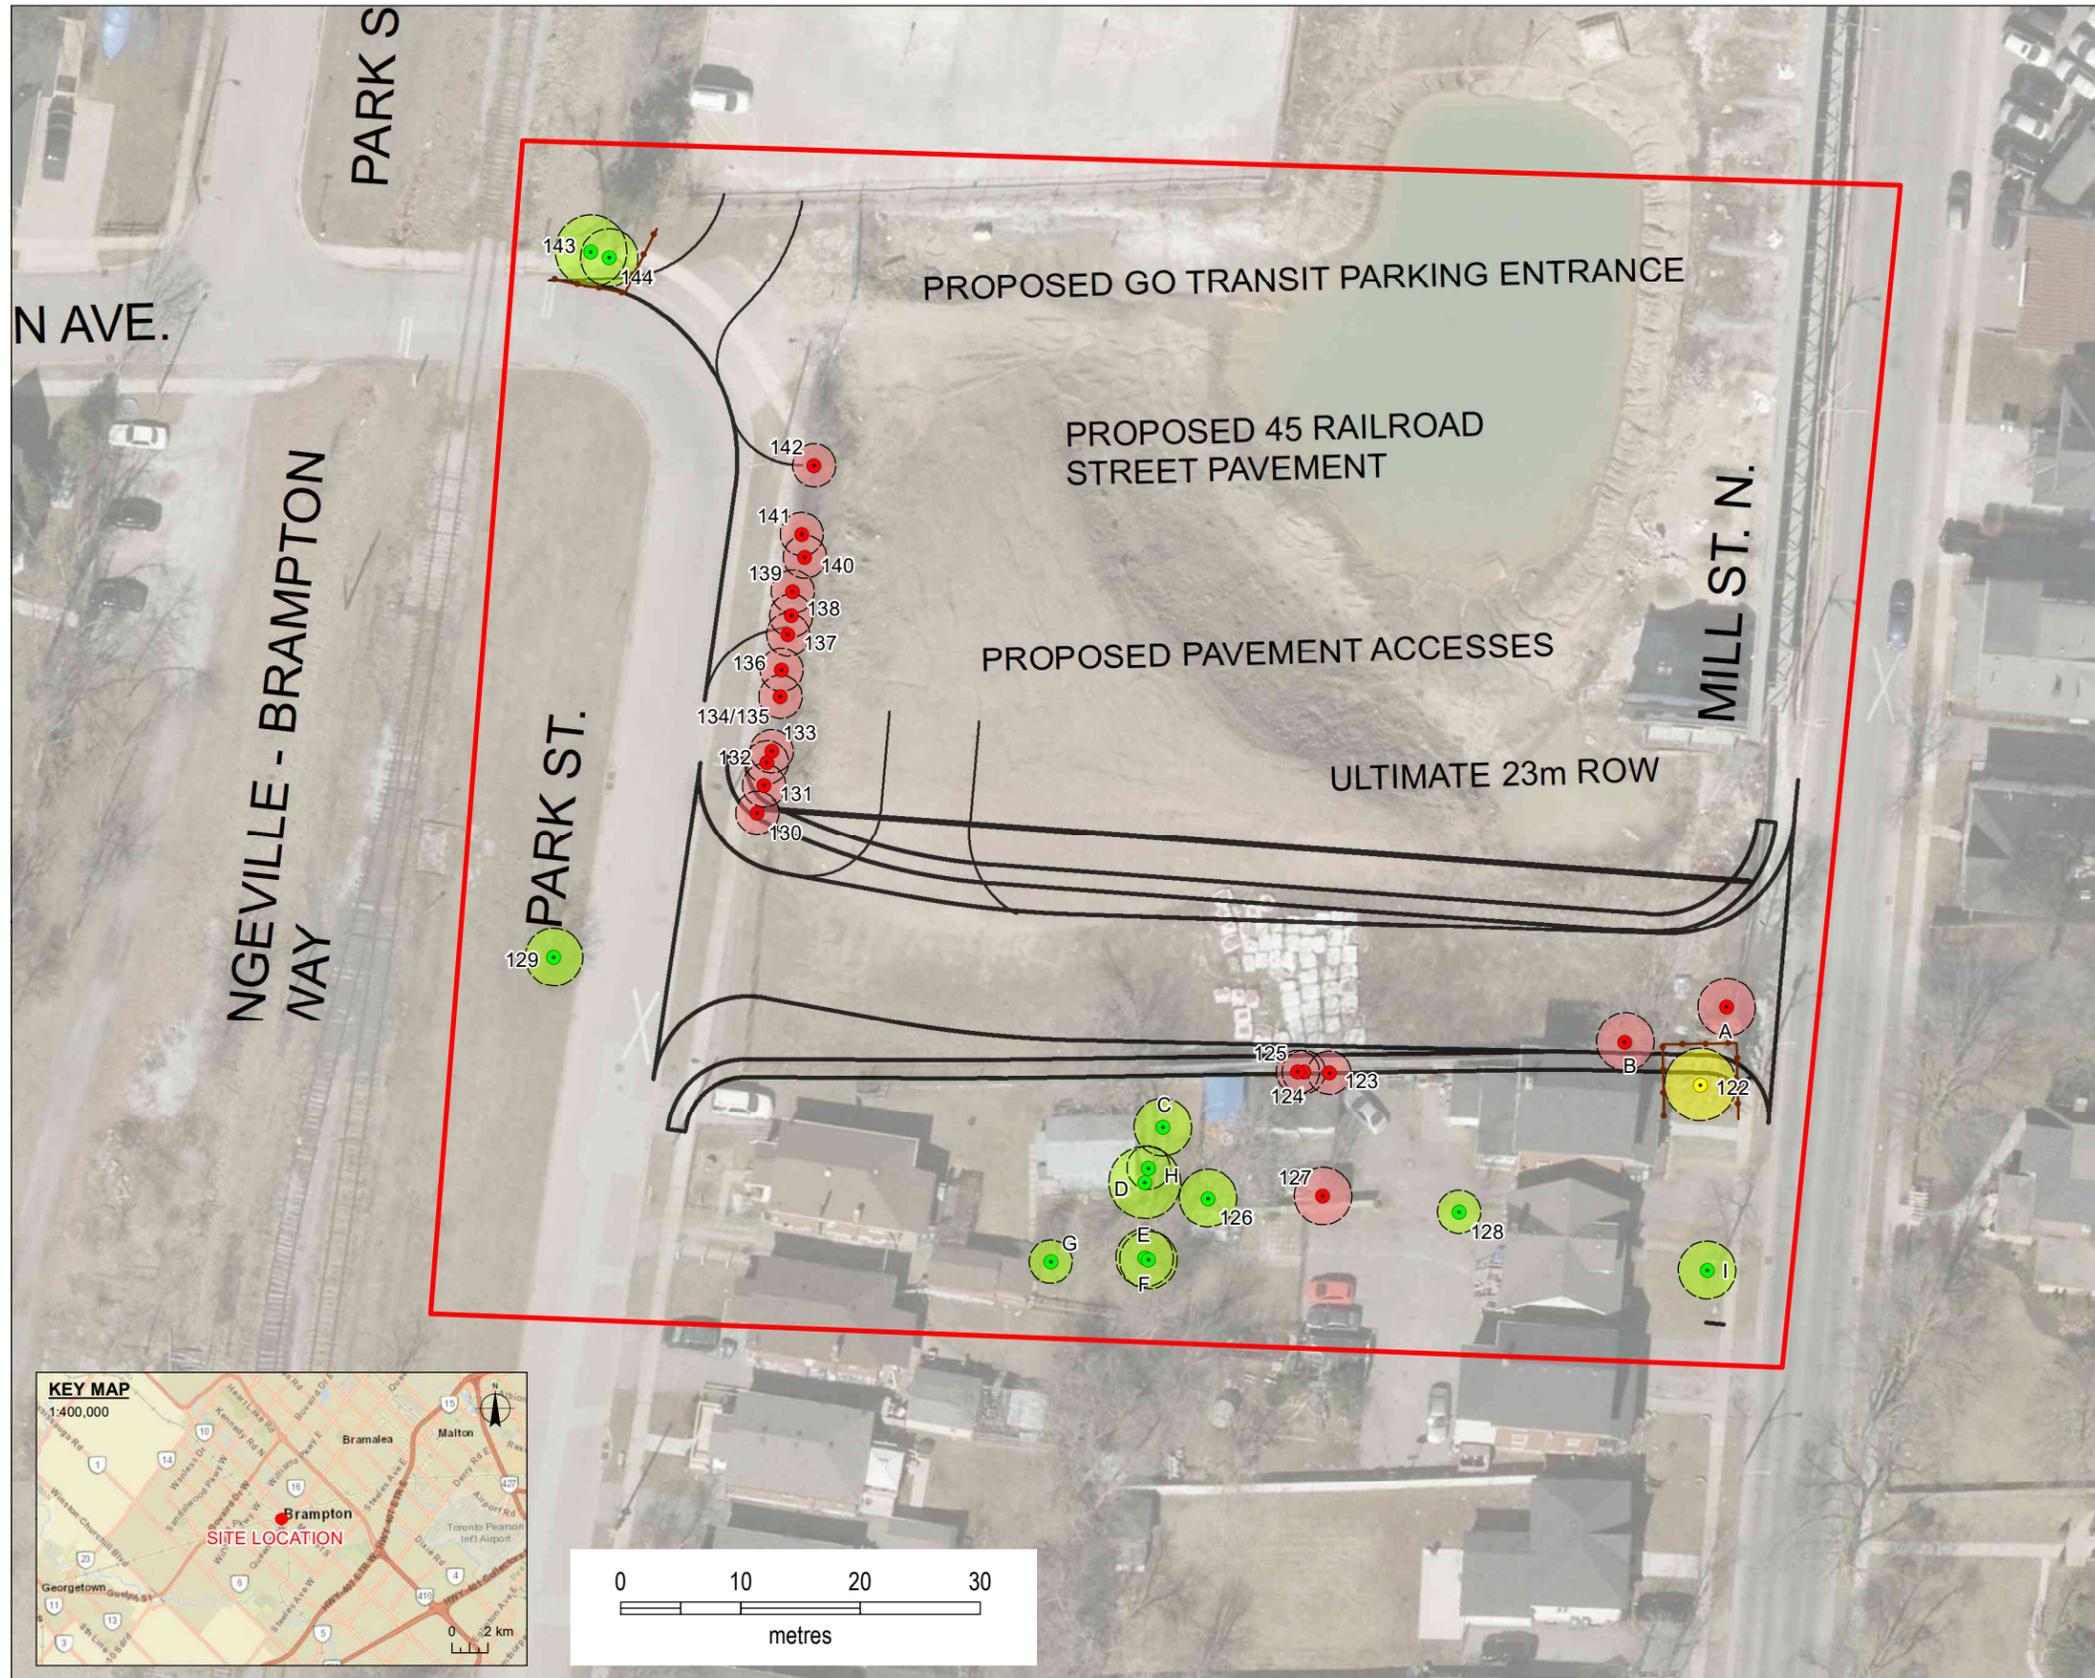
CLIENT: Associated Engineering
	PROJECT: Denison Ave Arborist Report
	Fig. 3 - Tree Preservation Plan

- ALL EXISTING TREES, THAT ARE DESIGNATED TO REMAIN, MUST BE FULLY PROTECTED WITH SOLID WOOD HOARDING OR TREE PROTECTION FENCING IN ACCORDANCE WITH CITY OF BRAMPTON DETAIL L110, WHICH IS TO BE ERECTED BEYOND THE DRIP LINE AND/OR CRITICAL ROOT ZONE (CRZ), WHICHEVER IS GREATER. THE CONSULTING LANDSCAPE ARCHITECT OR ARBORIST IS TO PROVIDE WRITTEN CONFIRMATION TO THE CITY OF BRAMPTON STATING THAT ALL TREE PRESERVATION MEASURES HAVE BEEN PERFORMED PRIOR TO THE ISSUANCE OF A TOPSOIL STRIPPING AND GRADING PERMIT. TREE PRESERVATION MEASURES MUST BE REVIEWED AND VERIFIED ON-SITE ACCORDING TO DETAIL L110 CITY OF BRAMPTON, BY PLANNING AND INFRASTRUCTURE SERVICES.
- TREE PROTECTION ZONES ARE TO INCLUDE SIGNS (AS PER BELOW) AT REGULAR INTERVALS ON THE FENCING. THE SIGNS ARE TO BE 40 CM X 60 CM AND MADE OF WHITE CORRUGATED PLASTIC BOARD OR EQUIVALENT MATERIAL.

ALL CONSTRUCTION RELATED ACTIVITIES, INCLUDING GRADE ALTERATION, EXCAVATION, SOIL COMPACTION, ANY MATERIALS OR EQUIPMENT STORAGE, DISPOSAL OF LIQUID AND VEHICULAR TRAFFIC ARE NOT PERMITTED WITHIN THIS TPZ.

The tree inventory comprised 32 individual trees, including 19 (59%) native and 13 (41%) non-native species (**Table 2**). All are trees commonly planted in southern Ontario landscapes. The most common species was Manitoba Maple, with 17 trees (53%) inventoried. There were no Species at Risk (SAR) trees observed, such as Butternut (*Juglans cinerea*). A single White Ash (*Fraxinus americana*) was recorded that demonstrated signs of extensive infestation by Emerald Ash Borer (*Agrilus planipennis*). The full tree inventory is provided in **Attachment A**. The locations of inventoried trees are shown on **Figure 3**.

It should be noted that a total of 13 individuals (Tree #130 to 142) are located along an existing chain-link fence comprising a fencerow community (**Figure 3**). Although about 46% (6 total) of the fencerow trees

A total of 13 trees are proposed to be retained (**Table 4**). Approximately 54% (7 total) of the inventoried trees to be retained are native species (Manitoba Maple). The remaining 46% (6 total) are comprised of planted non-native landscape species. Most of the trees proposed to be retained are in good to fair health (69%). Most of the trees to be retained are located within hedgerows located within private residential properties (**Figure 3**).

In general, tree protection fencing should be placed at a distance that is beyond the dripline for trees #122 and 144, or at the limit of road construction. Due to the good health condition of these trees, it is felt that they would be healthy enough and have an adequate rooting radius to tolerate slight impingement into its CRPZ. Although identified as in poor condition, due to the close proximity of Tree #143 to #144, fencing will consequently encompass this individual as well.

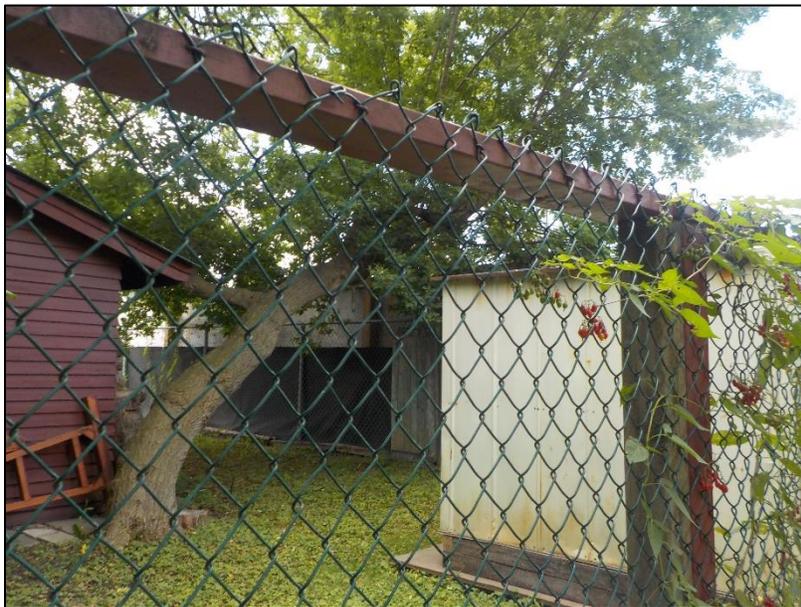
Photo 5. Tree #C, showing significant westerly lean into proposed development footprint.

In addition, Trees #C (**Photo 5**) and D were identified as having growth forms with significant westerly leans into vicinity of the proposed road alignment. Should pruning of their branches be required to accommodate the proposed development, then such work is to also be completed by a qualified arborist and performed in accordance to good arboricultural practices.

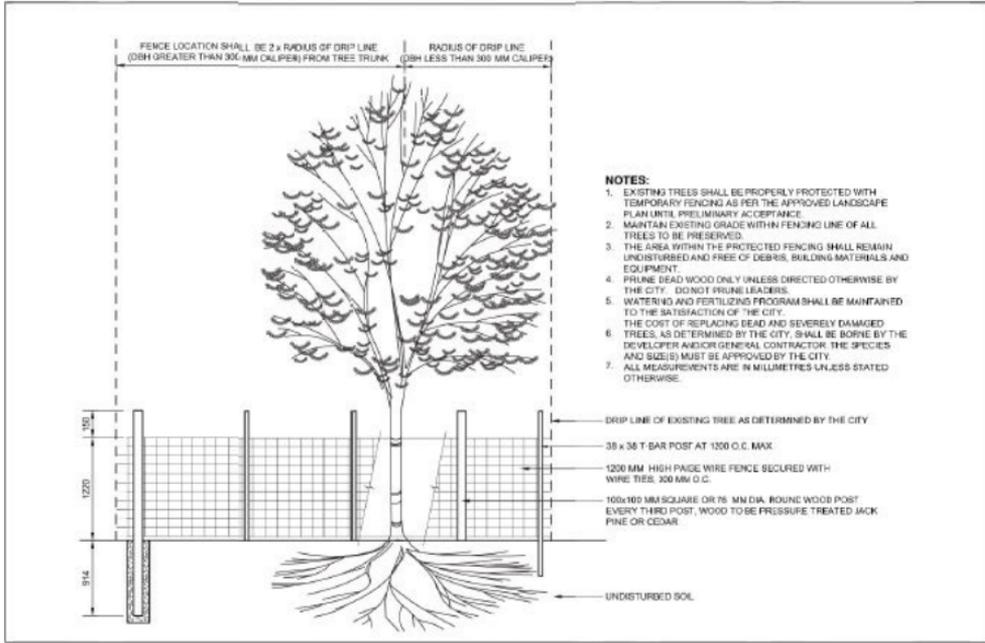
**City of Brampton Engineering
Standard L110**

1. EXISTING TREES SHALL BE PROPERLY PROTECTED WITH TEMPORARY FENCING AS PER THE APPROVED LANDSCAPE PLAN UNTIL PRELIMINARY ACCEPTANCE.
2. MAINTAIN EXISTING GRADE WITHIN FENCING LINE OF ALL TREES TO BE PRESERVED.
3. THE AREA WITHIN THE PROTECTED FENCING SHALL REMAIN UNDISTURBED AND FREE OF DEBRIS, BUILDING MATERIALS AND EQUIPMENT.
4. PRUNE DEAD WOOD ONLY UNLESS DIRECTED OTHERWISE BY THE CITY. DO NOT PRUNE LEADERS.
5. WATERING AND FERTILIZING PROGRAM SHALL BE MAINTAINED TO THE SATISFACTION OF THE CITY.
6. THE COST OF REPLACING DEAD AND SEVERELY DAMAGED TREES, AS DETERMINED BY THE CITY, SHALL BE BORNE BY THE DEVELOPER AND/OR GENERAL CONTRACTOR. THE SPECIES AND SIZE(S) MUST BE APPROVED BY THE CITY.
7. ALL MEASUREMENTS ARE IN MILLIMETRES UNLESS STATED OTHERWISE.
