HYDROGEOLOGICAL
INVESTIGATION
REPORT

CITY OF BRAMPTON

LAGERFELD DRIVE CLASS
ENVIRONMENTAL ASSESSMENT
HYDROGEOLOGICAL INVESTIGATION

PROJECT NO.: 141-15409-00
DATE: OCTOBER 18, 2018

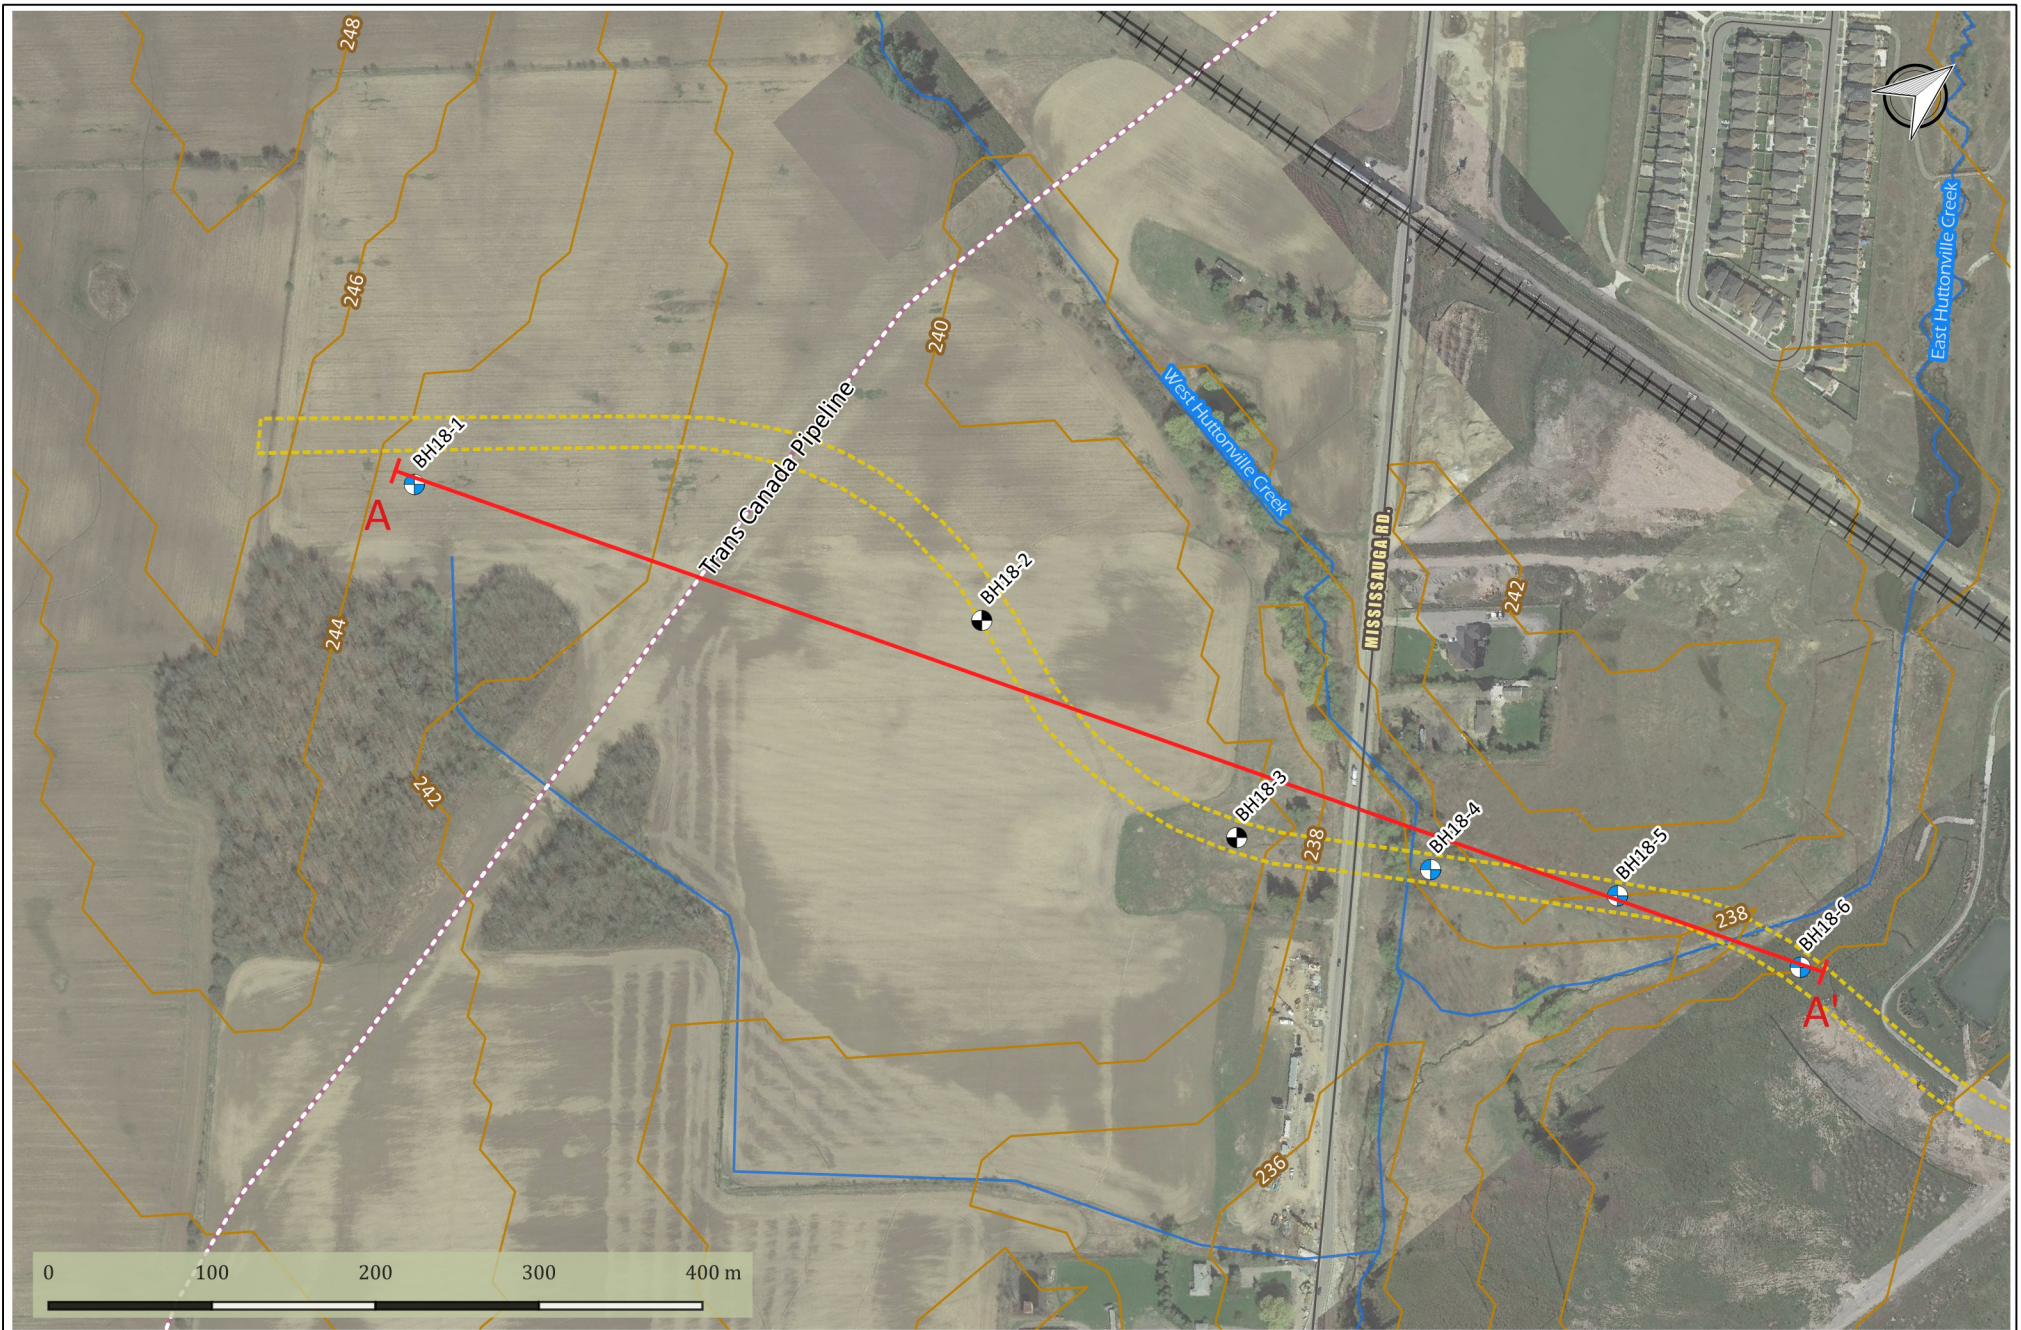
TITLE: MONITORING AND BOREHOLE LOCATION MAP
DISCIPLINE: HYDROGEOLOGY

LEGEND	— Contour (2 m)
Road Alignment	A - A' Cross-Section
Boreholes	
Borehole (WSP, 2018)	
Monitoring Well (WSP, 2018)

WSP conducted a geotechnical investigation at the Site in April 2018 to report on the subsurface conditions for the proposed roadwork. The field investigation consisted of the advancement of six (6) boreholes (BH18-01 to BH18-06) to depths that ranged from 3.2 m to 5.2 meters below ground surface (m BGS). Four of the boreholes were subsequently completed as monitoring wells (BH18-01, BH18-04, BH18-05 and BH18-06). The location of the boreholes and monitoring wells is presented on **Figure 4**.

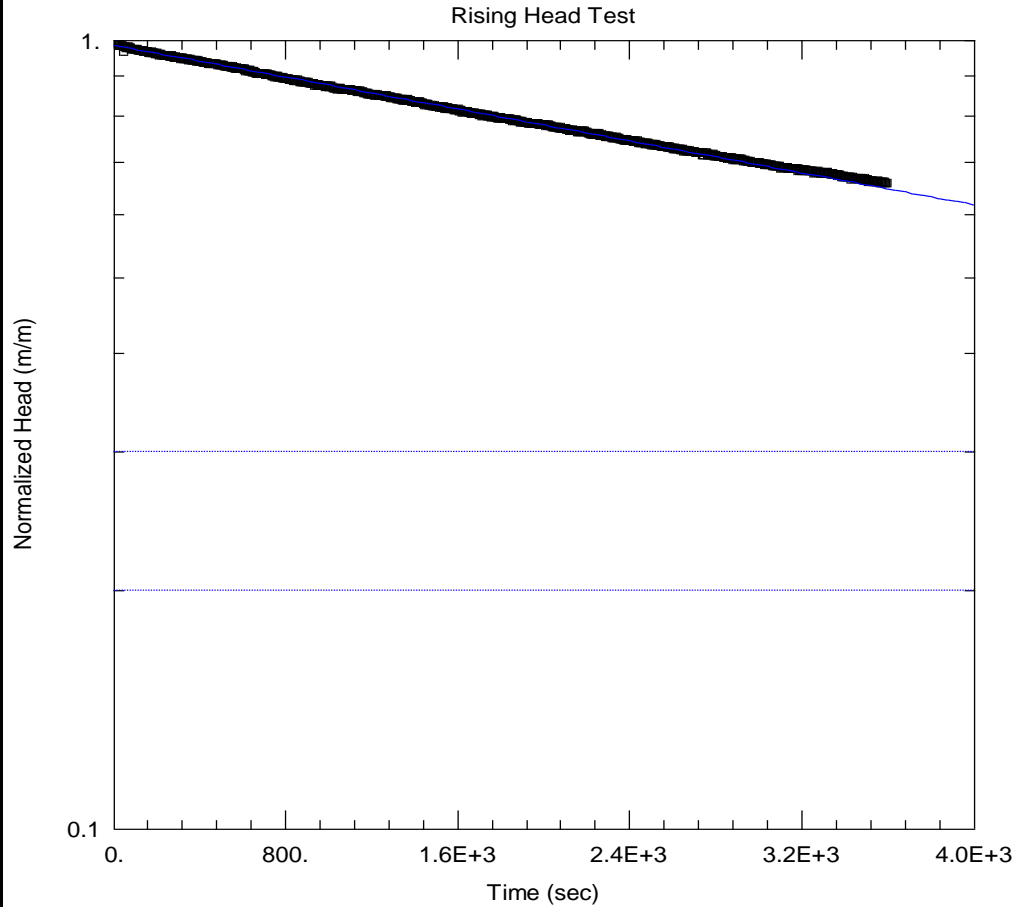
Obs. Wells
 □ BH18-01
 Aquifer Model
 Confined
 Solution
 Bouwer-Rice
 Parameters
 K = 8.925E-8 m/sec
 y0 = 0.4434 m

Screen Length (m)	1.5
Hole Radius (mm)	75
Well Radius (mm)	26
Static Water Level (mbgs)	1.1
Ground Elevation (masl)	
Well Depth (mbgs)	4.8
Top of Pipe (m)	1.2
Well Diameter (mm)	51.0
Well Elevation (masl)	
Solution Method:	Bouwer-Rice
Well ID	Hydraulic Conductivity
	m/s m/d cm/sec
BH18-01	8.93E-08 7.71E-03 8.93E-06
Material Screened	Silt till

During the SWRT, a slug of water was near-instantaneously removed from the well and the response to the water level was recorded. The hydraulic conductivity values for each of the tested wells were calculated from the SWRT data using Aqtesolv Software and the Bouwer-Rice solutions for unconfined conditions (Bouwer, 1976). The semi-log plots for normalized drawdown versus time are included in **Appendix C**. The summary of the hydraulic conductivity (K) values estimated from the SWRT are provided in **Table 4-3**.

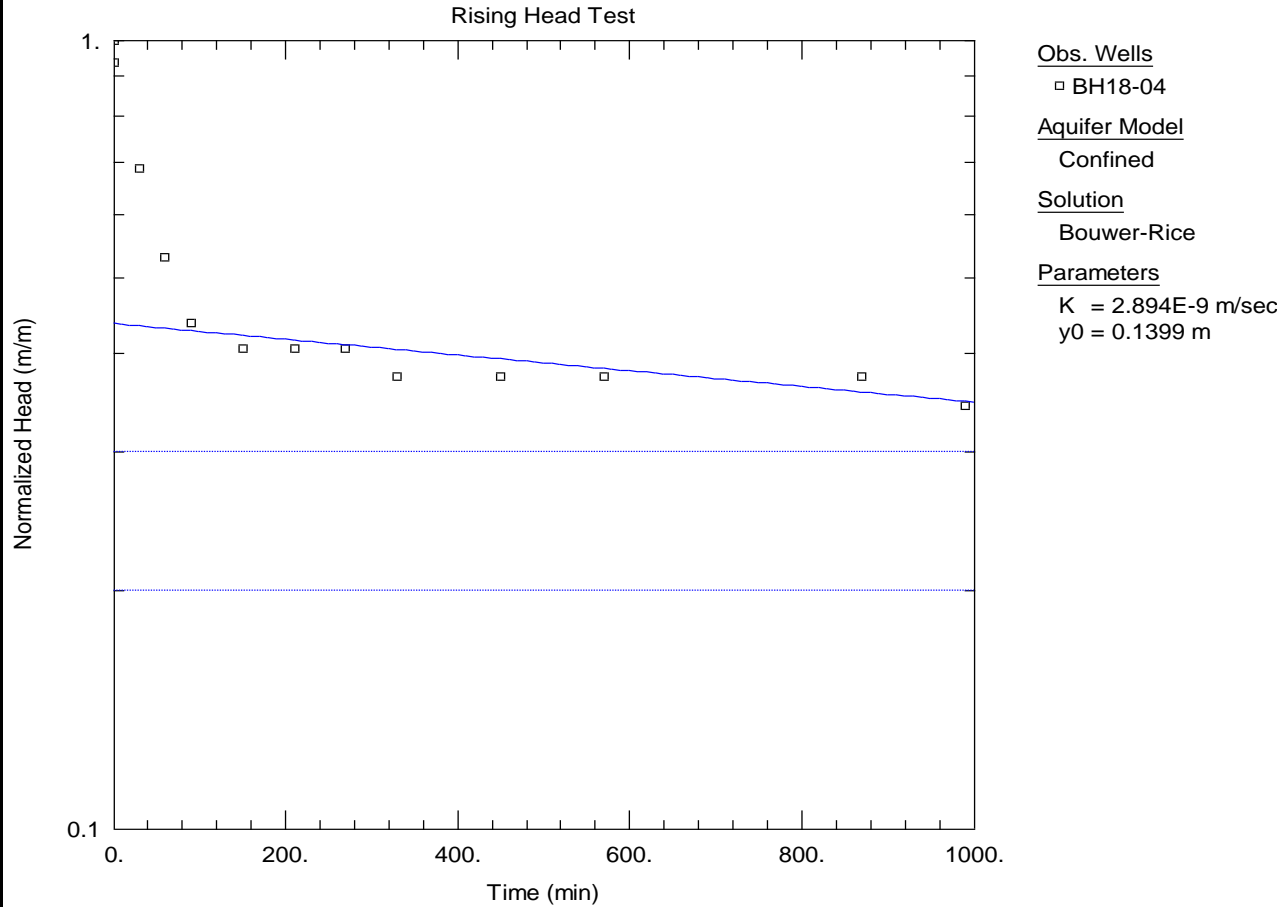
FIGURE C-2

Screen Length (m)	1.5
Hole Radius (mm)	75
Well Radius (mm)	26
Static Water Level (mbgs)	2.6
Ground Elevation (masl)	
Well Depth (mbgs)	3.1
Top of Pipe (m)	1.1
Well Diameter (mm)	51.0
Well Elevation (masl)	
Solution Method:	Bouwer-Rice
Well ID	Hydraulic Conductivity
	m/s m/d cm/sec
BH18-04	2.89E-09 2.50E-04 2.89E-07
Material Screened	Silt till
