Hydrogeological Study

Hydrogeological Study – Proposed Johnston Transit Facility

10192 Highway 50, Brampton, Ontario

Final – November 23, 2020

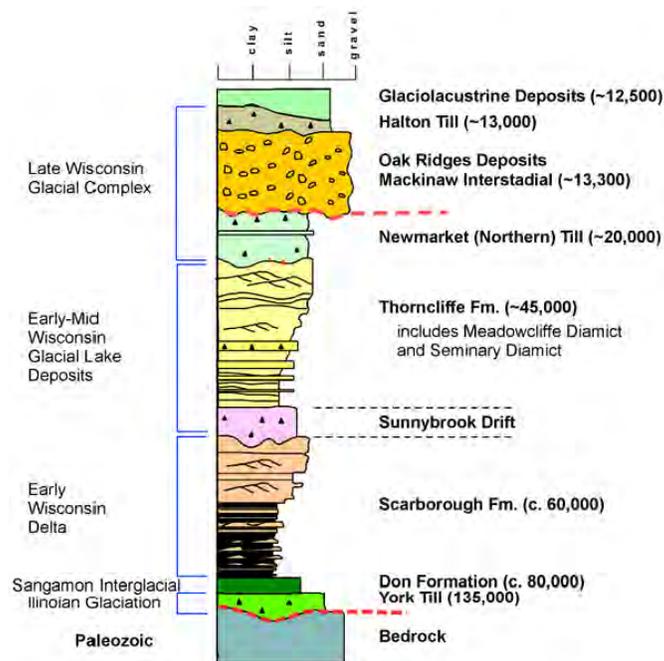
Figure 5: Quaternary Deposits within the Study Area (Eyles, 2002)

Quaternary sediments within the Humber River watershed consist of glacial and interglacial deposits (Eyles, 2002 and Karrow, 1989). **Figure 5** summarizes the Quaternary sediments generally found within the Humber River Watershed.

The uppermost surficial geologic unit consists of a sequence of glaciolacustrine deposits that form a veneer over the underlying Halton and Newmarket tills. These deposits vary from near shore sands and gravel beach deposits of the Lake Iroquois shoreline located within the southern part of the watershed, to the fine sands, silts and clays of glaciolacustrine deposits (ponding) that occur north of the Lake Iroquois shoreline. These sediments generally form a thin veneer over the underlying deposits, although locally they can be several meters thick.

The Halton Till deposit is typically 3 to 6 m thick, but locally its thickness can be as much as 40 meters. The Halton till generally comprises sandy silt to clayey silt, interbedded with silt, clay, sand and gravel. In some areas it is very clay-rich where the Halton ice has overridden glaciolacustrine deposits. The Halton Till is believed to form the surficial till unit extending southward to the Lake Iroquois shoreline. On the southern flanks of the Oak Ridges Moraine, the Halton Till overrides the granular Oak Ridges Moraine deposits.

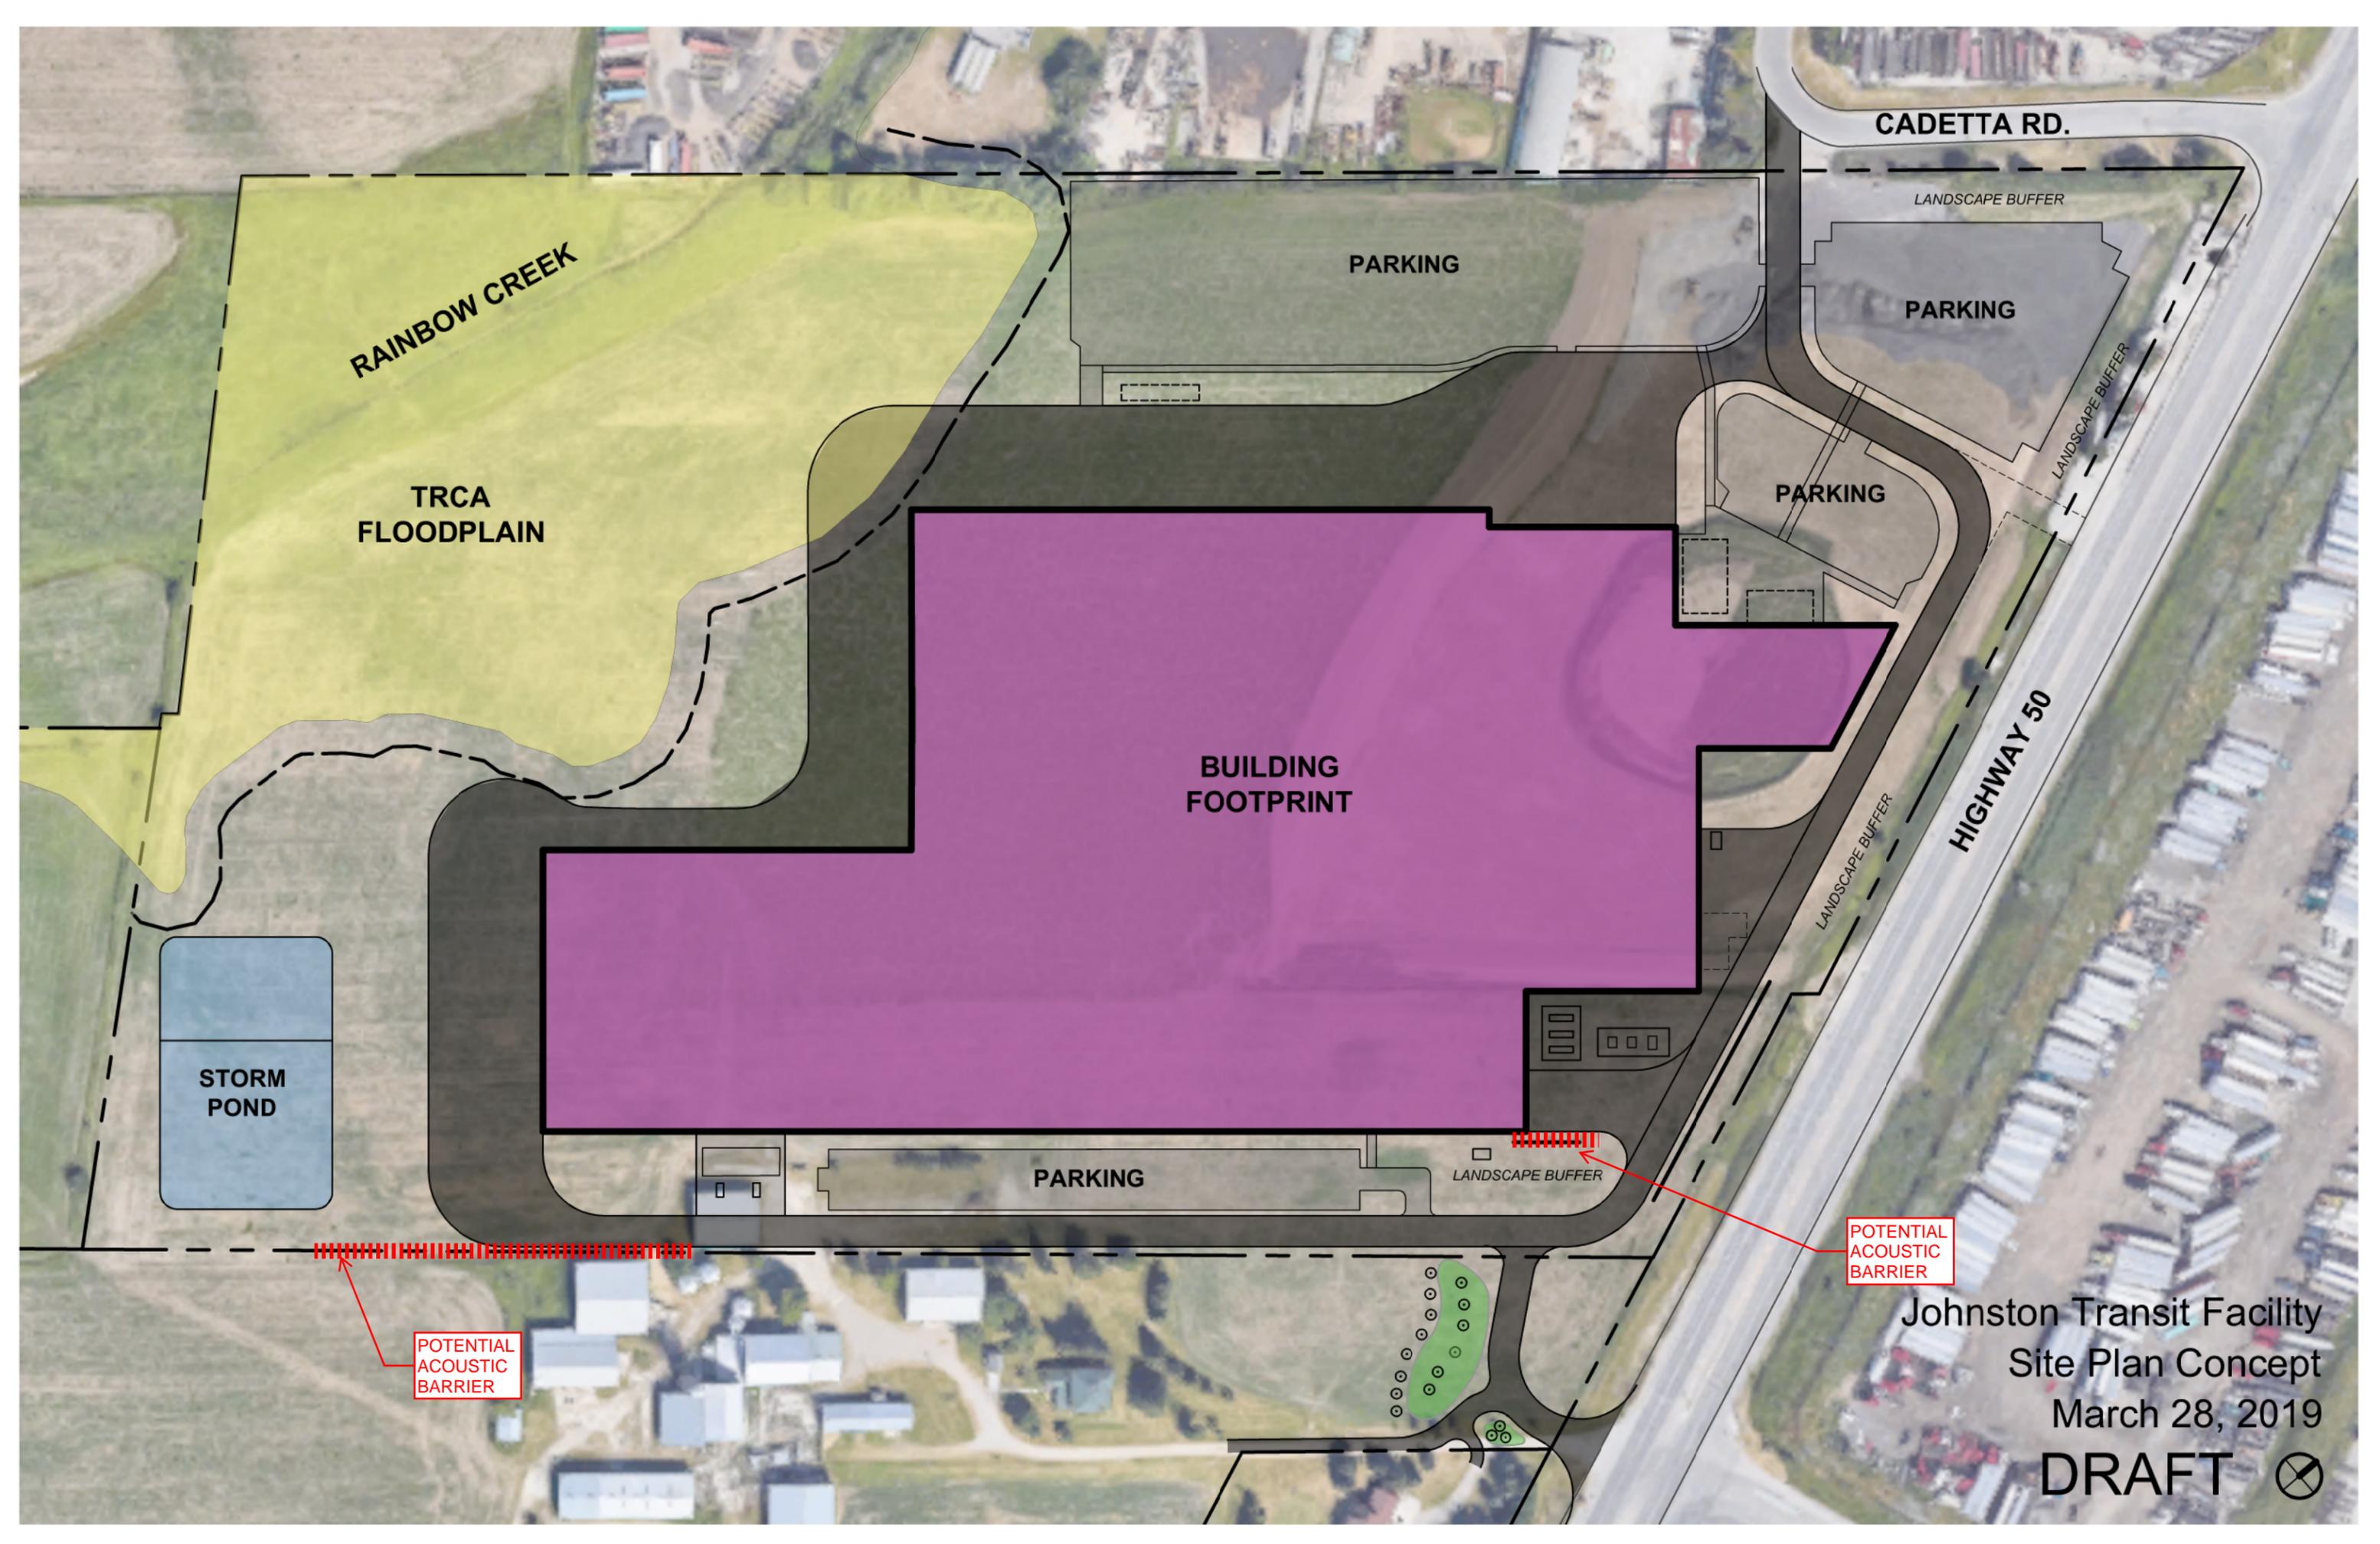
Johnston Transit Facility
Site Plan Concept
March 28, 2019

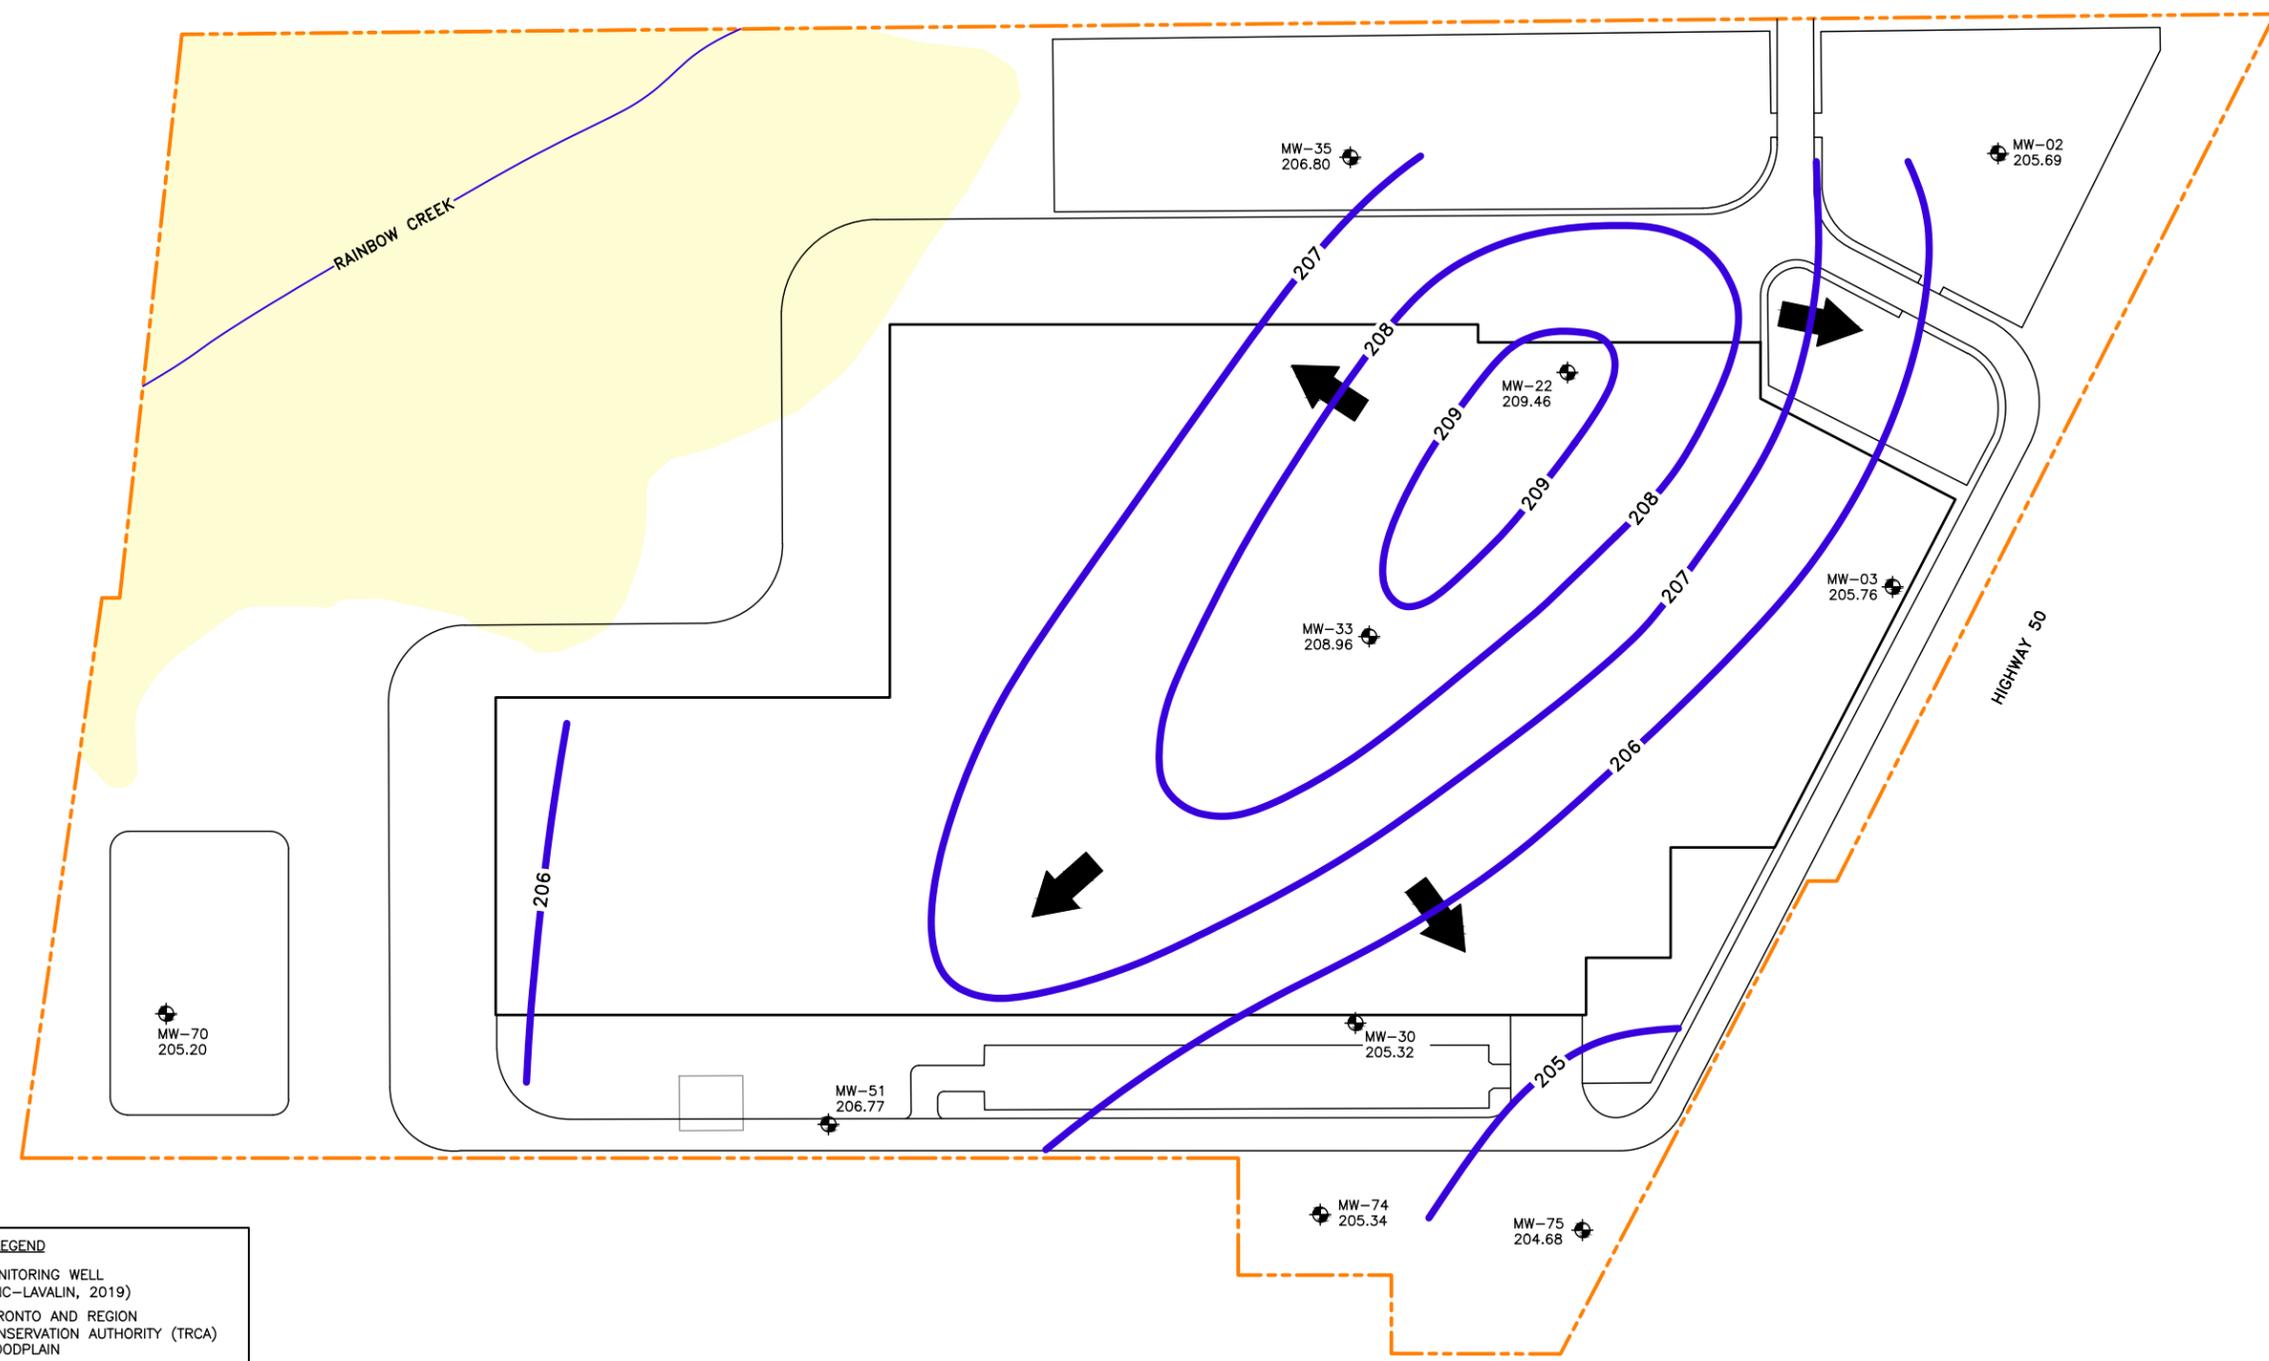
MONITORING WELL (SNC-LAVALIN, 2019)
	TORONTO AND REGION CONSERVATION AUTHORITY (TRCA) FLOODPLAIN
	SITE PROPERTY LINE
	EXISTING BUILDING
	PROPOSED BUILDING
	PROPOSED INFRASTRUCTURE
	INTERPRETED WATER LEVEL ELEVATION CONTOUR (m)
	WATER LEVEL ELEVATION (m) (OCTOBER 21, 2019)
	INTERPRETED SHALLOW HORIZONTAL GROUNDWATER FLOW DIRECTION

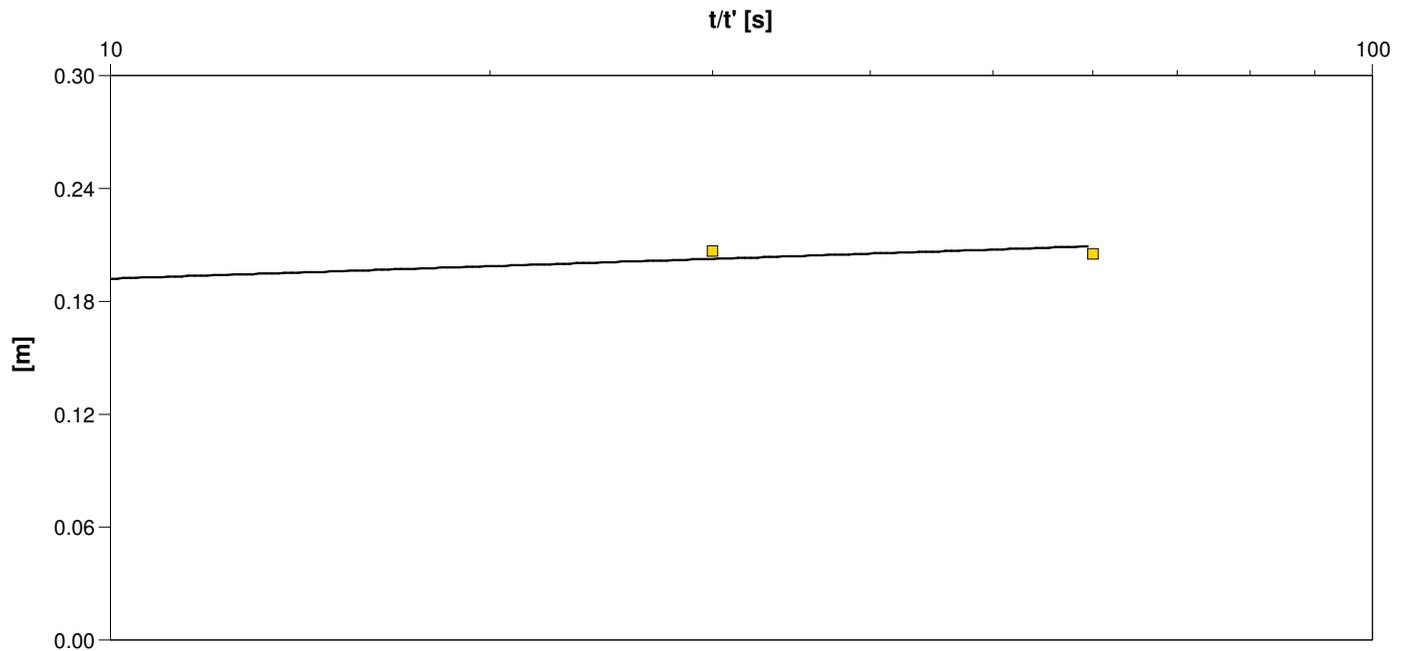
Location: 10192 Hwy 50, Brampton, ON	Pumping Test: MW-02B	Pumping Well: MW-02B
Test Conducted by: JP		Test Date: 2019/10/21
Analysis Performed by: WL	MW-02B	Analysis Date: 2019/11/22
Aquifer Thickness: 5.00 m	Discharge Rate: 0.00025 [m ³ /s]

Calculation using Theis with Jacob Correction

Observation Well	Transmissivity [m ² /s]	Hydraulic Conductivity [m/s]	Radial Distance to PW [m]	
MW-02B	2.16×10^{-3}	4.32×10^{-4}	0.03

It should be noted that the K test in MW-02B was conducted using a submersible pump set a discharge rate of 0.25 L/s due to the fast water level recovery. As a result, the pumping test was completed within one minute. The K analysis was completed using the Theis Solution (with Jacob Correction) for pumping test. Considering the short duration of the pumping test, the results are qualified in that it represents order of magnitude as would be expected for sand and gravel k values, however, the results may not fully reflect the actual physical characteristics of the aquifer. To obtain more representative site data at this level/layer (sandy gravel), a full scale pumping test is will be required (i.e., 24 to 72-hour continuous constant rate pumping test).

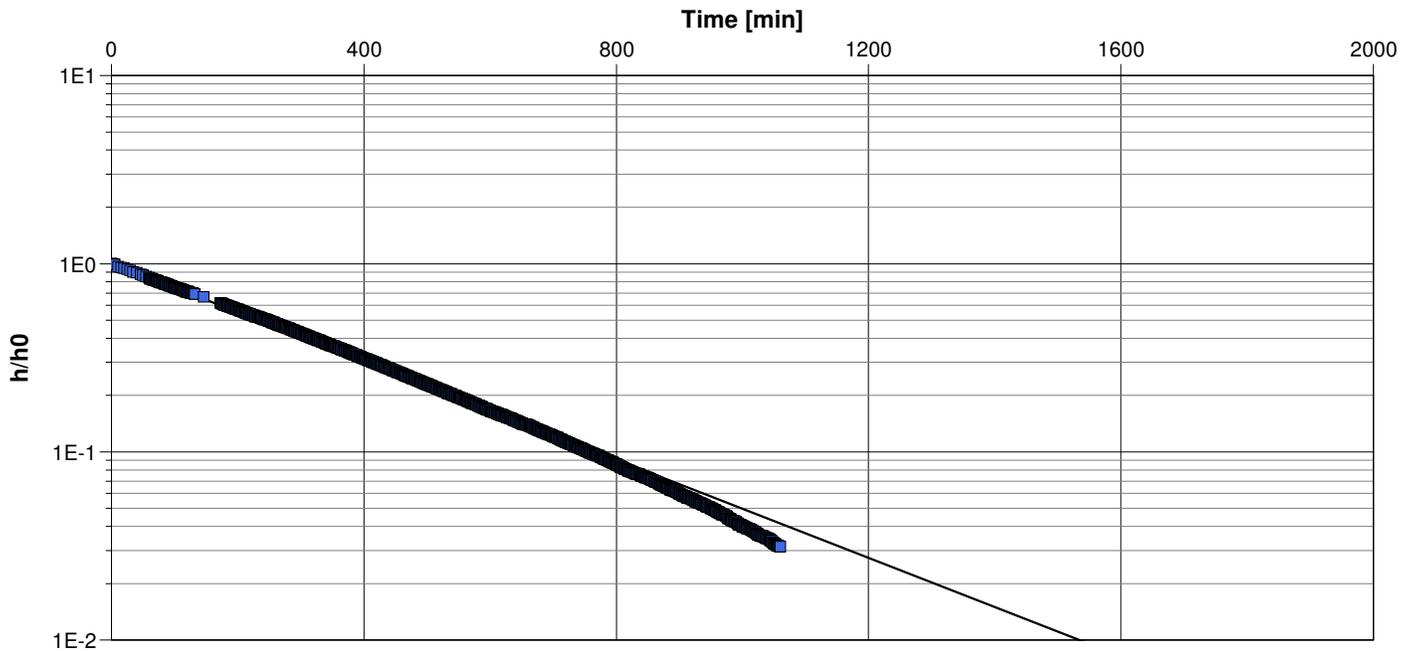
Calculation using Bouwer & Rice

Observation Well	Hydraulic Conductivity [m/s]
MW-03	1.92×10^{-8}

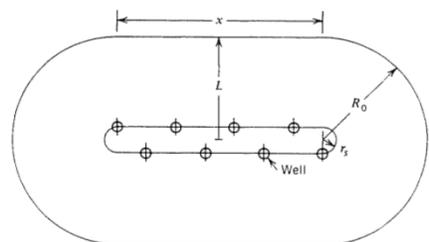
Figure 6.8 Approximate analysis of long narrow systems

Flow to a Drainage Trench from a Line Source			
$Q2 = 2 \cdot (X \cdot K \cdot (H^2 - h_w^2)) / 2L$	m ³ /day	Q2	86.4
	L/day	Q2	86,400

Total Flow to the Trench Excavation (Q1+Q2)	L/day	Q	94,300
Apply a Safety Factor of 2	L/day	Q	188,600
	L/min	Q	131

The results indicate that the typical daily dewatering rate was estimated to be 94,300 L/day, under the assumptions listed in Section 5.1, with no additional variations factored into the assessment. To account for seasonal or short-term groundwater level fluctuations, hydraulic conductivity heterogeneity and/or rain/surface water runoff and infiltration into the excavations, especially during the wet weather conditions, a safety factor of 2 was applied to the typical dewatering rates to provide a maximum daily dewatering rate (the worst case), which would be in the order of 188,600 L/day.

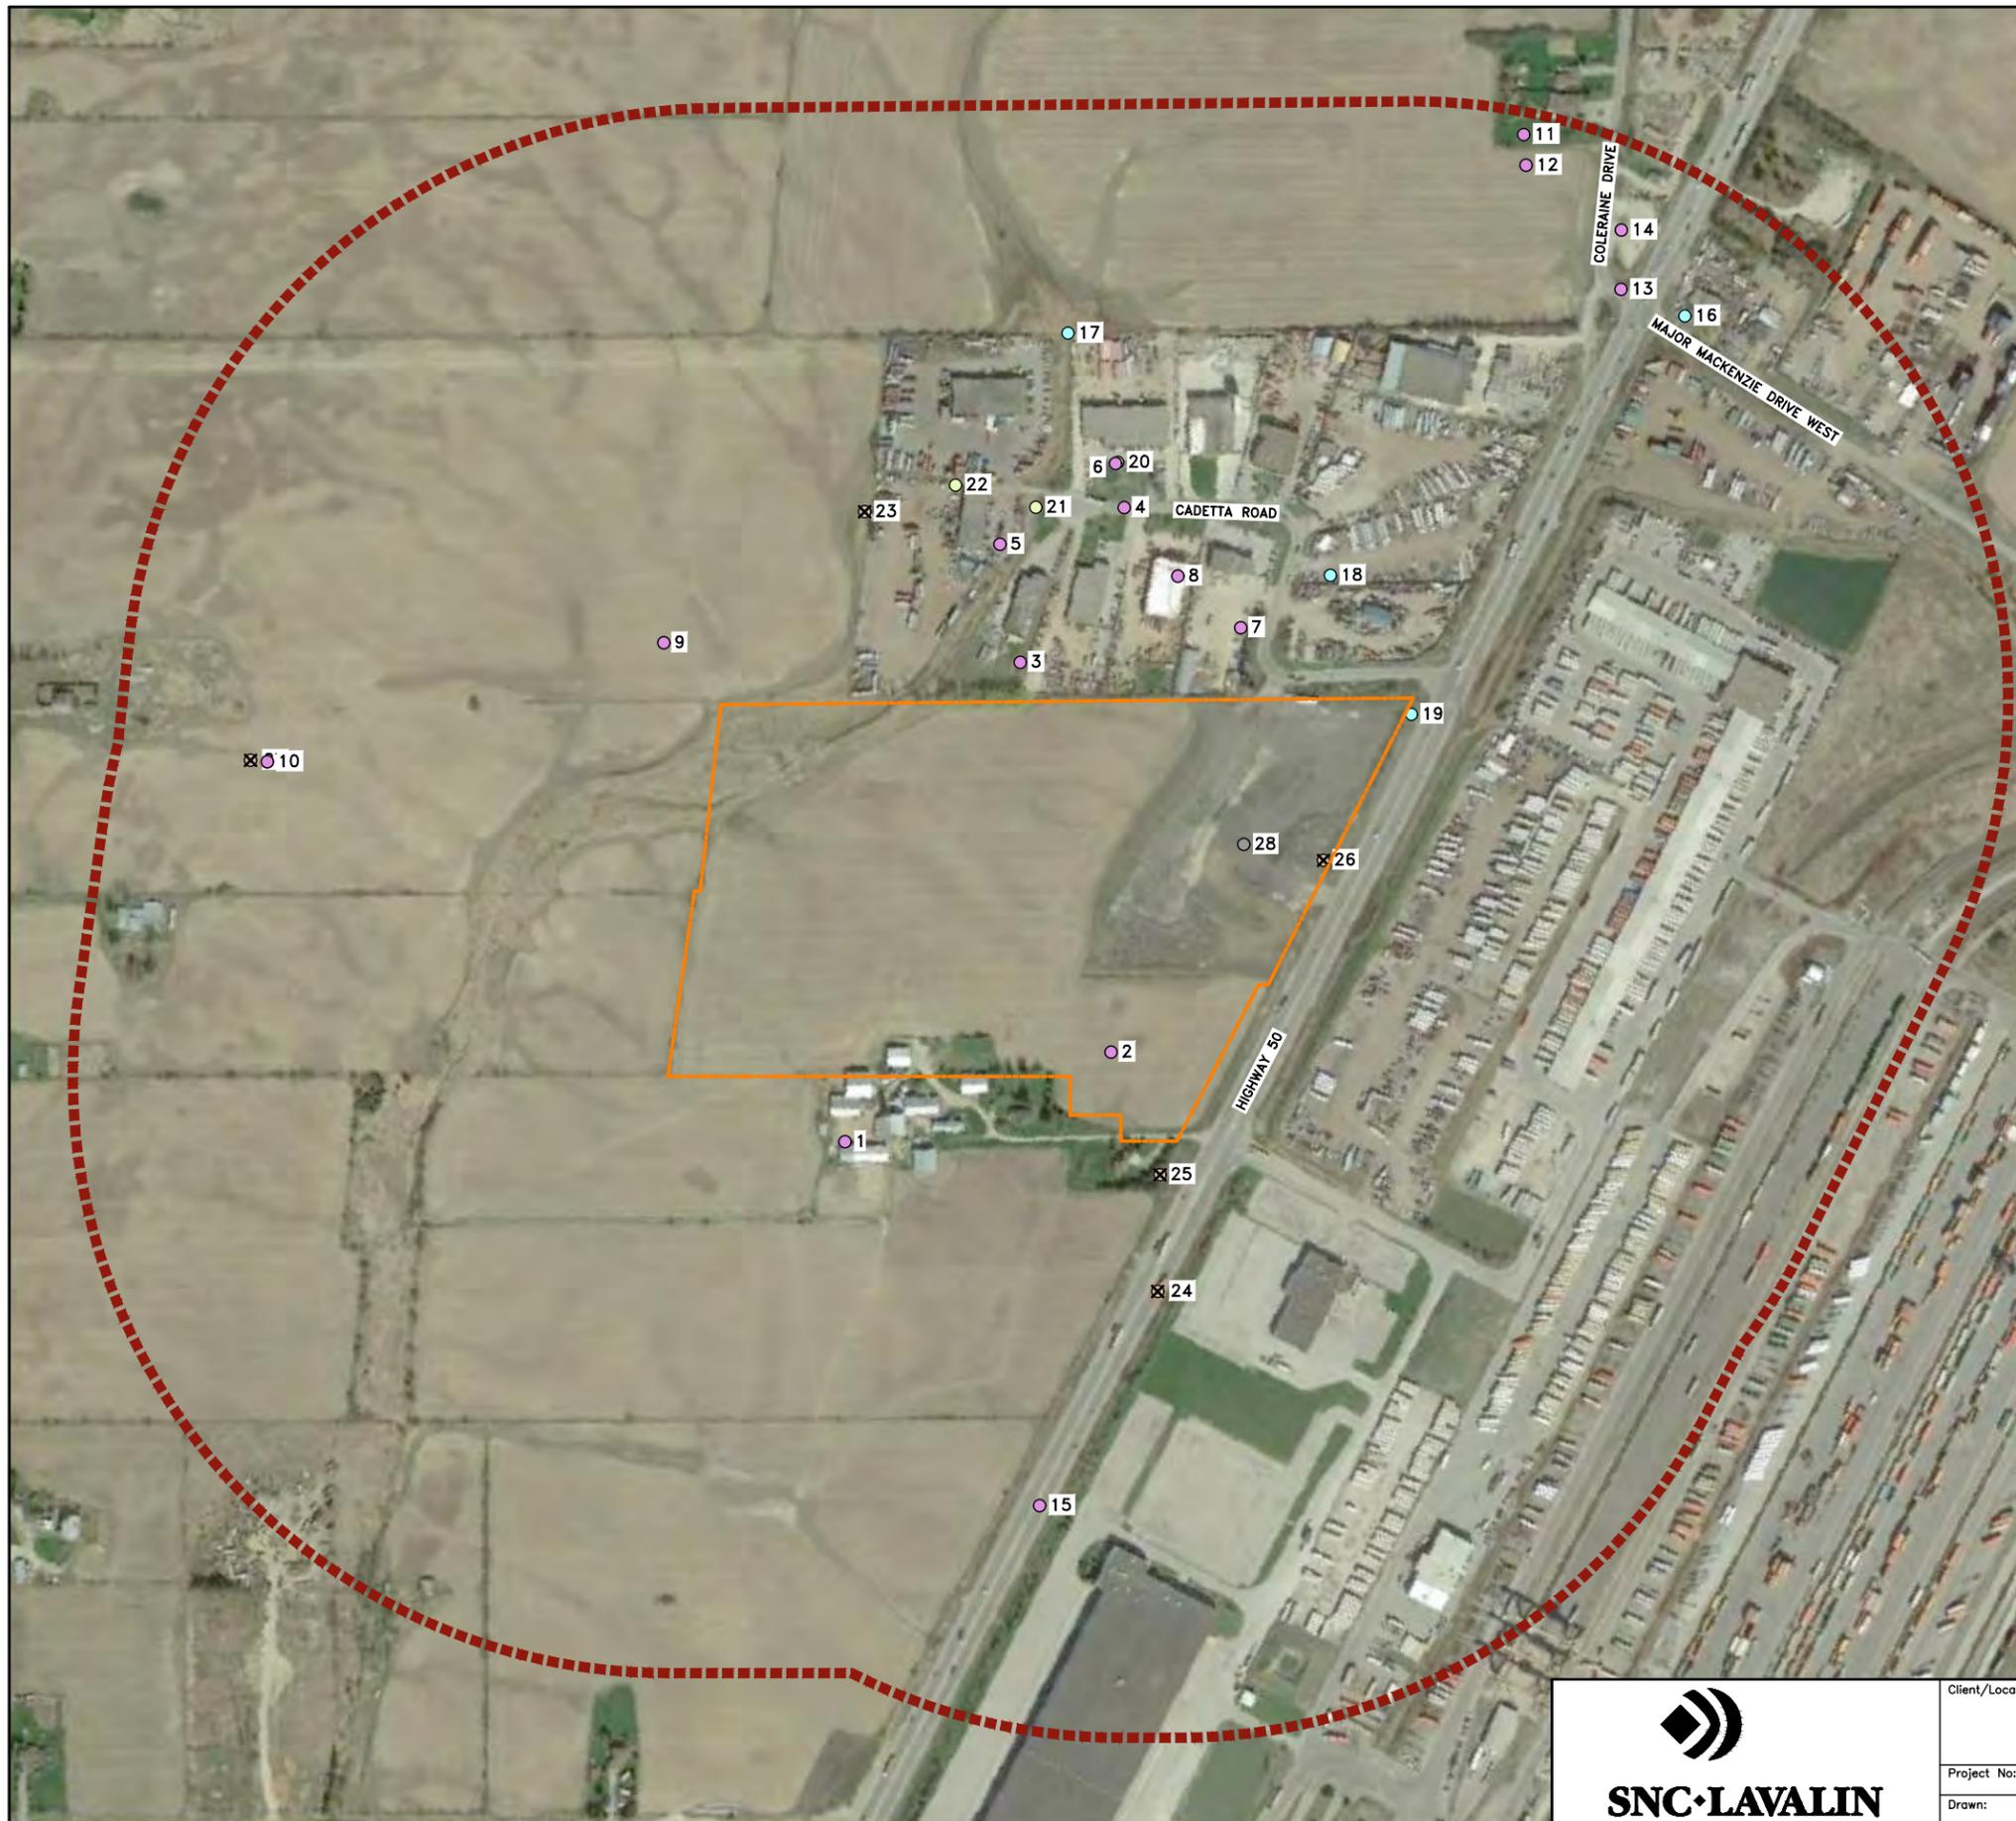
MECP Well Records

WELL LOCATION	WELL NUMBER	ADDRESS	DATE RECEIVED	USE
1	4902862	-	17-Jan-67	Water Supply
2	4905218	-	16-Nov-77	Water Supply
3	4905247	-	07-Dec-77	Water Supply
4	4905769	-	10-Apr-81	Water Supply
5	4905812	-	03-Nov-81	Water Supply
6	4905813	-	03-Nov-81	Water Supply
7	4906179	-	18-May-84	Water Supply
8	4906478	-	08-Aug-86	Water Supply
9	4908701	-	07-Feb-01	Water Supply
10	4902865	-	17-Jan-67	Water Supply
11	4904154	-	29-Aug-73	Water Supply
12	4904215	-	27-Nov-73	Water Supply
13	4904866	-	10-May-76	Water Supply
14	4905674	-	05-Aug-80	Water Supply
15	6907184	-	-	Water Supply
16	4909717	10021 HWY 50	-	Observation Wells
17	7116410	10514 COLERAINE DR.	-	Observation Wells
18	7241945	4 CORDETTA RD	28-May-15	Observation Wells
19	7282340	HWY 50 SOUTHBOUND LANE SOUTH OF CADETTA RD	28-Feb-17	Observation Wells
20	7166972	12 CADETTA RD	09-Aug-11	Test Hole
21	7178624	16 CADETTA ROAD	29-Mar-12	Test Hole
22	4905768	-	10-Apr-81	Test Hole

23	7225368	16 CADETTA RD.	12-Aug-14	Abandoned-Supply
24	7249972	HWY 50 ASTLEMORE ROAD-COLERAINE DR.	14-Oct-15	Abandoned-Other
25	7249973	HWY 50 CASTLEMORE RD. & COLERAINE DR.	14-Oct-15	Abandoned-Other
26	7249974	HWY 50 CASTLEMORE RD. & COLERAINE DR.	14-Oct-15	Abandoned-Other
27	4902864	-	17-Jan-67	Abandoned-Quality
28	7279718	-	26-Jan-17	Unknown

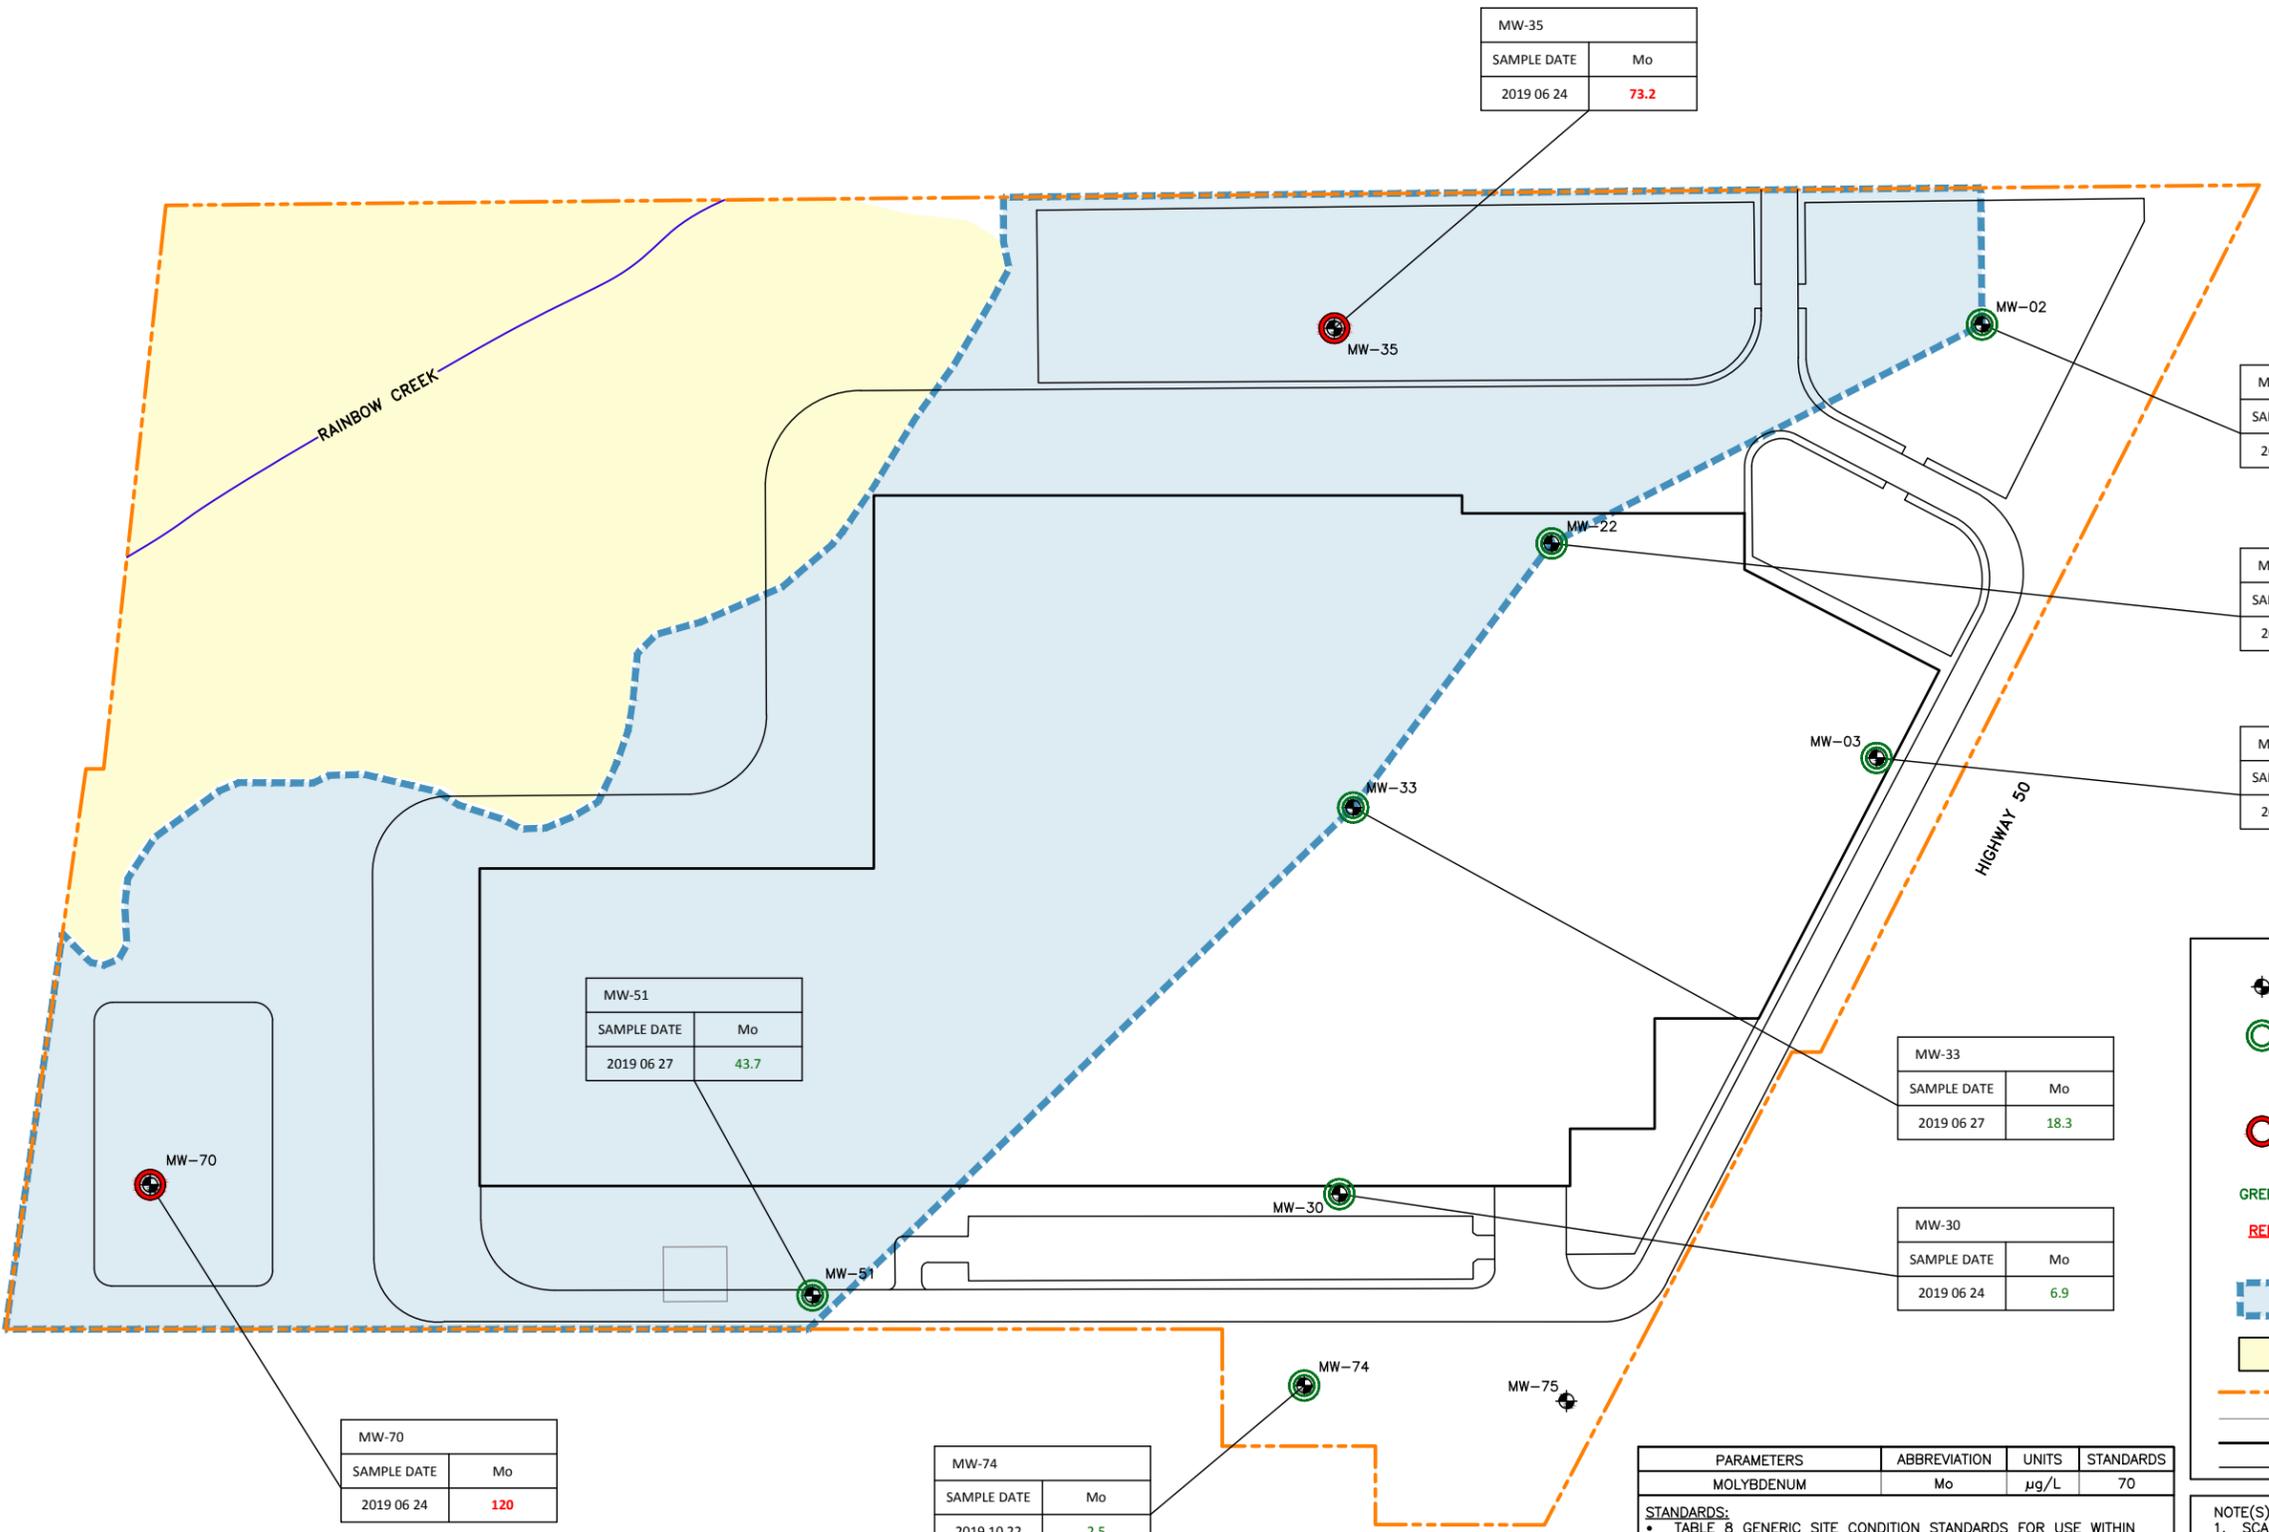
Client/Location:		CITY OF BRAMPTON 10192 HIGHWAY 50, BRAMPTON, ON		Title:		GROUNDWATER ANALYTICAL RESULTS	
	Project No:	665125	Filename:	008F11_665125	Date:	NOVEMBER 2019	Dwg No:	APPENDIX I
	Drawn:	AG	Verified:	WL	Project Manager:	AY

- MONITORING WELL (SNC-LAVALIN, 2019)
- LOCATION WHERE MOST RECENT GROUNDWATER SAMPLE MET STANDARDS FOR ALL PARAMETERS THAT WERE ANALYSED, SHOWN IN GREEN
- LOCATION WHERE MOST RECENT GROUNDWATER SAMPLE EXCEEDED STANDARDS FOR AT LEAST ONE PARAMETER THAT WAS ANALYSED, SHOWN IN RED
- GREEN** GREEN COLOURED CONCENTRATION MET THE MOE STANDARD
- RED** RED COLOURED AND UNDERLINED CONCENTRATION EXCEEDED THE MOE STANDARD
- INFERRED LIMITS OF CONTAMINATION
- TORONTO AND REGION CONSERVATION AUTHORITY (TRCA) FLOODPLAIN
- SITE PROPERTY LINE
- EXISTING BUILDING
- PROPOSED BUILDING
- PROPOSED INFRASTRUCTURE

The results indicated, concentrations of molybdenum exceeded the MECP Table 8 standards in two (2) monitoring wells (MW-35 and MW-70) during the groundwater sampling event in June 2019. The results from the remaining monitoring wells satisfied the applicable site condition standards (Table 8 Standards).
