TECHNICAL MEMORANDUM

City of Brampton

Denison Avenue Extension Safety Review

Safety Review

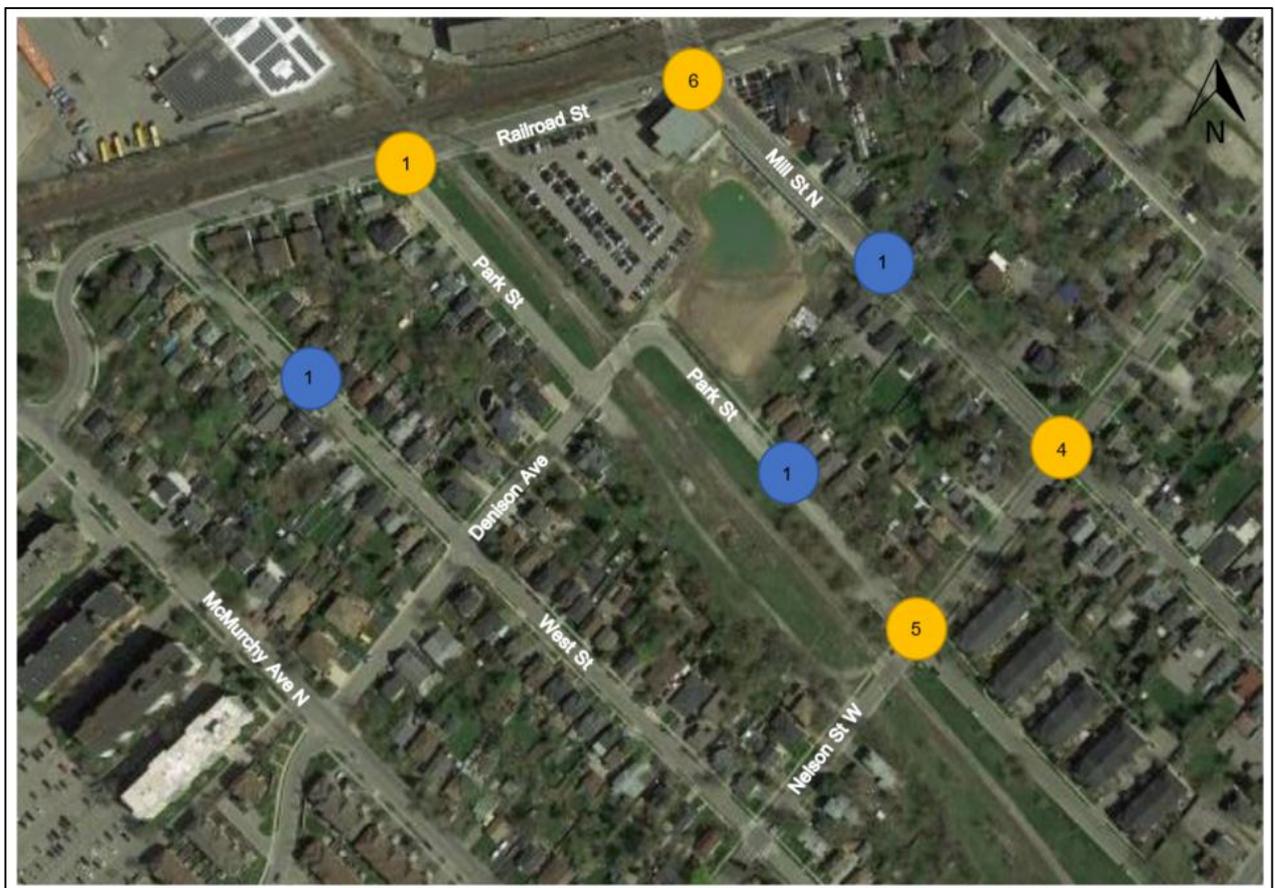
Figure 2-1
Collisions in Study Area (2013-2018)

Collision data from a five-year period (January 2013 – December 2018) was reviewed as part of this assessment. As seen in **Figure 2-1** and summarized in **Table 2-1** below. None of the collisions involved pedestrians or cyclists, nor did any involve trains. **Appendix A** contains further details on the collision data provided by the City.

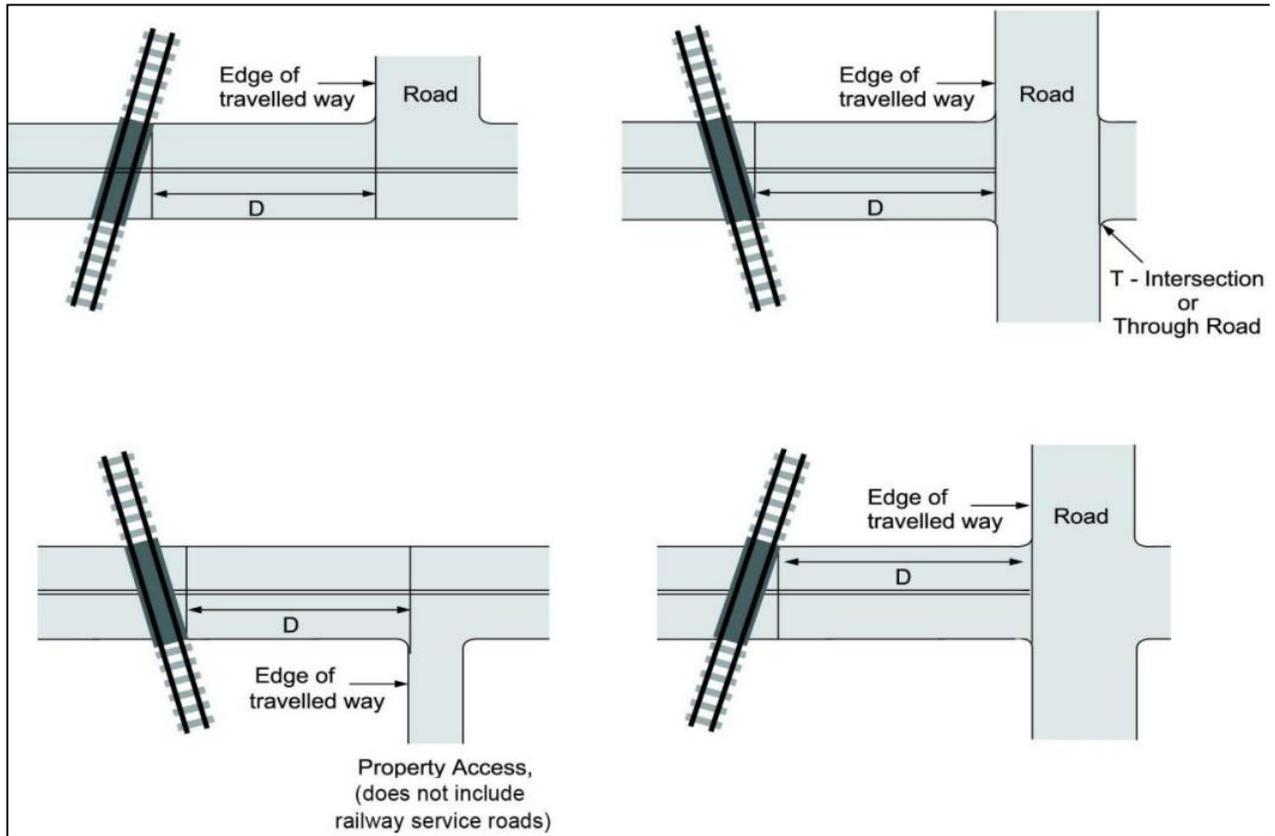
**Figure 2-7
Proximity Restrictions³**

Park Street intersects Denison Avenue approximately 13 metres west of the OBRY grade crossing. Field reviews confirm that, given the very low observed volume of traffic at the time of observation, it was not evident that there was any traffic regularly queuing across the tracks. While this intersection is currently non-compliant, its construction and use pre-dates the changes in the Standards.

The proposed Metrolinx access to the rear entry of the development at 45 Railroad Street is currently shown to be within 30 metres to the rail crossing, which is not compliant with the Standards, as shown in **Figure 2-7**. Section 11 of the Grade Crossing Standards states that “A public grade crossing where the railway design speed is more than 25 km/h (15 mph) must be constructed so that no part of the travelled way of an intersecting road or entranceway (other than a railway service road), is closer than 30 m to the nearest rail of the grade crossing”.

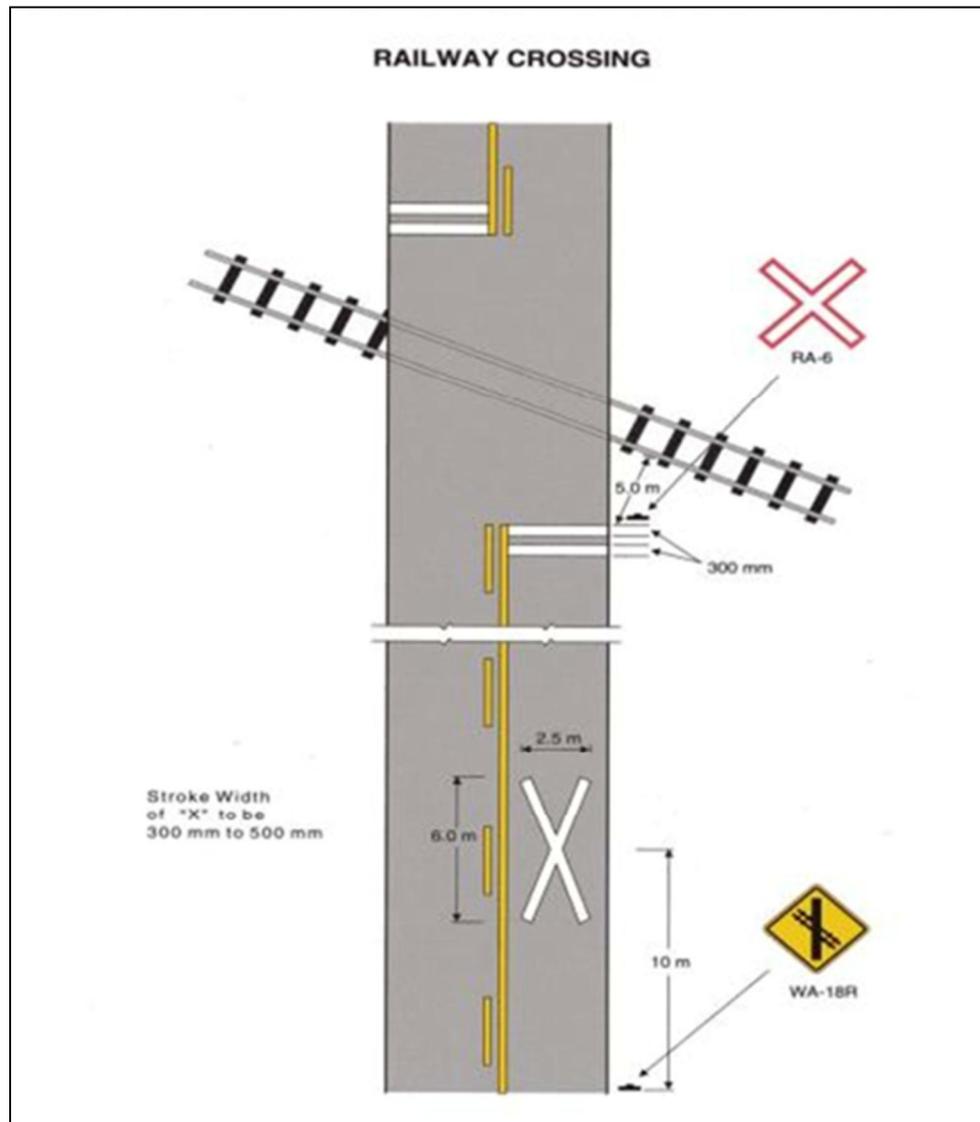
Figure 2-11
OTM Book 11 – Pavement Markings at Railway Crossings

Both the stop bars and painted X's are appropriately placed, and the paint is currently in suitable condition. However, the yellow centrelines were absent from this crossing location. Once construction at 45 Railroad

is completed, the stop bars and X's should be repainted, and the yellow centreline should be added. **Figure 2-11** shows the pavement markings to be provided at a railway crossing, as per OTM Book 11.
